BARBARA MARIA DEJA*

RENOVATION OF THE HISTORIC OLSZTYN VILLA CASABLANCA

The paper outlines the details of the design and difficulties that had to be overcome in the course of the renovation and adaptation of a rich German factory owner's residence from 1912, which in 1988 was entered into the register of historic buildings of the Warmia and Mazury region.

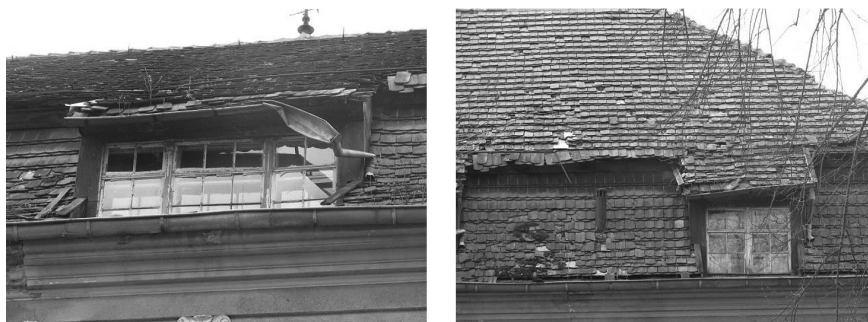
The most extensive damage noticed by the present owners when taking the building over were caused by leaking insulation layers, the failure of the rain water drainage system and losses of roof sheeting (Fig. 12, 13).

The result of flooding was partial fungal infection of the roof structure (which were also infested with wood pests) and floor damage.

Fig. 12, 13. The condition of roofing and guttering before renovation, 2008

Solving the rain water drainage issue, the structural repair of the roof, the replacement of the roofing (new timber and tiles), the protection of terraces and balconies against damp, replacing old plaster and the terrazzo layer and rebuilding the main entrance stairs were considered the main tasks to fulfil.

The roof structure required only minor repairs, but the roofing was completely replaced (the colour of the new plain tiles perfectly matched the original).

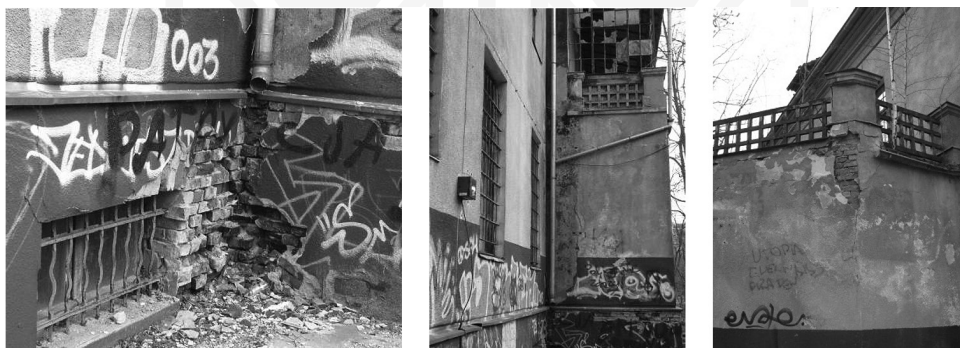
The dampness of the walls, escalated by recurrent freezing and thawing, caused numerous seam failures as well as the powdering and flaking of plaster. Areas of the walls striped of plaster were infested with micro-organisms. The destruction of the walls increased because of the cement plaster that was applied in the mid-twenties of the 20th Century being too permeable to water vapour [5].

Some parts of the plinth walls were also damaged due to rain water gathering caused by failure of the original sewer system. In the second half of the 20th Century, the plinth walls were fixed with terrazzo but it also did not help and finally went off especially around the main entrance and around the drain pipes (Fig. 14–16).

The cornice under the roof and the stuccowork details around the windows (covered with sealing cement, and few layers of emulsion paint) were constantly soaked with water which resulted in many seam failures and chipping. The terraces and the walls beneath lacked tight horizontal waterproofing. The most exposed elements of the elevations and the external stairs were also severely damaged by rain water (Fig. 16).

Fig. 14–16. The damage to walls caused by soaking, 2008

The old, damaged plaster of the diverse structure covering the external walls, which was successively repaired by applying more new layers in the past, was removed, and after scrupulous stratigraphic studies, the original colour of the elevation was restored.

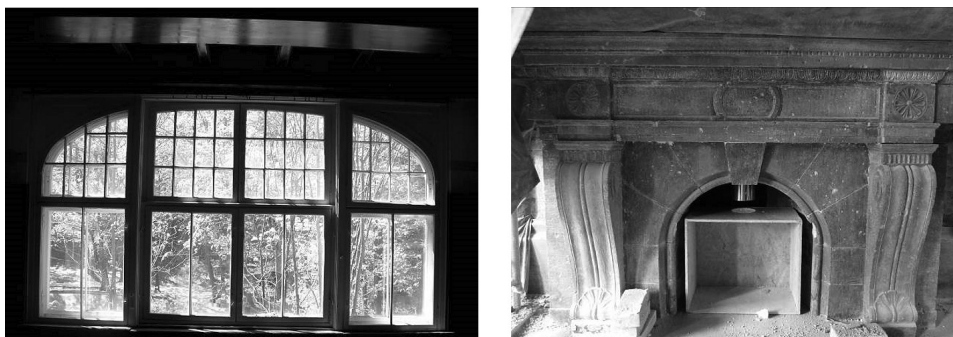
The interior is quite well preserved with historic ceilings, stairs, panelling and fireplaces (Fig. 18). However, the stuccowork decoration of the representative chambers, the art nouveau window bars in the roof windows and the historic carved doors all needed thorough renovation.

Fig. 17, 18. The splendid window in the dining room (2006) and the historic fireplace during the restoration process, 2011

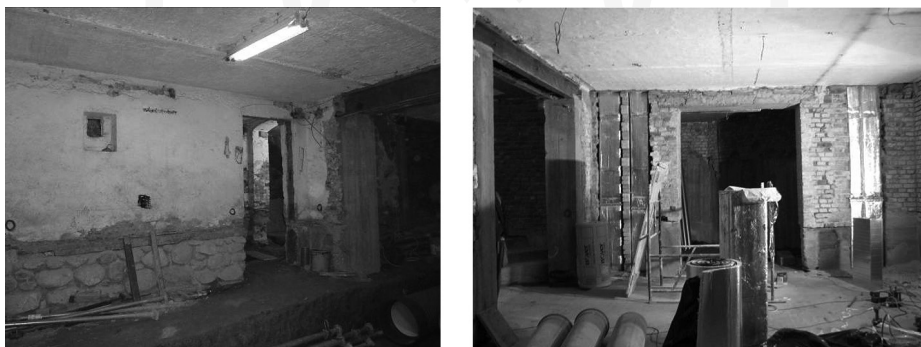
The decision of locating a restaurant in the cellar required the removal of some of the walls and the lowering of the floor level, hence lowering of the foundations. In the foundation design (proceeded according to Eurocode 7 [12]) there were many elements that had to be considered, and namely the relocation of bearing walls and bigger load of the building as a result of the functional changes and the allocation of the ventilation channels under the floor of the cellar (Fig. 21).

Fig. 21, 22. The works of deepening the cellar, 2011

In order to make the usable height of the underground rooms greater than 1.0 m, the cellar walls were partially undercut and founded on the monolithic walls and the strip foundation (Fig. 22). Work was conducted with a high degree of diligence in order to avoid damaging the ceramic, segmental ceilings above the cellar.

The sectional strengthening of the foundation was made alternately from both sides of the walls. The excavated wall segments were cleaned of debris and the brims were hammered to the required level of the designed floor and finally, after setting up reinforcement bars,

they were filled with concrete of C16/20 class. The reinforcement of the foundation was conducted successively after reaching the required strength in the previously repaired foundation sections.

The foundations were covered with a damp proof course. The foundation walls and cellar walls were isolated with waterproof plaster and a cover against mechanical damage.

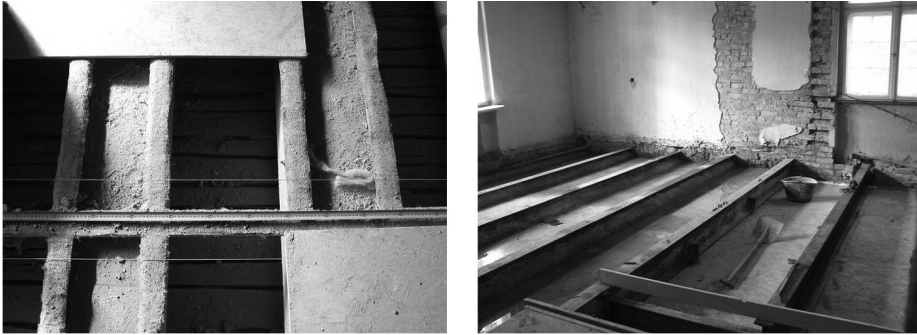
In the main part of the building, where the historic value of the ceiling is considerable and the strength of the wooden beams is insufficient (calculations made acc. to Eurocode 5 [15]), the cross-sections of the beams were reinforced by fixing additional timber elements on both sides of the beams (Fig. 23). The gaps between the beams were filled with mineral wool – additionally, fiberboard was used as sound insulation. Fire protection was guaranteed thanks to the paneling of the ceilings with fireproof materials (this protection was applied only from the upper side due to the need to preserve the original stuccowork of the ceilings).

Fig. 23, 24. The timber ceiling beams strengthened by additional wooden elements from both sides, and a new R-C ceiling based on steel beams, 2011

In the lower part of the building, because of the installation of lifts and the demolition of a part of the bearing walls as well as large load changes, new R-C I-bars ceilings were designed (Fig. 24). These ceiling slabs are made of C16/20 class concrete reinforced with 34 GS steel, resting on the steel I-bars which were put in previously prepared chases in the old masonry bearing walls or new steel binding joists replacing some of the areas where the walls were demolished.

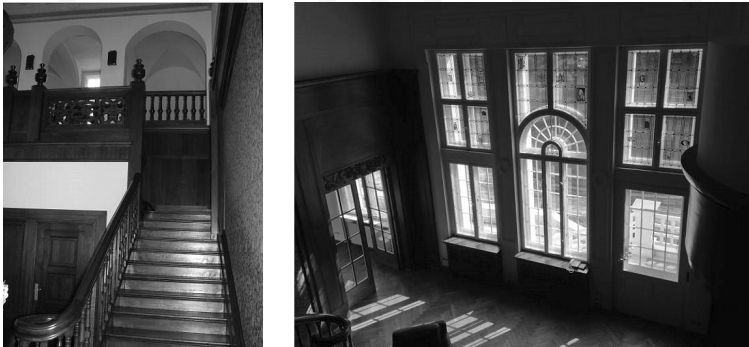
Fig. 25, 26. The historic staircase and the stained glass window in the ballroom after the renovation, 2013

The original, presentable, wooden staircase from the conference hall in the ground floor was restored (Fig. 25), as well as the ceramic stairs on steel beams in the maintenance area of the building. On the ground floor, to the left of the main entrance, a new staircase leading to the restaurant was made (Fig. 20).

The stained glass window in the ballroom (Fig. 26), as with most of the windows and interior doors (including a two-winged sliding door, hidden in the wall), was renovated. In the publication [16], there is a detailed description of the complex conservatory concerning the historic windows of Villa Casablanca.
