HENRYK CIUREJ*, PIOTR GWOŹDZIEWICZ*, ANTONI MAZERA**

ATYPICAL EXAMPLE OF THE REDUCTION OF THE SAFETY AND DURABILITY OF A TYPICAL MOTORWAY OVERBRIDGE

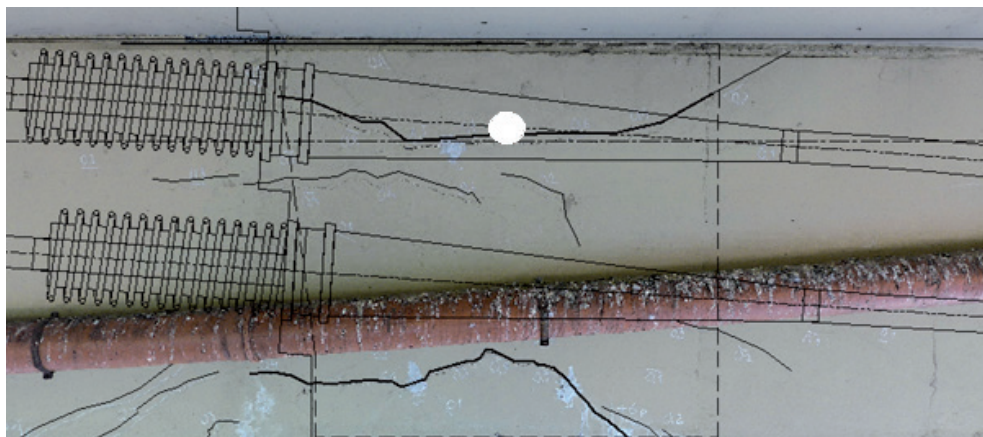
Clearly visible cracks served as the fundamental reason to undertake the tests and evaluation of the technical state of the structure. In the western side span of the bridge, the south girder was the most damaged. Numerous horizontal and skew cracks were concentrated mainly in the area located more than 5.0 m from the support towards the abutment. The area

with a high concentration of cracks is located directly at the construction joint, which is 5.0 m from the support. Fig. 2 presents the crack distribution over the surface of the beam together with the position of the cable ducts and the joint between the construction segments built successively.

Fig. 2. Layout of cracks on the beam surface and the position of the joint between the structure segments and prestressing cable ducts

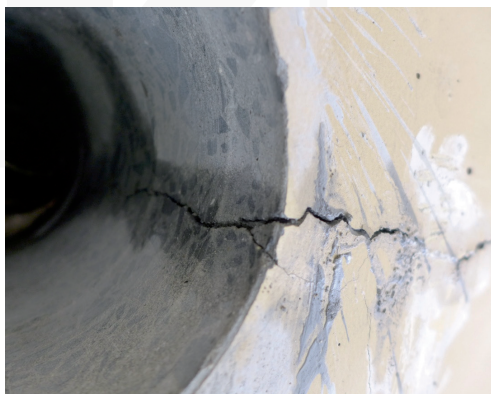
Due to the large width of cracks observed on the member's surface, the decision was taken to drill a core specimen along one of the cracks. The aim of this drill specimen was to investigate the depth and direction of the crack. The drilling was positioned at the level of the axis of the upper prestressing tendon, where the diameter of the cable duct progressively changes from 275 mm at the coupler to 100 mm at the entrance to the regular cable duct. In Fig. 2, the position of the drill is shown (indicated with a white dot). Because the crack width (Fig. 3) observed in the direction perpendicular to the surface was not decreasing, the drilling continued until the steel cover of the cable duct was reached. Inspection of the drill surface revealed the presence of another crack perpendicular to the drill axis and located 80 mm below the concrete surface. This crack is visible in the upper part of the drilled wall, slightly before the steel shield of the cable duct (Fig. 4). The observation of the crack inside of the drill specimen is in line with another observation of the concrete cover spalling – this was confirmed by means of an acoustic check of the concrete surface using a metal hammer.

Fig. 3. Crack position in the drill wall of the beam under investigation

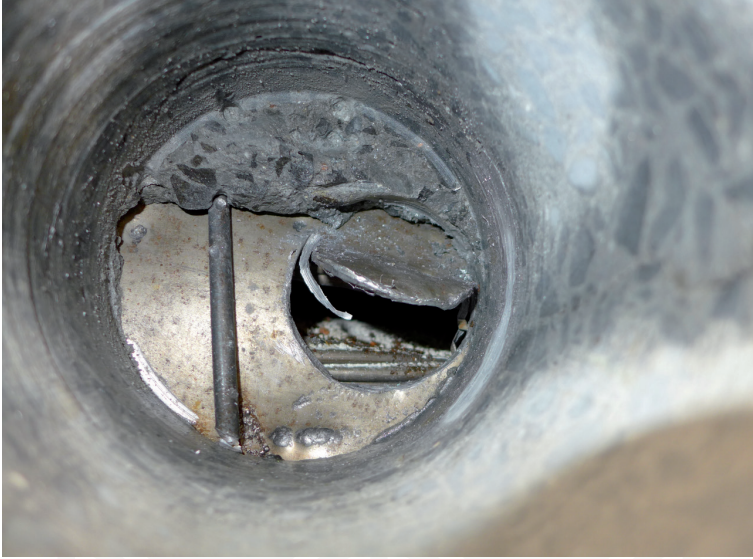
Fig. 4. View into the drilled hole in the girder subjected to investigation. The steel cover of the prestressing cable duct and its interior are visible

Observations regarding materials inside of the structure in the area of drilled cores also brought many interesting observations. After penetrating the cable duct shield, it was found that instead of the duct being completely filled with cement grout as expected, there was a substantial lack of grout (Fig. 4). Punctual corrosion of the stressed, exposed prestressing strands was also found inside of the duct. The mortar filling the bottom part of the prestressing cable duct was non-cohesive – it was in the form of a powder with a grain size of 1–4 mm and with a white-beige colour. The lack of grout in the proper form, local corrosion of the prestressing strands as well as the corrosion points on the surface of the cable duct shield are evidence of the risk of tendon corrosion. The interior of the cable duct is shown in Fig. 6. Naked strands, local corrosion of the prestressing steel as well as of the internal surface of the duct shield was observed. Moreover, concrete splitting from the external surface of the cable duct shield was also observed (Fig. 4).

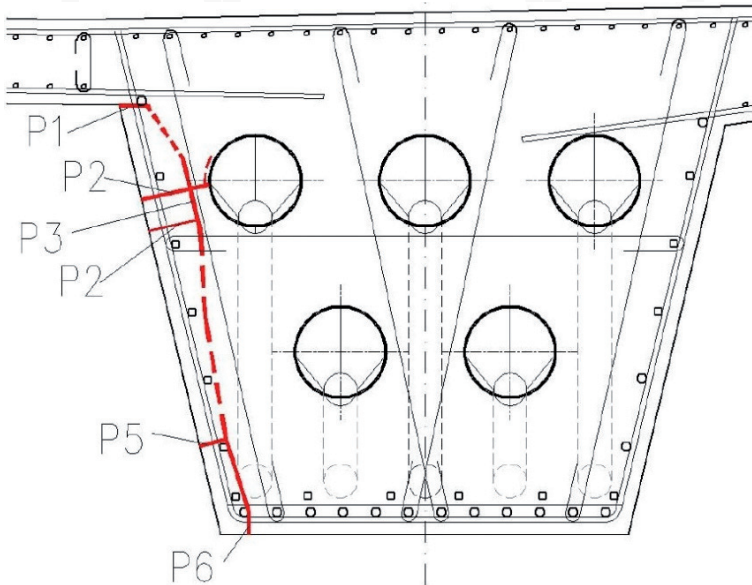
Fig. 5. Spalling of concrete along the depth of the girder – the continuous line represents the observed cracks, the dashed line represents their hypothetical trajectory. P1 to P6 – observed locations of cracks

The acoustic check indicated that the spalled layer occurs on the whole vertical edge of the beam from the slab at its top to the bottom edge and the length of the damaged area along the beam exceeds 2.5 m. The position of the observed splitting and its hypothetical trajectory are shown in Fig. 5.

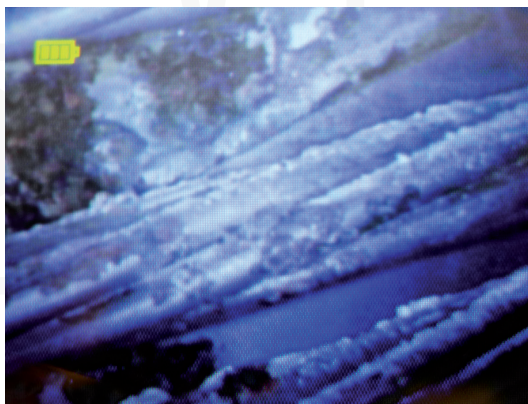
Fig. 6. View of the interior of the prestressing cable duct
