WACLAW CELADYN*

CLIMATIC ASPECTS OF DURABILITY
IN CONTEMPORARY ARCHITECTUREKLIMATYCZNE ASPEKTY TRWAŁOŚCI
W ARCHITEKTURZE WSPÓŁCZESNEJ

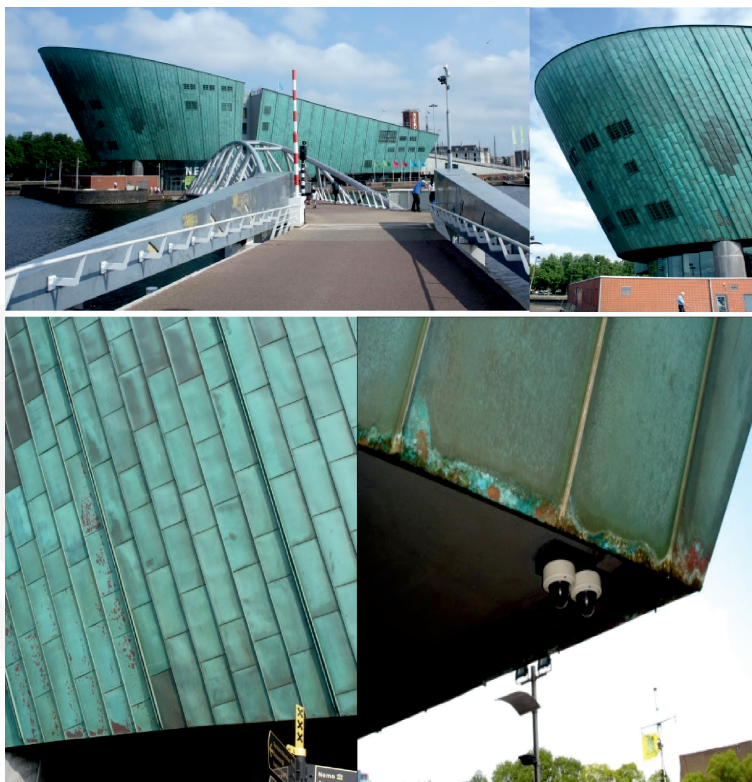
Ill. 1, 2, 3, 4. Nemo Science Center, Amsterdam (arch. R. Piano), 1997 (photo by author)

Among the analyzed examples of contemporary Dutch architecture, a spectacular case of deterioration, unexpected to this extent, is the building of the Nemo Science Center in Amsterdam. Located by the water, it is subjected to degradation of the technical and aesthetical values of its elevations (Ill. 1).

It was constructed in 1997, and after 17 years of its use presents visible symptoms of unintended damages to the copper cladding. This is the case of the north façade, which faces a nearby water basin. Traditionally resistant to climatic factors, the copper sheet has yielded to early degradation and a disfiguring process of patchy change of colour can be seen (Ill. 2,3). On the south elevation, a spotty tarnish on the patina and discoloured coating appears over a series of corrosion spots at the lower edge of the cladding (Ill. 4). Even during a nice, rainless weather, the water drips from it, due to a water basin and cascades located on top of the building.

It seems that the stains on the copper sheet and the apparent deposits of dust have appeared due to the detrimental action of climatic factors. It is the rain water, which has not yet washed off the dusty overlay from the negatively inclined façade during the multiple cycles of its watering. A proof of this process may be the lighter and natural colour of the copper elevation, that remained unchanged at its upper brim, as well as the apparent streaks made by the water flowing down the façade and dislocating the dust deposits, eventually forming darker patches below. Similar patterns can often be seen on the stone facades. More intensively washed vertical west elevation, which is subjected to the action of prevailing winds, is devoid of such disfiguring effects. This is probably due to its tilt encouraging the washing. (Il. 1). In the case of the south elevation (Ill. 3), the apparent spots of corrosion should be assigned to faulty workmanship, and possibly also to poor design solution. A shallow water pool with cascades, located on top of the building, has contributed to that deteriorating process. A faultless construction in this case would be a very difficult task. The one carried out on this roof has proved to be technically unreliable, causing the water penetration into the structure of the façade, and eventually its flow down the internal face of the copper cladding.

Spośród analizowanych przykładów holenderskiej architektury współczesnej dość spektakularnym przykładem degradacji, zapewne niespodziewanej w tym stopniu, jest budynek Nemo Science Center w Amsterdamie. Usytuowany bezpośrednio nad wodą, ulega widocznemu obniżeniu wartości technicznych i estetycznych swoich elewacji (il. 1). Wybudowany w 1997 roku, po 17 latach użytkowania demonstruje widoczne symptomy niezamierzonych zmian na fasadach z blachy miedzianej. Ulegają ona stopniowo procesowi plamiastych przebarwień północnej, wyeksponowanej na zbiornik wody, części elewacji. Jak widać, nawet odporna na czynniki atmosferyczne blacha miedziana nie oparła się stosunkowo wczesnej degradacji (il. 2 i 3). Miejscowa zmiana barwy blachy miedzianej i wyraźny nalot przebarwiający obserwuje się również na elewacji południowej, powyżej widocznego na dolnym obrzeżu blach skupiska ognisk korozyjnych (il. 4). W tym miejscu nawet przy ładnej, bezdeszczowej pogodzie można zauważyć wodę ściekającą po materiale elewacji z basenu znajdującego się na dachu budynku.

Jak się wydaje, przebarwienia w formie wykwitów oraz osadu pyłu można odnieść do czynników klimatycznych – głównie wody opadowej, która nawet z powierzchni ujemnie nachylonej nie zdołała spłukać warstwy pyłu w trakcie wielu cykli nawilżania. Świadczyć o takim procesie może jaśniejsza, naturalna barwa blachy w strefie górnej krawędzi elewacji. Widać wyraźnie zacieki od wody przemieszczającej osad pyłu w kierunku na dół i jego koncentrację w postaci ciemniejszych plam poniżej. To proces dość często obserwowany również na elewacjach kamiennych. W tym wypadku intensywniej spłukiwana elewacja od strony zachodniej (dominujący kierunek wiatrów) jest pozbawiona ciemniejszych plam; zapewne również ze względu na pionową, a nie nachyloną ujemnie powierzchnię tej części elewacji (il. 1). Jeśli chodzi o fasadę południową (il. 3), powstanie ognisk korozyjnych należy przypisać błędowi wykonawczym, a zapewne i projektowym. Na dachu umieszczono wzmiankowany wcześniej płytki basen wodny z kaskadami. Rozwiązanie takie niezwykle trudno zrealizować w sposób bezbłędny i stąd penetracja wody z dachu do struktury elewacji i jej spływ po wewnętrznej stronie blachy.

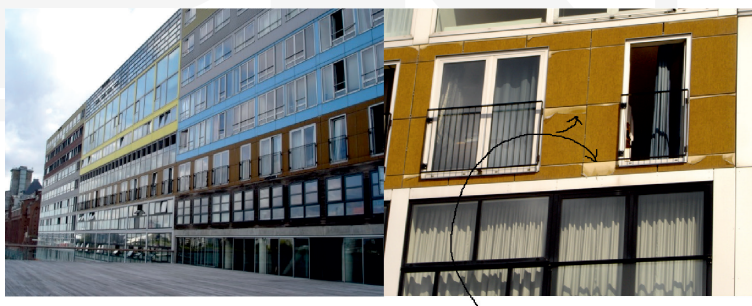
Ill. 5, 6. Office and residential building Silodam, Amsterdam (arch.MVRDV), 2002 (photo by author)

The building has been constructed in a climatically utterly adverse location, over the river bank, and founded on piles. It is a very windy place. The building facades are clad in a few various materials, being a designers' aesthetical option (il.5). After 12 years of its use, the majority of applied materials do not exhibit substantial apparent signs of deterioration, except for the fragments of the elevation clad in beige HPL (High Performance Laminate) panels. Some of them have been conspicuously damaged by the wind. Their outer finishing layer has partly come off along the edges (Ill. 6). This defacement of the outer skin of the building seems to have been unavoidable in such adverse climatic conditions. The synergetic action of the wind and humid air, as well as that of the slanting rains, have brought about the disintegration of this vulnerable cladding material. The bonding capacity of the resinous glue in those panels has presumably subsided, and ultimately has caused this negative effect. The HPL materials, having been in a relatively short-time use, have demonstrated their obvious flimsiness in such extreme conditions. That serious degradation could have probably been avoided, or at least reduced by the application of a waterproof framing along the edges of the panels. It would protect them from the penetration of rain water and humidity inside them.

Ten obiekt jest usytuowany w skrajnie niekorzystnej klimatycznie lokalizacji. Znajduje się ponad wodą przy brzegu i jest zbudowany na palach. W miejscu tym wieją silne wiatry. Elewacje obiektu są wykonane z kilku odmiennych materiałów, co było estetyczną opcją projektantów (il. 5). Po 12 latach użyt-

kowania większość materiałów nie wykazuje istotnych widocznych oznak degradacji. Jednakże wyjątkiem są fragmenty fasady wykończone bezowymi płytami HPL (*High Performance Laminate*). Na ilustracji 6 widać wyraźnie częściowo oderwane fragmenty laminatu. Zauważalna degradacja płyt laminatu w postaci oderwanych przez silne wiatry zewnętrznych warstw na ich obrzeżach wydaje się zjawiskiem nieuniknionym w tych warunkach klimatycznych. Synergiczne oddziaływanie wiatru i znacznej wilgoci w powietrzu, a także zacinających deszczy, doprowadziło do rozwarstwienia tego wrażliwego materiału. Siła wiążąca lepiszcza żywicznego w płytach uległa zapewne osłabieniu, powodując opisywane zjawisko. Materiały HPL, będące jeszcze w stosunkowo niedługim użytku, wykazały w tych ekstremalnych warunkach swoje ewidentne wady. Prawdopodobnie uniknięto by tak poważnej degradacji, zabezpieczając krawędzie płyt przed penetracją wilgoci do ich wnętrza przez zastosowanie szczelnego profilu obwodowego.

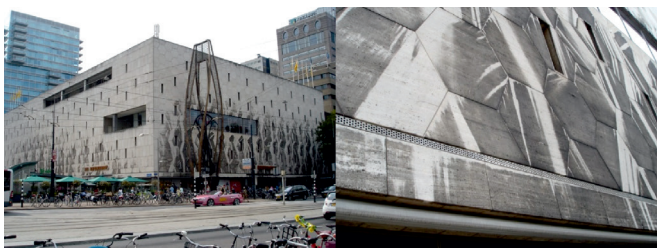
III. 7, 8. Shopping center De Bijenkorf, Rotterdam (arch. M. Breuer), 1957 (photo by author)

This building has its long history, and thereby, it is different from the new ones analyzed above. It was constructed in 1957 (arch.M.Breuer). The travertine-clad facades are marked with spectacular dark patches making a characteristic pattern (Ill. 7). Fifty seven years after their installation, they present quite a similar image as it was in the 18-th year of the building's use, when I perceived them previously. The high porosity of the applied stone favours the water penetration into its structure, resulting in an easy adherence of dust to its surface. A thick deposit of dust particles can be easily spotted on the building's east façade

exposed to a city's thoroughfare, where the dust is being intensively stirred and raised, due to heavy traffic. It is the lowest part of the façade, which is, quite understandingly, especially subjected to this process. The upper part of this elevation, being less intensively covered with dust, and more intensively washed with rain water, has maintained its original appearance. On the basis of an analysis of the superficial water flow, it can be claimed, that the intriguing patchy pattern on the facades has presumably been made as a result of their specific articulation. It was achieved by the use of identical hexagonal stone panels, separated by relatively deep joints, which had formed draining channels (Ill. 8). The changing direction of the local strong winds in this city have caused the streaks of rain water flow down the facades, in a way to form an irregular pattern of fragmentarily preserved dust deposits. As it seems, the porous character of the applied stone had made the procedures of cleaning and maintenance works, carried out at some time, visibly ineffective. They not only had failed to remove the dusty deposits, but presumably, even made them permanent. The analyzed effect of climatic deterioration of the facades, basically, does not reduce substantially the technical performance of the applied material, in this case. However, in the majority's opinion, it has a significant negative impact on the aesthetical values and durability of the building.

Ten obiekt ma długą historię i z tego względu nieco odbiega swoim charakterem od poprzednich, gdyż okres jego budowy sięga 1957 r. (arch. M Breuer). Trawertynowe elewacje budynku pokryły się spektakularnymi ciemnymi plamami o charakterystycznym wzorze (il. 7). Po 57 latach użytkowania wyglądają niemal tak samo, jak po 18 latach, gdy ich stan poprzednio zarejestrowałem. Znaczna porowatość kamienia sprzyja penetracji wody do wnętrza jego struktury i tym samym przywieraniu pyłu do powierzchni. Grubszy osad pyłu można zauważyć szczególnie na elewacji od strony ruchliwej drogi i w dolnej jego partii, co jest zrozumiałe. Górna partia fasady, podlegająca mniejszemu zapyleniu i intensywniej zmywana wodą opadową, zachowała naturalny kolor. Jak można przypuszczać na podstawie analizy spływu wody po elewacji, powstały na niej intrygujący wzór plamisty wynikł zapewne ze specyficznego jej podziału za pomocą sześciokątnych, jednakowych płyt kamiennych z zachowaniem dość głębokich spoin. Stały się one kanalikami odprowadzającymi wodę (il. 8). Zmienny kierunek silnych wiatrów w tym mieście portowym uwidocznił się w niejednorodnym ułożeniu strug wody splukujących fragmentarycznie pył. Przypuszczalnie ze względu na porowaty charakter kamienia procedury jego czyszczenia konserwacyjnego tylko w niewielkim stopniu usunęły plamy, a być może nawet je utrwaliły. Zanieczyszczenie elewacji w tym wypadku nie obniża zasadniczo stanu technicznego ich materiału, wpływa jednak zapewne w powszechnej opinii na obniżenie walorów i trwałości estetycznej budynku.

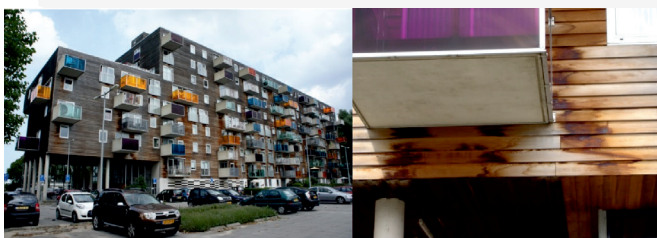
III. 9, 10. Seniors house WoZoCo, Amsterdam (arch. MVRDV), 1997 (photo by author)

It is particularly conspicuous on the south façade (Ill. 9), which is finished with horizontal wooden siding.

The brown planks have been sporadically marked with bleached streaks made by the rain water washing out the dark impregnant. This effect has, certainly, not been taken into account by the architects, as part of their initial aesthetical concept. Slanting rain water has made unevenly arranged patches of bleached material. The washed-out impregnant has been dislocated and spots of its concentration appeared in the direct vicinity of the streaks of water, which flowed down the façade forming darker irregular strips (Ill. 10).

An analysis of the case indicates, that the irregularity of this pattern results from the unevenly located windows and balconies, which spectacularly protrude from the façade's plane. They protect some parts of the façade against the rainwater on the one hand, but on the other, they direct the streams of water to other parts of the cladding. Noteworthy is the comparison of the look of the south façade with the other ones. The west elevation has no discoloured patches (Ill. 11). This is due to its more advantageous orientation, in relation to the local dominating winds, as well as its protective screening by a neighbouring building and trees. This situation proves a diversified impact of climatic factors on building facades, depending on their spatial configuration.

Budynek ten nie znajduje się wprost w bezpośrednim sąsiedztwie zbiorników wodnych, niemniej dość silne wiatry w portowym Amsterdamie na luźno zabudowanej przestrzeni oraz problematyczny dobór materiału elewacji spowodowały w ciągu 17 lat eksploatacji widoczne od strony południowej ślady degradacji (il. 9). Fasada wykończona poziomo ułożonymi deskami, potraktowanymi brunatnym impregnatem, zniekształcona została spektakularnymi zaciekami wodnymi. Efekt zapewne nie był przez autorów zamierzony. Zacinające strugi wody deszczowej dokonały nierównomiernych plamiastych zaników impregnatu, który przemieścił się i skoncentrował w miejscach bezpośrednio przylegających do stref najczęściej wypłukiwanych. Uwidoczniło się to w postaci ciemniejszych brązowych pasm (il. 10). Nieregularność wzoru jasnych plam powstałych po wypłukaniu impregnatu z desek oraz ciemniejszych jego koncentracji jest związana, jak można stwierdzić po wnikliwej analizie, z nieregularnym rozłożeniem okien i mocno wystających balkonów. Z jednej strony stanowiły one osłonę przed deszczem pewnych partii elewacji, a z drugiej, podobnie jak parapety okien, tworzyły powierzchnie kierujące wodę na deski elewacji. Znamienne jest porównanie fasady południowej z pozostałymi. Elewacja zachodnia, jak widać na ilustracji 11, nie posiada znaczących odbarwień i plam. Jest ona korzystniej usytuowana względem miejscowych dominujących kierunków wiatrów, a jednocześnie jest osłonięta drzewami i sąsiednim budynkiem. To świadczy

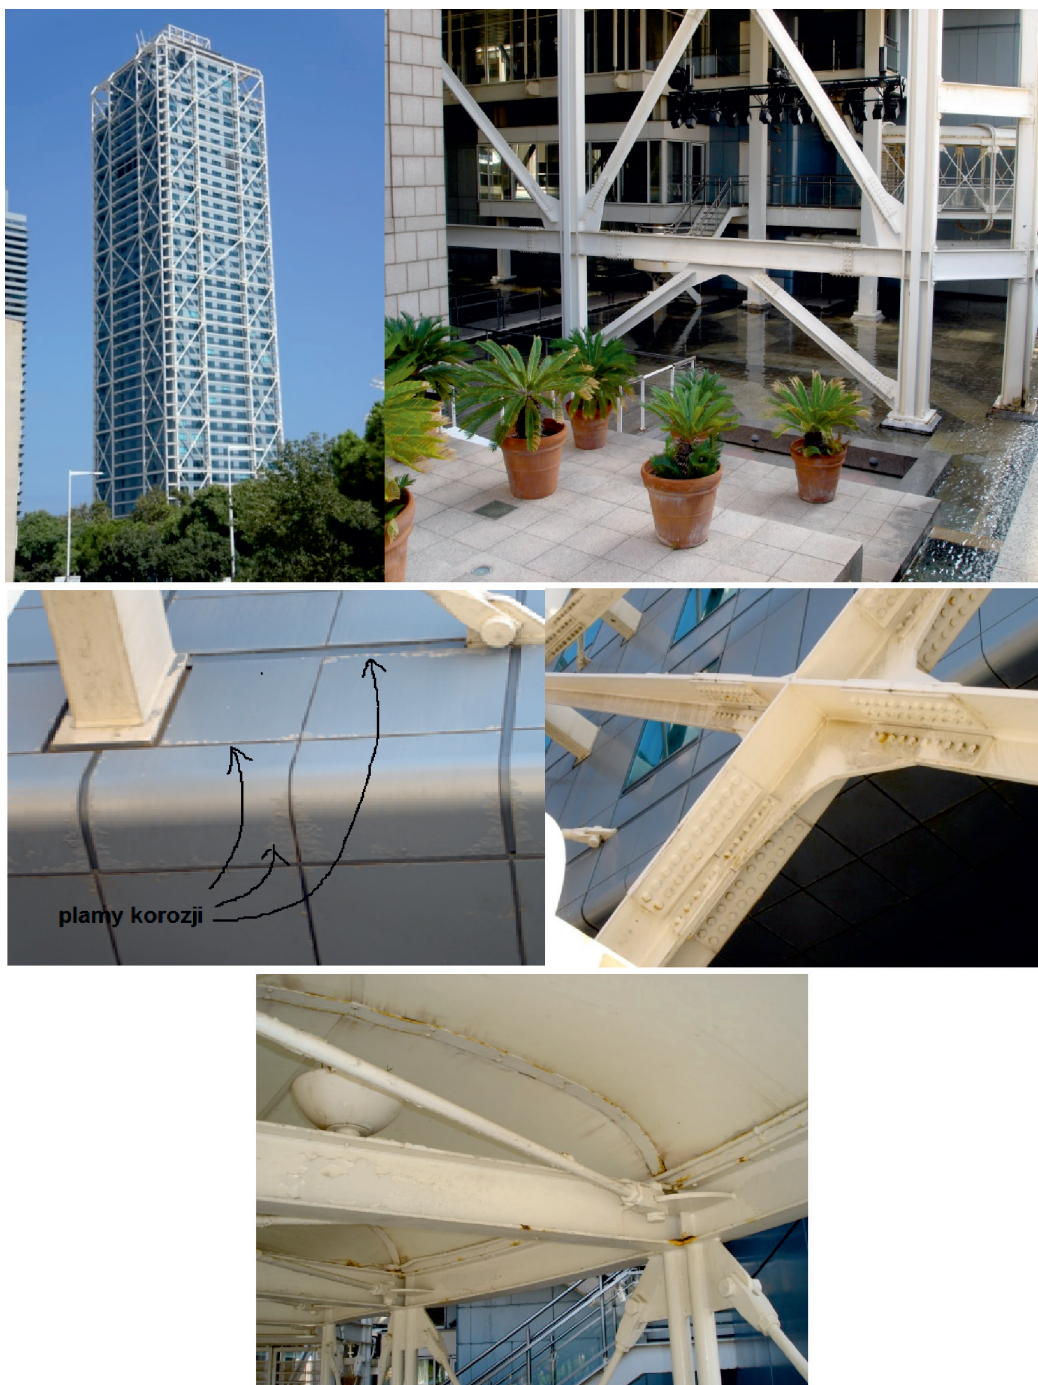
III. 12, 13, 14, 15, 16. Hotel Arts, Barcelona (arch. SOM), 1992 (photo by author)

This is a luxury high-rise hotel located directly at the coast of the Mediterranean Sea. It was constructed in 1992, and is a characteristic landmark of the coastal district of the city, due to its height and exposed external steel framing (II.12). The building is remarkable in view of the discussed problems of technical and aesthetical durability in architecture. Its structural concept, based on the use of steel, was rather risky, given the coastal location and salty air being ideal for the development of the corrosive process. After 22 years of its use, the building exhibits clear symptoms of the formation of corrosive spots, despite the protective anticorrosive treatment of its framing. This undesirable situation has been worsened by the installation of an open water pool under the building (III. 3). The rising water vapour acts not only on the structural elements, but also on the panels of metal cladding of the facades, which have deteriorated in part, and will need to be replaced at some later time (III. 14–16).

Ten wysokościowy luksusowy hotel położony jest niemal bezpośrednio nad brzegiem Morza Śródziemnego. Wybudowany w 1992 r., stał się charakterystycznym elementem krajobrazu nadmorskiej części Barcelony ze względu na swoją wyeksponowaną na zewnątrz stalową kratową konstrukcję (il. 12). Jest on godzien szczególnej uwagi w kontekście rozważanych problemów trwałości estetycznej i technicznej. Wydaje się, że koncepcja tego obiektu w zrealizowanej formie była dość ryzykowna z powodu jego nadmorskiego położenia. Przesycone solą morską powietrze stwarza bowiem niemal idealne warunki do powstania zjawisk korozyjnych. Jak się można przekonać, tego rodzaju obawy okazały się niebezpieczne. Po 22 latach użytkowania na budynku widać wyraźnie proces rozwijania się korozji, pomimo zabezpieczenia antykorozyjnego powłoką malarską. Sytuację pogarsza basen wodny na otwartym powietrzu zlokalizowany pod budynkiem (ilustracja 13). Unosząca się z niego para wodna ogarnia nie tylko elementy konstrukcyjne, ale także metalowe płyty wykończenia elewacji, które powoli ustępują procesowi korozji (il. 14–16).

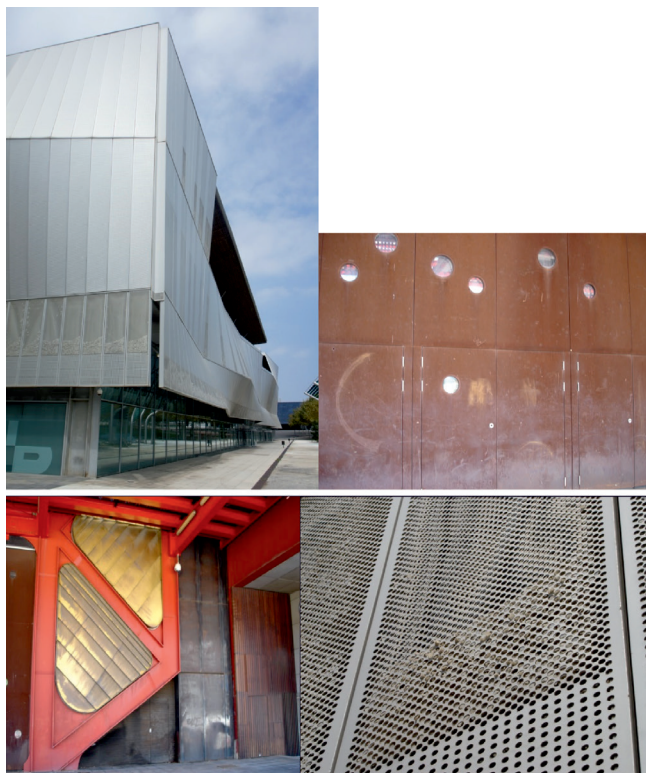
Ill. 17, 18, 19, 20. El Centro de Convenciones Internacional de Barcelona (arch. J.L.Mateo), 2004 (photo by author)

This is an ample conference building located in a coastal area of the city. After 10 years of operation, it shows exceptionally many symptoms of degradation that reduce its technical and aesthetical longevity (III. 17). Dominating are the damages and deformations of climatic origin that have contributed to the degradation of its facades. A process of dust accumulation had originated from a nearby heavy- traffic-artery and has found its expression on a lower part of the east elevation. It has been clad with brass sheet, which is protected against washing with rain water by protruding structural steel components above (III. 19). Another fragment of the elevation, located above, has preserved its original colour and technical value, due to the rain washing through a gap between the façade and contiguous canopy. A similar process was elucidated while considering the Dutch buildings. Quite an opposite, negative effect of climatic origin can be seen in yet another part of the building (III. 18), where a “corten” steel cladding has been devoid of an impregnative and corrosive layer in its lower part, because of the missing protection against slanting rain by the protruding elements of the façade. The resulting light patches on the metal sheet have disfigured the vulnerable material. The aesthetically and technically negative effect was further worsened by some ensuing perceivable maintenance procedures aimed at the removal of graffiti that had covered the metal. It has become obvious over time that the choice of this material had not been adequate, due to its vulnerability to vandalistic acts of mechanical character in that socially specific area. Glazed openings, in that same fragment of the elevation, have been responsible for unaesthetical markings made by the rain water or condensed vapour flowing in streaks down the panel. If, in the case of the two previously analyzed components, some maintenance procedures can presumably lead to the regaining a close-to-original result, the latter exposed to adverse climatic effects can only be completely replaced.

Another disadvantageous disfiguring process, taking place on the elevations over the ground floor, can be easily noticed. The majority of steel panels of the facades have been irreparably deformed and damaged (III. 20). That time, however, it was another adverse climatic factor and its destructive impact that had caused it, namely solar radiation. Intensive insolation, characteristic of that coastal geographic latitude, has brought about thermal movements of panels made of perforated stainless steel. Deformation, and ensuing delamination of those panels, as well as further slipping down of the soft polyurethan foam interleaf comprised between two thin metallic covers making a component, have become a spectacular example of technical and aesthetical failure. This effect had been caused by cyclic extension and contraction of the material exposed to such extreme thermal load. These movements have led to the destruction of bonding material holding all the three layers in place and, in consequence, to sinking of the foamy interlayer. The bulging of metal sheets had generated the delamination process and the creation of air

gaps between them. A decisive factor at the origin of this series of events was a fixed joining of layers at the perimeter of the panels. That hampered their mutual free thermal movements. Noteworthy is that the bulging and delamination were most intensive at those areas of the panels where the perforation was dense, and thereby the metal sheet more prone to deformation (il. 20). Permanently disfigured steel sheets are, in practice, a material unsuitable for correction. The analyzed process had been difficult to foresee as the applied stainless steel sheet has a lower value of the coefficient of thermal expansion than a regular steel. Therefore, it could have been assumed that it would not succumb to such deformations so easily. And yet it has happened.

Ten usytuowany w strefie nadbrzeżnej rozległy obiekt konferencyjny wykazuje po 10 latach użytkowania wyjątkowo wiele symptomów degradacji obniżających jego trwałość techniczną i estetyczną (il. 17). Dominują uszkodzenia i deformacje pochodzenia klimatycznego. Na ilustracji 19 widać zjawisko akumulacji osadu pyłu komunikacyjnego w dolnej partii elewacji wykończonej blachą mosiężną, która nie jest zmywana wodą opadową za sprawą osłonowego charakteru wystających profili stalowych usytuowanych powyżej. Fragment elewacji powyżej nich zachował swoją barwę i pierwotny stan techniczny dzięki dostępowi wody docierającej do niego poprzez szczelinę w przyległym zadaszeniu. Obserwuje się tutaj podobieństwo do zjawisk poprzednio omawianych na przykładach holenderskich. Niekorzystne efekty klimatyczne o przeciwnym charakterze można dostrzec na ilustracji 18, gdzie panele elewacyjne ze stali typu „corten” zostały w dolnej części pozbawione pierwotnej warstwy impregnacynnej wskutek braku osłony przez wystające górne fragmenty fasady – w rezultacie warstwa rdzy została zniszczona. Pozostały w tej strefie jaśniejsze plamy na materiale. Do degradacji tego materiału przyczyniły się również dość widoczne zabiegi konserwacyjne dokonywane w celu usunięcia graffiti. W tej zagrożonej aktami wandalistycznymi strefie dokonany wybór materiałowy najwyraźniej nie był decyzją właściwą ze względu na wrażliwość materiału na uszkodzenia mechaniczne. Otwory przeszklone w płytach, do których dotarła woda opadowa, a prawdopodobnie także kondensat powstały na szkle, umożliwiły powstanie wyraźnych zacieków na powierzchni płyt. O ile w dwóch poprzednich przypadkach pewne zabiegi konserwacyjne mogą doprowadzić w zróżnicowanym stopniu do poprawy estetyki tych fragmentów elewacji, o tyle kolejny wymieniony niekorzystny efekt oddziaływania czynników klimatycznych jest praktycznie niemożliwy do korekty. Ilustracja 20 przedstawia płyty elewacyjne

znajdujące się powyżej parteru, które uległy nieodwracalnej deformacji. Tym razem uwidocznił się wpływ innego czynnika klimatycznego – promieniowania słonecznego. Intensywna insolacja, jaka występuje w tej śródziemnomorskiej lokalizacji, spowodowała znaczne ruchy termiczne płyt z perforowanej blachy nierdzewnej. Na fotografii widać rozwarstwienie płyt i obsunięcie się umieszczonej pomiędzy dwiema warstwami blach miękkiej pianki poliuretanowej. Nastąpiło to w wyniku cyklicznego rozszerzania się i skurczu blach, co doprowadziło do destrukcji spoiwa międzywarstwowego, a w konsekwencji do opadnięcia pianki. Było to spowodowane wybrzuszeniem się blach (pierwotnie ze sobą spojonych) generującym siły rozwarstwiającej i utworzeniem się wolnej przestrzeni między nimi. Zjawisko takie wystąpiło za sprawą nieprzesuwnego połączenia blach ze sobą na obrzeżu i uniemożliwienia tym samym ich swobodnych ruchów dylatacyjnych. Jak można zauważyć na fotografii, wybrzuszenie i rozwarstwienie wystąpiły szczególnie intensywnie w tych rejonach blach, gdzie perforacja była bardziej gęstsza, a tym samym te fragmenty były bardziej podatne na deformacje. Trwale powyginana blacha jest w tym wypadku elementem praktycznie nienadającym się do naprawy i ponownego „wyplaszczania”. Zjawisko to było dość trudne do przewidzenia, jako że zastosowana blacha nierdzewna ma niższy współczynnik rozszerzalności termicznej niż zwykła blacha stalowa. Można było zatem przypuszczać, że nie ulegnie ona tak łatwo deformacjom.

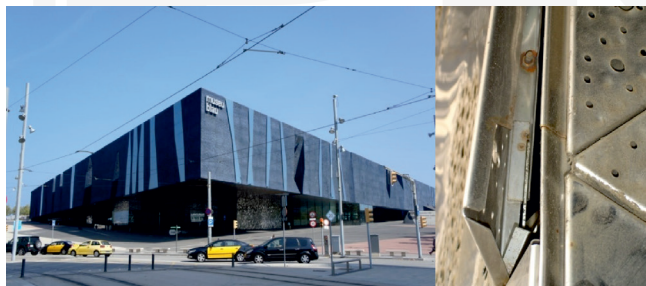
Ill. 21, 22. Museum of Natural History Museu Blau (arch. Herzog&de Meuron), 2012 (photo by author)

The Museum of Natural History, designed by Herzog&de Meuron, was erected in 2012. After only 2 years of its use, it shows signs of technical and aesthetical degradation attributed to climatic factors, but also to mechanical disfigurement caused by vandalistic acts to which the building has proved to be vulnerable (Ill. 21). In this case, presumably, a destructive impact of climate, coupled with the salty air, have become a real problem. Although the ground floor area is well protected against the rain water by the overhung upper story, there are many corrosive spots on the stainless steel panels of cladding and its steel fixing elements on this level (Ill. 22). The corrosive process favoured also an increased accumulation of dust on metallic elements, which is reaching the site from a nearby busy street.

Powszechnie znana realizacja biura Herzog&de Meuron – budynek Muzeum Historii Naturalnej, zrealizowany w 2012 r., zaledwie po 2 latach funkcjonowania zdradza ślady degradacji estetycznej i technicznej z powodów klimatycznych, a także mechanicznych związanych z wandalizmem, na który jest stosunkowo mało odporny (il. 21). W tym wypadku ujawniło się przede wszystkim destrukcyjne działanie czynnika środowiskowego w postaci nasyczonej solą morską pary wodnej. Przyczyniła się ona do powstania w strefie parteru, dobrze chronionej przed wodą opadową przez nadwieszenie budynku, widocznych ognisk korozji na metalicznych powierzchniach paneli ze stali nierdzewnej oraz na elementach je mocujących (il. 22). Występuje tu także akumulacja pyłu na powierzchniach metalowych wynikająca z sąsiedztwa ruchliwej ulicy, co jest czynnikiem sprzyjającym korozji. Obiekt demonstruje także inne niekorzystne zjawiska natury pozaklimatycznej. Dostępność dolnych fragmentów fasad nadwieszonych nad parterem umożliwiła pojawienie się w części budynku uszkodzeń mechanicznych spowodowanych intencjonalnym zaangażowaniem użytkowników sąsiedniej przestrzeni. Uszkodzenia te są ceną zastosowania nowatorskiej technologii grubowarstwowego tynku elewacyjnego użytego po raz pierwszy w tym obiekcie i wzbudzającego autentyczne zainteresowanie zwiedzających (il. 23). Tynk, pokryty warstwą farby elewacyjnej o barwie fioletowej, ze względu na swoją grubą fakturę jest w sposób naturalny narażony na nadmierną akumulację na swej powierzchni cząsteczek pyłu pochodzącego zarówno z sąsiedniej ruchliwej ulicy, jak i niesionego wiatrem z pobliskiej plaży. W wyniku tego zjawiska wyraźnie się uwidoczniły strefy wzmoczonego osiadania żółtawego osadu tam, gdzie rzeźbiarska, chropowata elewacja posiada fragmenty wypukłe. W podobnych miejscach można też zaobserwować inne niekorzystne zjawisko polegające na systematycznym ich zmywaniu przez wody opadowe. W rezultacie tynk pozbawiony został warstwy farby elewacyjnej i powstały na nim jaśniejsze plamy. Proces rozjaśniania początkowo intensywnej barwy fioletowej zapewne z czasem będzie szybko postępował (il. 24).

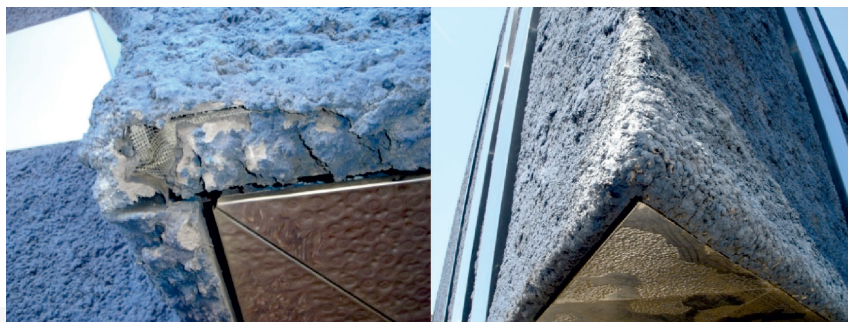
III. 23, 24. Museum of Natural History Museu Blau (arch. Herzog&de Meuron), 2012
(photo by author)

The building exhibits the results of some other detrimental processes caused by the factors different from climatic. The lower parts of the upper story facades turned out to be vulnerable to damages done by the passers-by out of pure curiosity. That was possible due to their accessibility from the ground level. The plaster finish was systematically chipped off at its edges. These disfigured fragments are the price of the application of an innovative plastering technology, which attracts attention, and thus provokes an undesirable behavior of visitors (Ill. 23). The plaster finish painted in violet, due to its rough surface, is prone to excessive accumulation of traffic dust as well as of the beach sand blown onto it by the wind. As a result of that, the protrusive spots of the plaster finish brought about yellow patches of accumulated dust and sand on the elevation. The sculptural character of the external finishing material is also associated with another disadvantageous process, which consists in systematic, uneven washing of the façade by the rain water and disappearing of the violet paint. Disfiguring brighter patches gradually appeared making the façade's look even worse. This process will certainly, constantly proceed, and will lead to the aesthetical degradation of the building (Ill. 24).

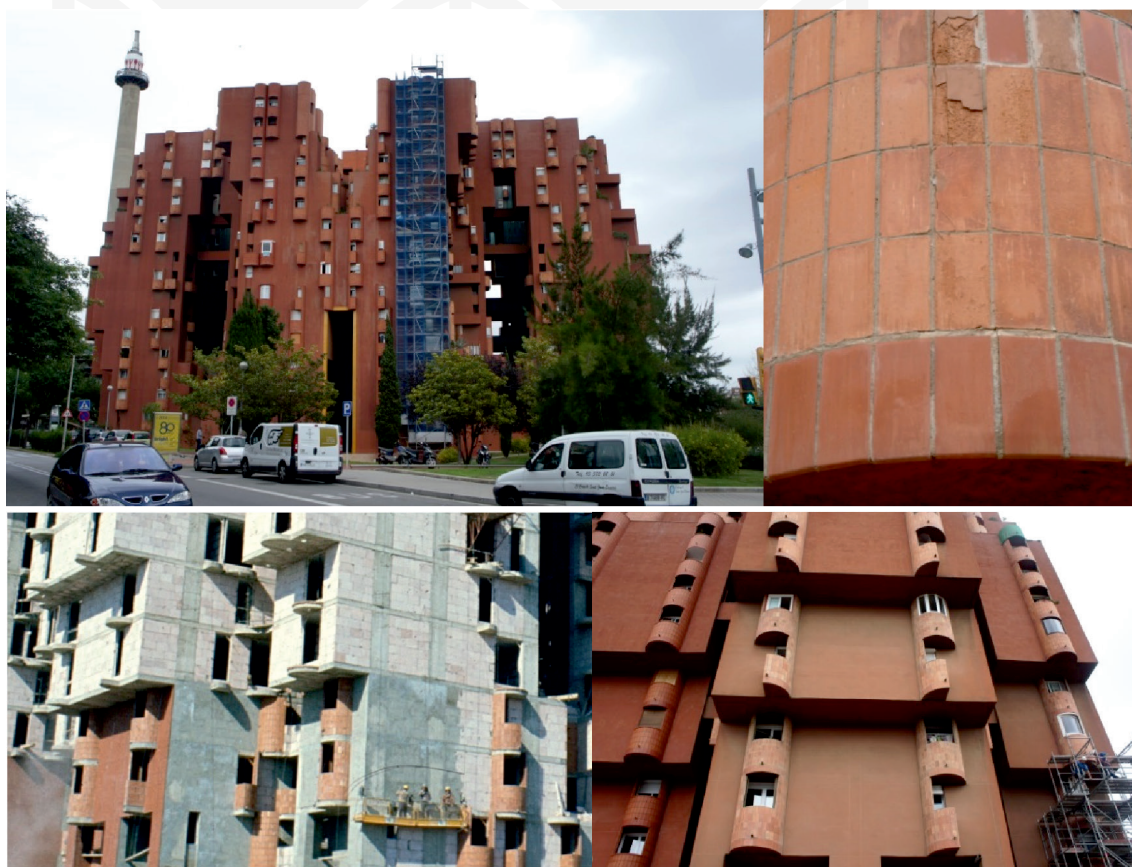
III. 25, 26, 27, 28. Residential building Walden 7 (arch. R. Bofill), 1975 (photo by author)

The building is interesting for its history, and it very well illustrates the problems of durability of buildings (Ill. 25). It was completed in 1975. Its structure is made in a concrete framing technology with exterior walls of light concrete blocks (Ill. 27). Directly on this material, a ceramic tile finish of low quality on all the facades has been installed (Ill. 26). The architect was apparently not aware of the future problems with that technical solution, but they appeared not much later. In 1988, after 13 years of its use, on my second visit to the site, the building was surrounded with a mesh canopy, which was designed to protect the passers-by against the ceramic tiles coming off the facade and falling down. The reason of that endangering process were the changes in the air temperature and the resulting cyclic thermal movements of tiles, which would break the bonds between them and the fixing mortar. Moreover, the condensation of water vapor from inside the building, which would penetrate the walls of high vapor permeability, had contributed to

such a result. The high temperature of dark red tiles, heated by the solar radiation, brought about presumably the increased pressure of water vapour within the structure of the wall and, in consequence, made the tiles come off. As a climatic factor, the solar radiation had certainly become the main destructive reason of the failure of the façade's material. It is noteworthy, that the diffusion of water vapour through the exterior walls, and its negative consequence: the reduction of the technical durability of buildings, have not been seriously considered, so far, in the Mediterranean countries with clement climates. It has not been a real problem in that region, due to the dominating one-material technology for exterior walls. But it appeared to be a problem in the analyzed case of the residential building, characteristic of the increased humidity of the interior air. The external finish of ceramic tiles, impermeable for water vapour, had been installed on light concrete blocks characterized by a high rate of vapour permeability. From our view point, it is an obvious faulty solution, contrary to the accepted rules in building design. As a result of unexpected damage to the elevations, refurbishment works have started. The tile finish is now being replaced with coloured plaster on the whole façade, except for the balconies and bay windows, where the old tiles are being replaced with new ones of higher quality (Ill. 28). This building is stricken not only with the aforementioned problems, but also with another type of deterioration. The owners of some apartments have remodeled their balconies and replaced the original windows with new ones of different sort, in an uncontrolled way, thus an esthetical "destruction" has taken place (Ill. 28).

Obiekt ten jest niezwykle ciekawy ze względu na swoją historię dobrze obrazującą problematykę trwałości budynków (il. 25). Oddano go do użytku w 1975 roku. Skonstruowany został w technologii szkieletu żelbetowego ze ścianami wypełniającymi z bloczków lekkiego betonu (il. 27). Bezpośrednio na tym materiale zainstalowano na zaprawie czerwone płytki ceramiczne niskiej jakości na wszystkich

elewacjach jako wykończenie zewnętrzne (il. 26). Najwyraźniej projektant nie zdawał sobie sprawy z późniejszych problemów. Nastąpiły one stosunkowo szybko. Już w 1988 roku, czyli po 13 latach użytkowania, w czasie mojej drugiej wizyty w tym budynku, obiekt został nad parterem otoczony zadaszeniem z siatki w celu ochrony przechodniów przed odpadającymi od elewacji i spadającymi na dół płytkami. Głównym powodem tego zjawiska były zapewne zmiany temperaturowe i cykliczne ruchy termiczne płytek powodujące w konsekwencji ich odspojenie. Prawdopodobnie doszło również do kondensacji pary wodnej penetrującej ze środka budynku poprzez ściany o znacznej paro- przepuszczalności. W wyniku wzrostu temperatury mocno absorbujących ciepło ciemnoczerwonych płytek następowało rozprężanie pary i w konsekwencji odspojenie płytek. Czynnikiem klimatycznym w postaci promieniowania słonecznego stał się zapewne główną przyczyną destrukcji materiału elewacyjnego. Zjawisko dyfuzji pary wodnej przez zewnętrzne przegrody budowlane i jej negatywne konsekwencje zmniejszające ich trwałość techniczną w krajach śródziemnomorskich (o łagodnym klimacie) nie było należycie doceniane. W wypadku dominujących tradycyjnie na tym terenie ścian jednorodnych nie był to znaczący problem. Jednakże, jak się wydaje, stał się on istotnym zagadnieniem w omawianym wariancie funkcji mieszkalnej związanej z podwyższoną wilgotnością względną. Wykończenie zewnętrzne budynku wykonano z użyciem elementów o niskiej przepuszczalności pary wodnej zainstalowanych na materiale o wysokiej paroprzepuszczalności, co jest niezgodne ze sztuką budowlaną. W ostatnim okresie rozpoczęto ostatecznie wymianę oryginalnego ceramicznego materiału elewacji na tynk barwiony. Wymieniono także wykończenie balkonów i wykuszy na nowe płytki o wyższej jakości (il. 28). Na ilustracji 28 można zaobserwować zjawisko destrukcji estetycznej, która następuje stopniowo poprzez niekontrolowane działania właścicieli poszczególnych mieszkań. Zróznicowana, nieskorelowana zabudowa balkonów i aneksja ich przestrzeni w celu powiększenia powierzchni mieszkalnej, wymiana okien z zastosowaniem różnych wzorów i technologii to zjawiska niekorzystne, znane nie tylko na tamtym terenie, a powodujące wiele szkód w wymiarze estetycznym.
