Faculty of Mining and Geoengineering, AGH University of Science and Technology

Jastrzębska Spółka Węglowa S.A.

THREATS OF FLOODING OF SELECTED MINING AREAS – REPAIR MEASURES

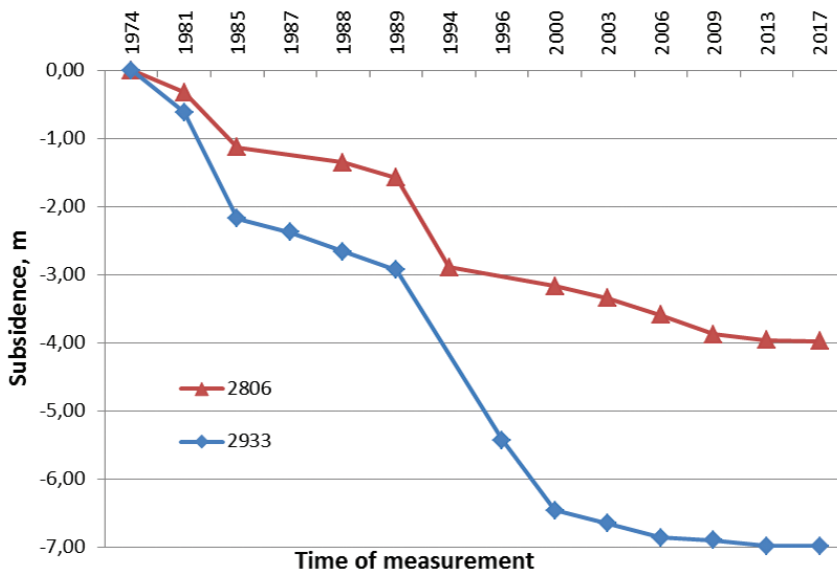
Fig. 4. The subsidence of points located in the analysed region in the period 1974–2017

The values of subsidence caused by mining in the area in question are documented by the geodetic surveys performed from October 1974 to June 2017. The article presents subsidence occurring at two characteristic measuring points 2806 and 2933 – wall benchmarks. At measuring points 2806 and 2933, the subsidence levels observed over 43 years are 3.97 and 6.98 m, respectively. These values illustrate the effect of coal mining in the referenced region. The course of subsidence over time at the selected benchmarks are presented in Fig. 4.

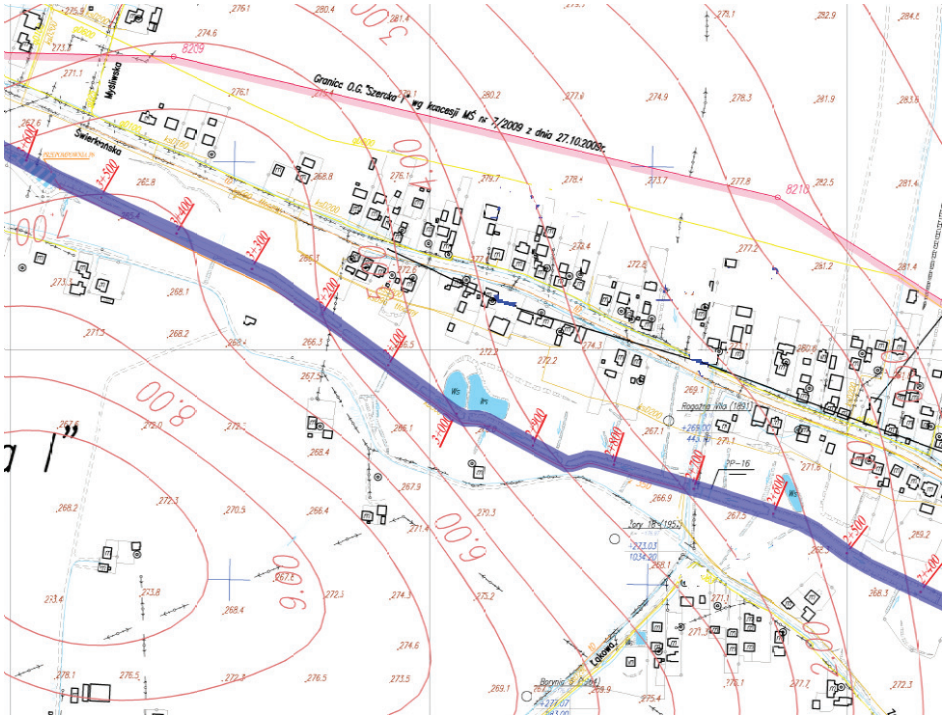
Fig. 5. Land surface subsidence trough – mining conducted in the period 1974–2017

The mining operations of 1978 to 2019 resulted in category IV to V surface deformations. The smallest subsidence was observed in the locations of gravity flow, while the greatest occurred near a pumping station, where the hydraulic continuity of the stream was interrupted.

Further mining in this area is expected from 2019 to 2025 in seams 404/1, 405/1 and 404/1lg, which will result in the area in question depressing by 0.148 to 1.049 m.

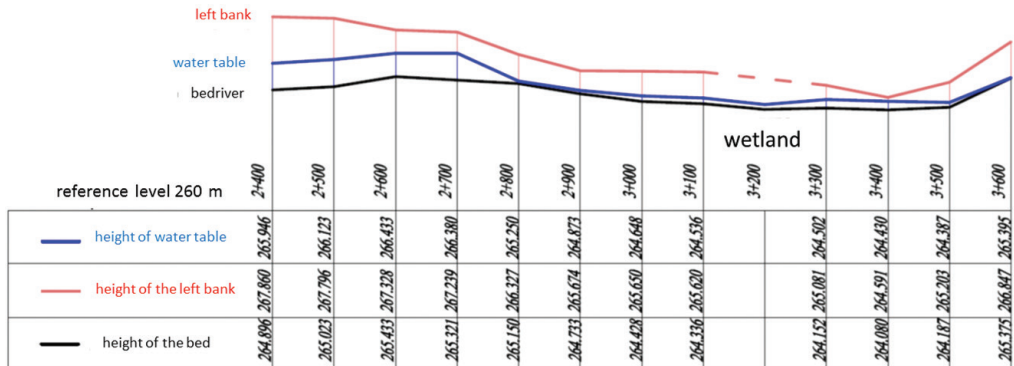
Fig. 6. The longitudinal section of the Boryński stream

The longitudinal section of the analysed section of the Boryński stream illustrates that the riverbed of the stream is slanted in the opposite direction to the outflow of water from the catchment area (Fig. 6). This results in no outflow from the catchment area and the emergence of overflow land. The existing pumping station is unable to effectively pump out the water flowing within the Boryński stream riverbed. The outlet of the pressure piping of this pumping station is permanently flooded due to the lack of runoff.

The mining – induced damage which occurs in the analysed region causes interruptions in the outflow of surface water. An interior basin formed at the 2+400 to 3+600 km section of the Boryński stream riverbed. It is drained using the pumping station on Zamkowa Street. The outlet of the pressure piping of this pumping station is at 2+710 km (above Łakowa Street level). The pumping station is unable to effectively pump out the water from the basin, especially in the case of heavy rainfall.

The entire section of the stream riverbed covered by the analysis is unsuitable for the drainage of storm water. It is therefore necessary to deepen the riverbed and make it slant towards the designed retarding reservoir and pumping station.

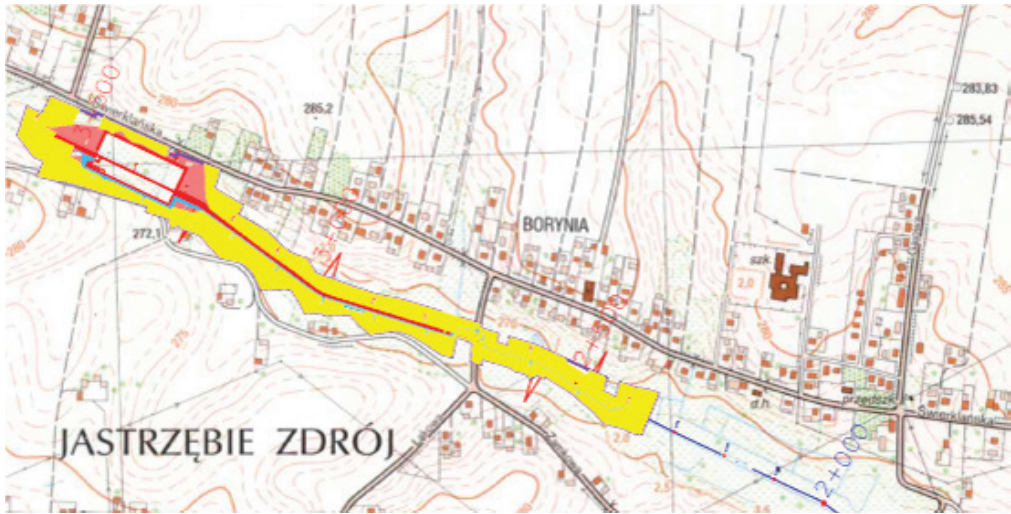
Fig. 7. A layout plan showing location of repair measures in the Boryński stream area

Interruptions to the outflow of water along the Boryński stream riverbed have been observed for many years. Unfortunately, the technical facilities made in 2006–2007 are becoming ineffective in the case of heavier precipitation. The interior basin which forms between the Zamkowa and Świerkłańska Streets fills up with water during heavy rainfall and results in the flooding of areas and buildings adjacent to the riverbed. In order to solve this problem, it is necessary to change the subsidence trough drainage system.

In order to ensure the correct waterflow in the riverbed and to maintain appropriate technical and hydraulic parameters, appropriate construction works were planned [7] (Fig. 7), including:

- ▶ the construction of a pumping station equipped with two pumps with a capacity of $Q = 55 \text{ dm}^3/\text{s}$ and one pump with a capacity of $Q = 300 \text{ dm}^3/\text{s}$;
- ▶ the creation of a retarding reservoir in the Boryński stream riverbed with dimensions of 71 x 160 m and a volume of 27 650 m³;
- ▶ the installation of pressure piping with diameters of 355 mm and lengths of 1210 and 1166 m along the stream riverbed, up to the location of gravity flow;
- ▶ the installation of a decompression chamber at the pressure piping outlets;
- ▶ Boryński stream riverbed improvement along a section of 1220 m;
- ▶ elevation and development of degraded area for agricultural purposes.

The designed retarding reservoir is to be located in the deepest depression of the Boryński stream riverbed from 3+318 to 3+456 km. This reservoir collects water from subcatchments located downstream of 2+400 km. Water from the reservoir will be gravitationally discharged to two wells with pumps. Up to a height of 265.00 m, the reservoir will have vertical walls of steel sheet piles topped with caps. The bottom of the reservoir will be profiled accordingly and provided with a 6‰ slope towards the axis of the Boryński stream.

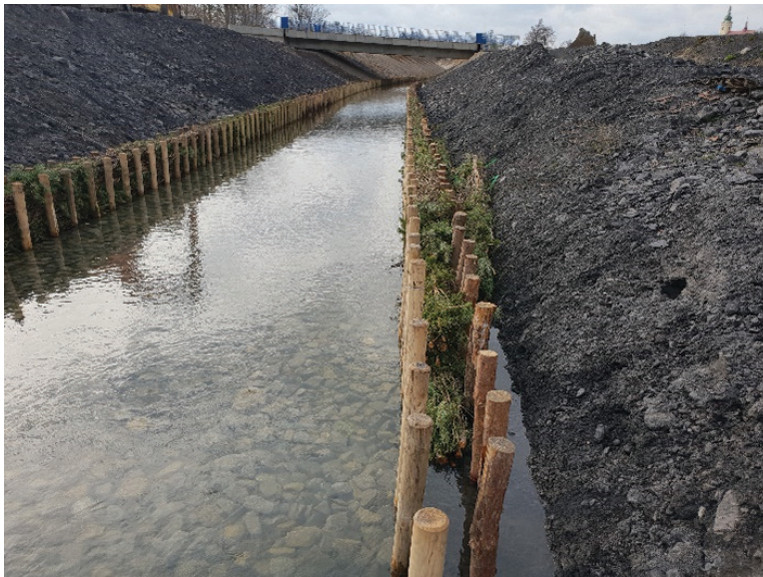
Fig. 10. Works related to the incorporation of fascines and humus – covering the scarps along the Pszczyńska river

Due to the formation of a stagnation area caused by the uneven subsidence of the Pszczyńska riverbed, into which the Boryński stream flows, the riverbed was reinforced over a distance of 1 km [6, 9]. As part of reprofiling, the riverbed was reinforced with riprap, assuming a riverbed with a maximum bottom width of 4.0 m (Fig. 10).

The works performed in the Pszczyńska riverbed focused on natural restoration and made it possible to restore the width of the riverbed to its original condition, prior to its subsidence.
