REPAIR PROCESS IN THE PITHEAD BUILDING AND ITS INFRASTRUCTURE AS AN EXAMPLE OF REPAIR WORKS IN INDUSTRIAL FACILITIES

Abstract

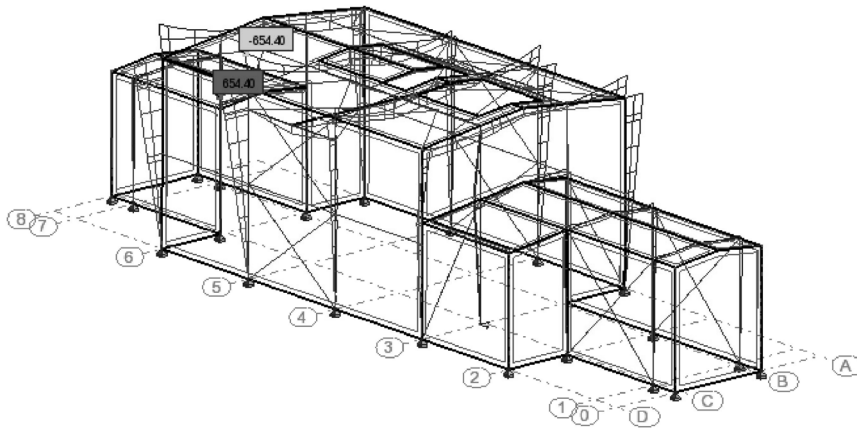
Table 1 shows the values of maximum cross-forces, as well as maximum tension values in the structural elements. Figure 2 shows an example of a graph of maximum torque M_y .

Analysing the values of maximum tension obtained, we can conclude that they do not cause maximum effort in the steel profiles. Stress with approx. values of 150.0 MPa should be safely transferred by the structural components used.

A maximum displacement value of 4.4 cm was obtained in node no. 10 of the structure, which is located in axes 6 and D in the joint between the column and the beam. Due to the fact that the stiffness of both the wall and roof elements were not taken into account, and their permanent joint with the structure significantly increases the overall stiffness, the real registered displacements should be lower. It should be further emphasised, that the forced settling of the foundations related to the settling of a section of the ventilation shaft is a decisive factor causing the deformations. Calculated deformations, taking the additional stiffening of certain panel elements of walls and roof into account, should be safely transferred by the structure in question.

Based on these calculations, it can be concluded that no limit state in those elements is exceeded. However, further settling of the ventilation shaft, as well as the foundations in axes C and D in the southern part of the pithead building, should be limited. Further settlement growth will significantly reduce the load capacity of the main structural elements and can lead to exceeding the limit states of load capacity and serviceability of the building. Due to the positive experience of the mine with foundation reinforcement in this area using micro-piles, the previously used solutions should be adapted to protect the foundations of the

Fig. 2. Graph of maximum torque M_y of the pithead building structure

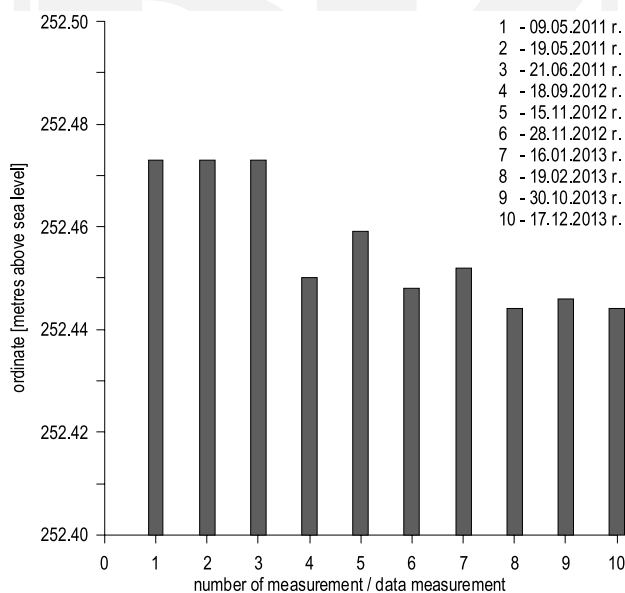
Mine engineers have been making geodesic measurements near the pithead building for many years. Measuring points were placed both on the building and on its floors. The geodesic monitoring allowed for determining both the past displacement of measurement points and the effectiveness of the repair process carried out. The measurements obtained show that the largest vertical displacements prior to repairs occurred in the direct vicinity of the resting place of the column in axes D and 3 on the ventilation duct. Total displacement at this point was 3.1 cm. Slightly smaller displacements of 1.6–1.9 cm were recorded at points located in the vicinity of the wall in axes B and 1–2, as well as C and 1–2, and at a point in the vicinity of the foundation shaft tower brace. Other displacement measuring points did not exceed 1.0 cm, and extra points installed after finding displacement of the ventilation duct showed no significant changes.

Fig. 3 is an exemplary diagram of vertical displacements recorded at measuring point No. 78, located on the wall in the immediate vicinity of the resting place of the column on the ventilation duct. It should be noted that significant displacements of 2.4 cm at this point were recorded directly before the repair works commenced (18.09.2012). As a result of the repair process, the displacements have stabilised and are currently not hazardous to the pithead building. It should be emphasised that similar relationships have been recorded at other measuring points.

Fig. 3. Vertical displacements of measuring point no. 78
