Tomasz Niemiec¹, Piotr Gruchlik²

RECTIFICATION OF THE CHURCH BUILDING IN BYTOM MIECHOWICE AND THE RESULTS OF LASER SCANNING 3D

Keywords: mining operation, building tilt, 3D laser scanning, rectification

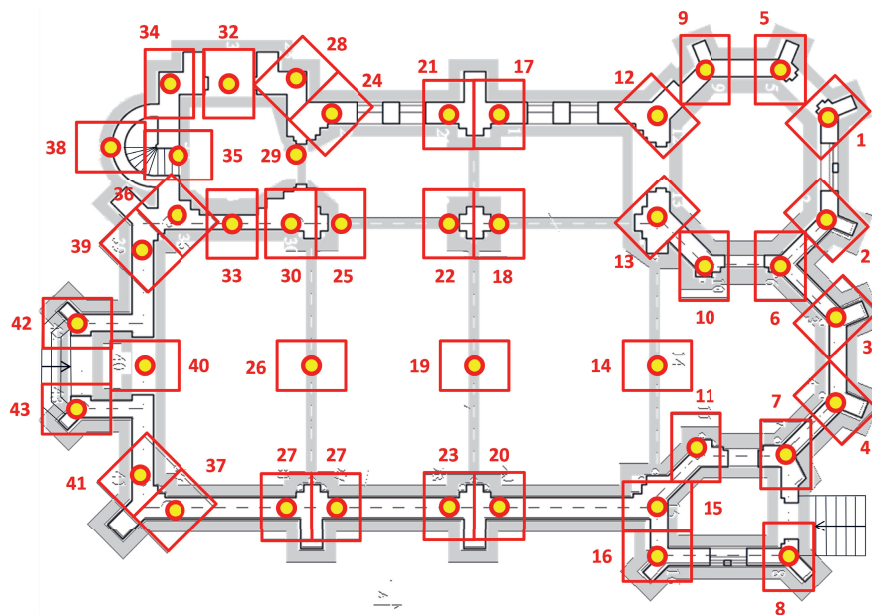
Fig. 3. Steel reinforcement of church's walls and jack's configuration chart

Temporary steel reinforcement was built inside of the church's building while rectification works were in progress. It is made of channel section 160 connected to the walls with steel bolts. Reinforcement method has been introduced on below drawings and photos.

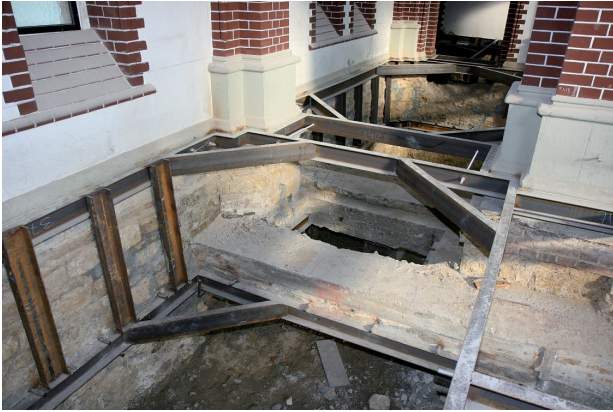
Fig. 4. Flooring reinforcement set up for the duration of rectification

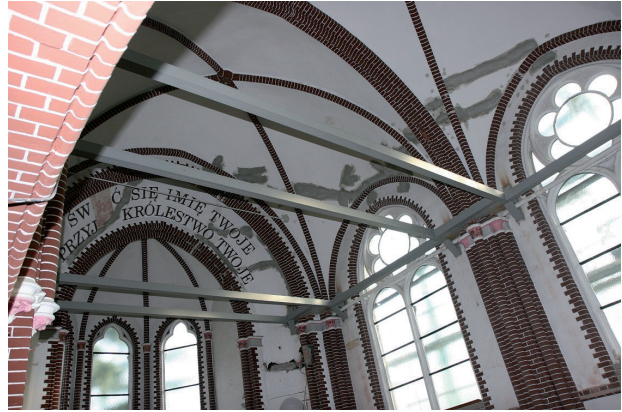
Fig. 5. Vault reinforcement set up for the duration of rectification

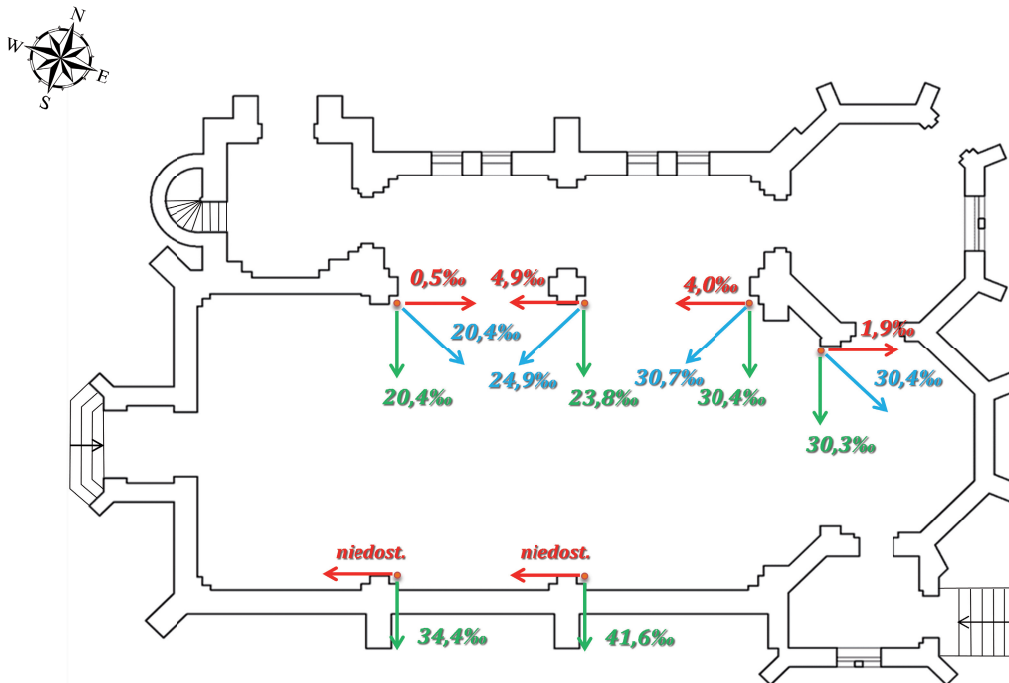
Fig. 6. The results of measurements of the church's building declination, performed by the main ($T_x av = 2 \text{ mm/m}$, $T_y av = 30 \text{ mm/m}$)

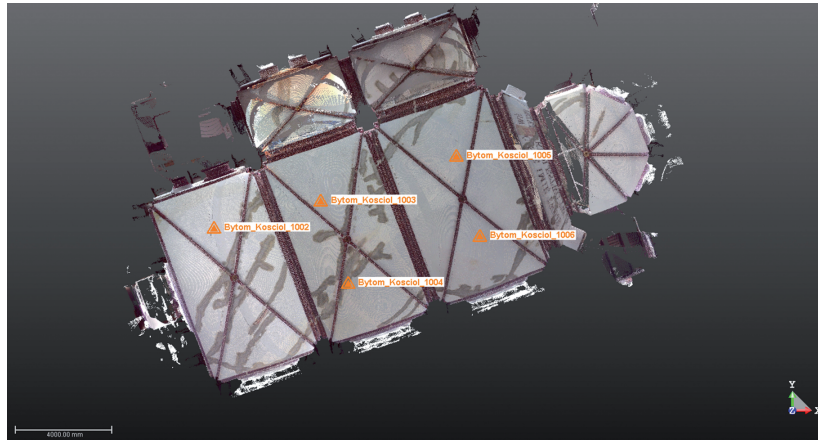
Fig. 7. Distribution of laser scanner 3D Trimble TX5 measuring positions. Visible signs of repair cracks in the ceiling

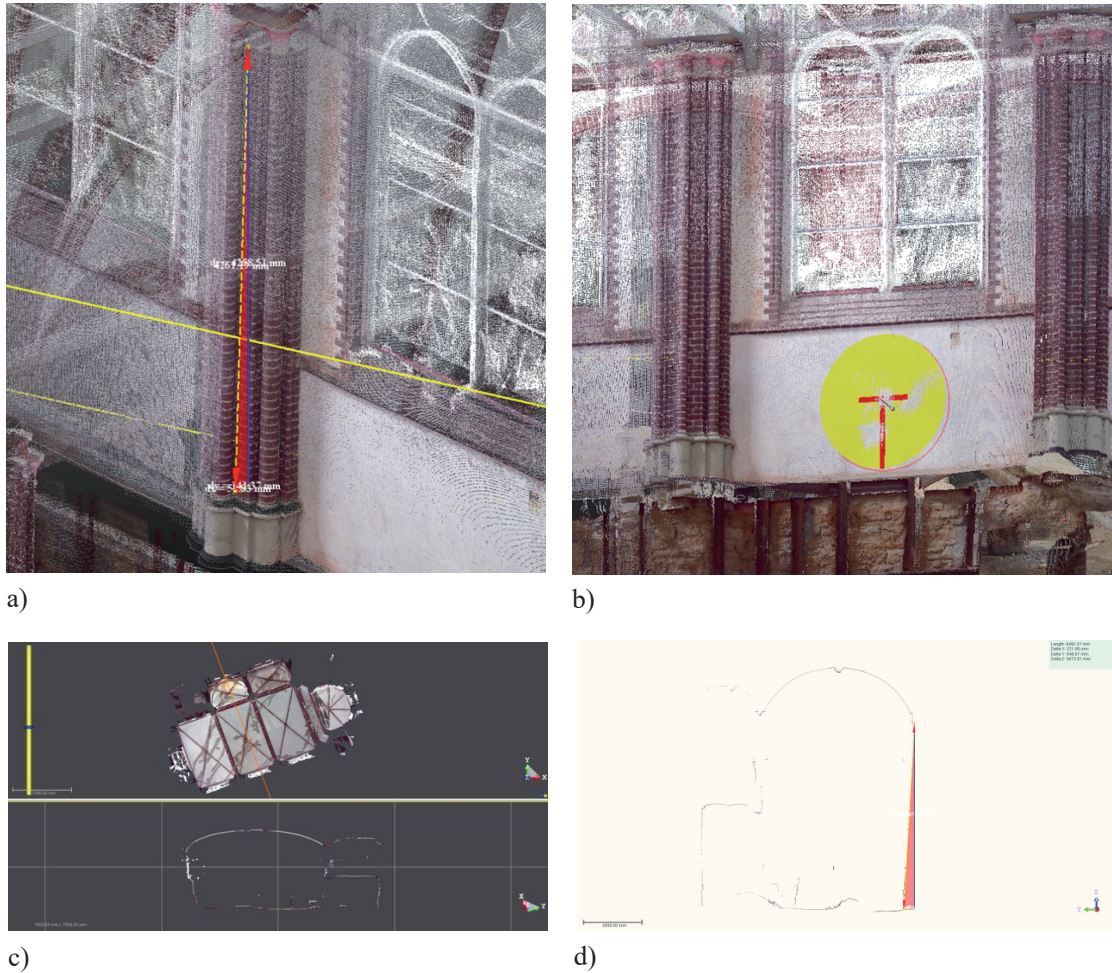
Fig. 10. Example of declination measurement using 3D model: a) based on coordinates of the points at the top and bottom of the pillar $T_y = 35$ mm/m, b) based on plane orientation adjacent to a chosen object $T_y = 38$ mm/m, c) based on the measurement section of the church in the desired location $T_y = 39$ mm/m

The measurement of the orientation of the plane adjacent to any selected portion of the object allows to evaluate changes in its declination before and after rectification. For wall visible at fig. 10b declination from 38 mm/m has decreased into 8 mm/m. Change of declination 30 mm/m is consistent with a given rectification angle.

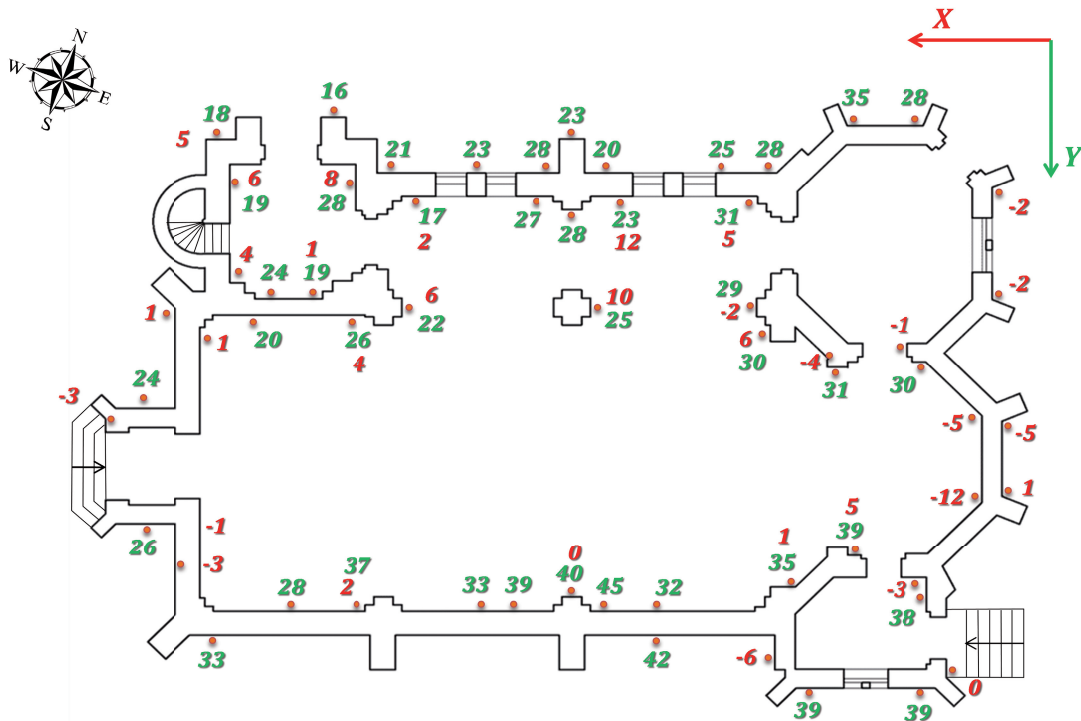
Fig. 11. Sketch to locate declination measurement points of the church building using the electronic level and the measured values of declination in two directions

The fig. 11 shows measurement points inside and outside the building. Distribution of measured values is shown in fig. 12; the average value of declination along the transverse axis equals $T_y=29$ mm/m.

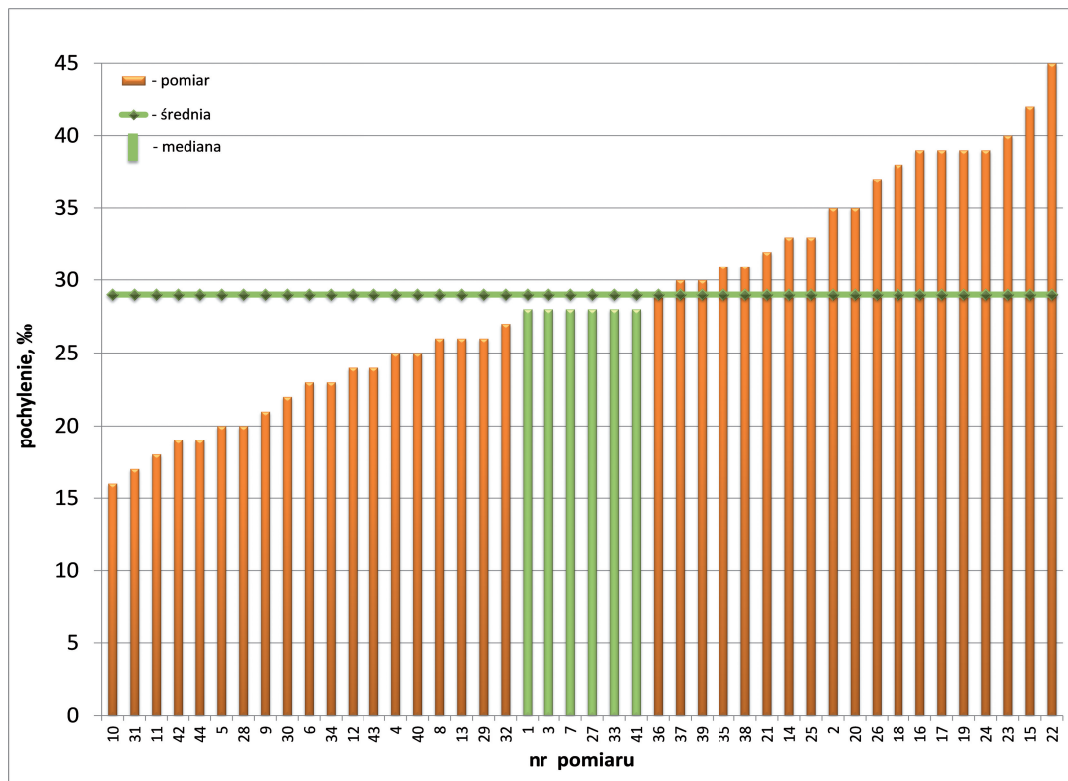
Fig. 12. Distribution of the declination of selected elements of church's building (according to fig. 11) and their average value (29 mm/m) and median (28 mm/m)
