BOŻENA ORLIK-KOŹDOŃ*, AGNIESZKA SZYMANOWSKA-GWIŹDŹ*

THE EFFECT OF TRADITIONAL STRUCTURAL
ELEMENTS OF PARTITION WALLS
IN RESIDENTIAL BUILDINGS ON THE QUALITY
OF THE USE OF THE PREMISES

This paper describes the phenomenon of mould growth on the inner surface of partition walls of multi-block constructed residential buildings. An assessment was undertaken of the impact of the resulting damage, in terms of health and safety of residential premises.

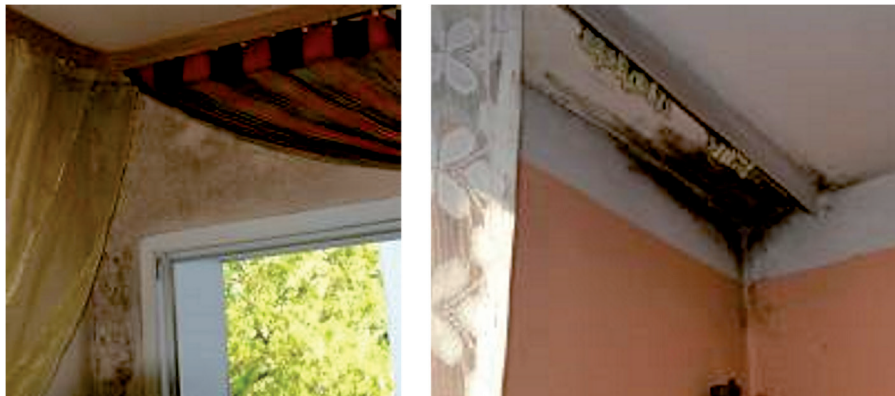
calibration protocol No. 02356831). Moisture values were given as a percentage value expressed in relation to dry material mass. The level of humidity present on the inner surfaces where mould damage had occurred, ranged between 1.3% to 2.8%. An increase in humidity of 3.2% to 5.4% was recorded at the north-west side on the second and fourth floors.

Fig. 3, 4. The view on mould outbreaks on external walls: detail D1 (3) and D5 (4) in flats on second floor

Detail	Site of occurrence	Floor	Humidity
D1	wall	1	1.8–1.9%
		3	1.9%
		4	1.7–1.8%
D2	wall	1	1.9–2.5%
		2	1.8–2.1%
		4	2.5–2.7%
D3	wall	1	1.6%
		2	1.3–1.8%
D4	wall	4	5.4%
D5	ceiling	2	5.0–5.2%

However, regardless of the theoretical computer-generated results obtained for all of the analyzed fragments of the partition walls, mould corrosion outbreaks were observed, and in the case of D_4 and D_5 ($f_{Rsi} > f_{Rsi,max}$), humidity levels were greater on the partition wall's surface (up to 5.4%). Such high humidity levels on partition walls indicate considerable proclivity to exceptional humidity levels in the winter months when the heating system is fully functional and a lack of opportunity for drying out in the spring and summer. Operating conditions in domestic properties during these periods may differ significantly from those indicated in these calculations. This means that temperatures inside residential properties may be lower than 20°C and operating humidity levels may be higher than 50%.

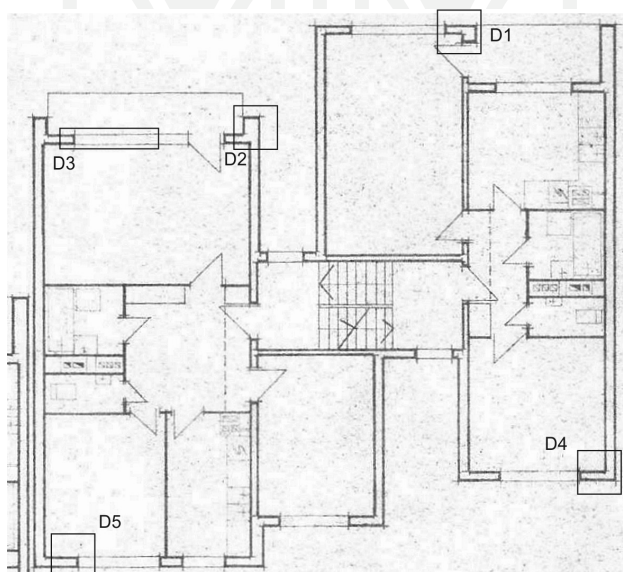
In June 2013, the building was subject to a visual inspection, in response to residents reporting a problem with mould affecting partition walls in part of the premises. The surveys confirmed that mould had affected the inner surfaces of the walls and small areas next to ceilings. Spores were located in corner positions, at the juncture of the curtain walls and external structural walls, mostly next to loggias (recessed balconies on the south-east elevation), but also on the north-west elevation.

Detail_1: connection of recessed balcony wall with curtain wall

Detail_2: connection of recessed balcony wall with curtain wall

Detail_3: connection of balcony panel with curtain wall

Detail_4: corner of wall (juncture of block wall and PGS block wall)

Detail_5: juncture of ceiling and curtain wall

Fig. 5. Sites of mould occurrence and details

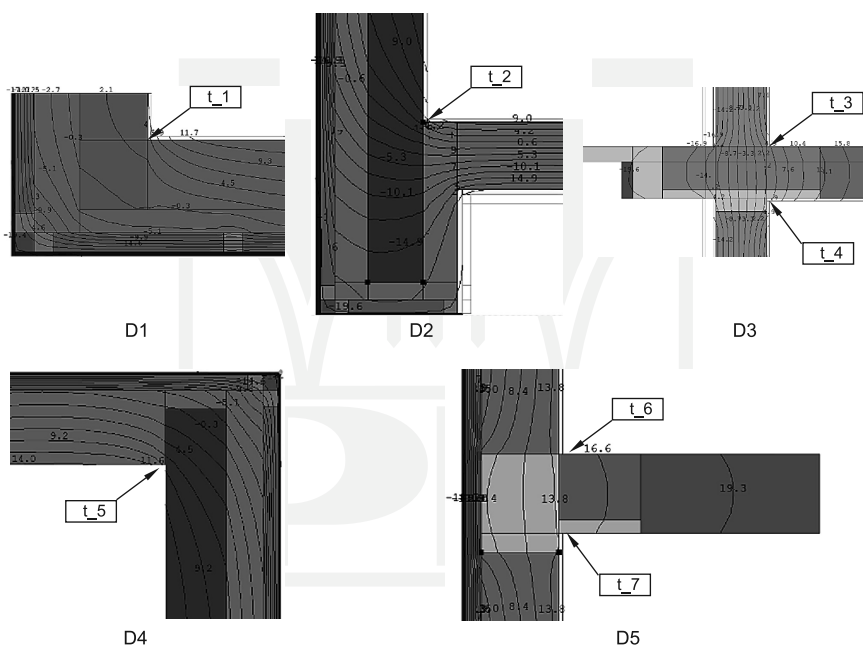
Fig. 6. Geometric models of details and locations of temperature readings

Scheme	Surface temperature determination method	Temperature in joint [°C]		Temperature factor f_{Rsi}	
		Variant_1 $t_i = 20^\circ\text{C}$ $t_e = -20^\circ\text{C}$	Variant_2 $t_i = 20^\circ\text{C}$ $t_e = -2.4^\circ\text{C}$	Variant_1 $t_i = 20^\circ\text{C}$ $t_e = -20^\circ\text{C}$	Variant_2 $t_i = 20^\circ\text{C}$ $t_e = -2.4^\circ\text{C}$
Detail D1	t_1	4.8	11.5	0.62	0.62
Detail D2	t_2	6.7	12.4	0.66	0.66
Detail D3	t_3	4.5	11.2	0.61	0.60
	t_4	3.7	10.8	0.59	0.58
Detail D4	t_5	8.6	13.6	0.71	0.72
Detail D5	t_6	14.7	17.0	0.86	0.86
	t_7	14.4	16.6	0.86	0.84

The calculation results indicate there is a risk of surface condensation and of the formation of mould in both of the computed variants, in the joints marked D_1, D_2, and D_3. These partitions have complex material elements and characteristics. A concrete (class B20 according to the old marking) core joint, reinforced with plain bars, with favourable thermal parameters (shown in details D_1 and D_3), is in place alongside the light concrete elements of the wall. In comparison to the temperature reading of the D_1 structural wall and curtain wall combination (i.e. wall blocks with PGS blocks but without a column

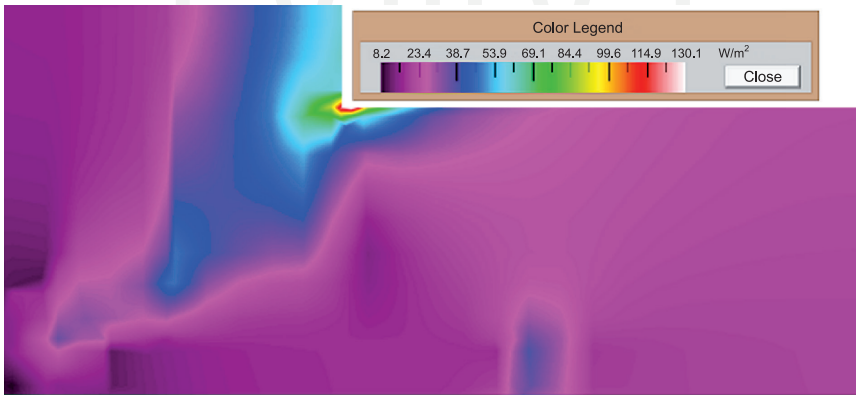
Fig. 7. An example of the heat flux density distribution in the cross-section – Detail D_1

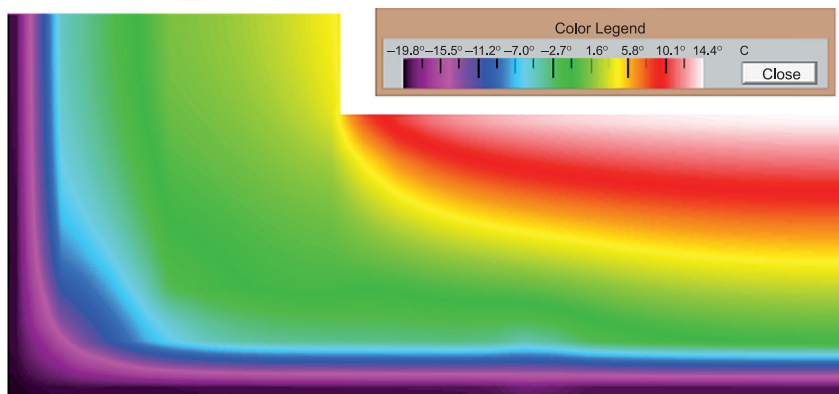
Fig. 8. An example of the field temperature distribution in the cross-section – Detail D_1
