KRZYSZTOF DYDUCH*, RAFAŁ SZYDŁOWSKI**

MATERIAL-CONSTRUCTION SOLUTIONS APPLIED IN LONG-TERM REPAIRS OF REINFORCED GRANULATION TOWERS IN NITROGEN PLANTS

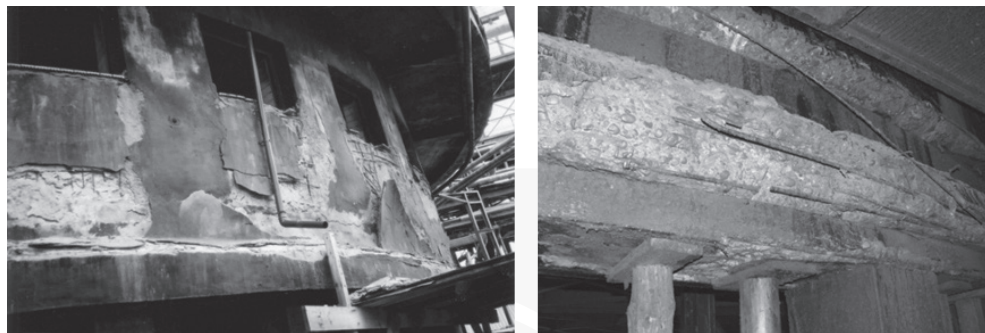
In 2002, after fifty years of operation in the aggressive environment of the plant, the towers were subjected to advanced degradation as a result of the ammonium and sulphate corrosion of the concrete. The monolithic foundation of the tower (Fig. 3) as well as the prefabricated

cylindrical shell (Fig. 4) were seriously destroyed. Losses of concrete in the prefabricated wall reached two-thirds of the wall thickness. Additionally, there was considerable local damage to the cross-section of the vertical ribs. In the lower monolithic part of the tower, the concrete cover of the cylindrical walls, columns and tie beams were damaged. Almost completely corroded reinforcing bars were localized.

Fig. 3. Corrosion of monolithic foundation of the tower in 2002

It was recommended to remove the concrete cover from reinforced concrete foundation columns and to protect these columns with a 5–7 cm thick reinforced layer. Additionally, the concreting of the monolithic ring wall from the outside was designed to be at a level of +3.00 to +6.00 m with 15 cm thick concrete reinforced with two meshes ϕ 8 every 150 mm on both surfaces and anchored to the original wall with ϕ 12 mm anchors spaced at 300×300 mm.

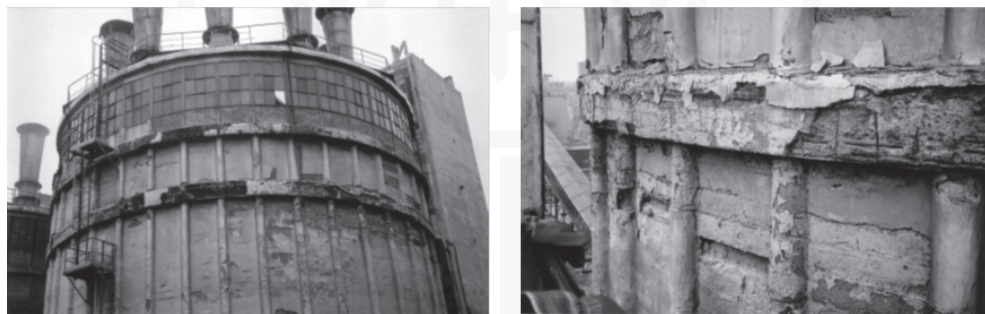
Fig. 4. Corrosion of the prefabricated cylindrical shell (2002)

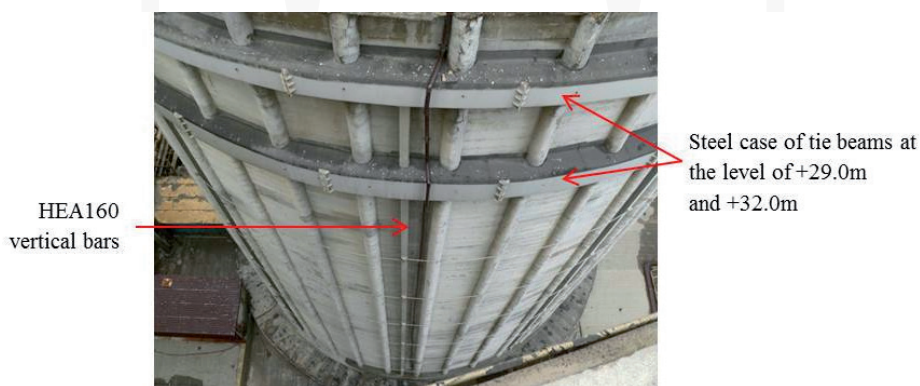
Fig. 5. Steel reinforcement of the granulation tower

The reinforcement of the tie beams at a level of +29.12 and +31.83 m were designed in the form of steel casing as well as additional 10 HEA 160 vertical bars extending from a level of +6.0 to +29.12 m and anchored to the prefabricated cylindrical wall (Fig. 5). The role of the designed reinforcement was to safely transfer the loads from the top of the tower (technological ceiling, flat roof and reinforced concrete upward extension) and relieve the prefabricated coating.

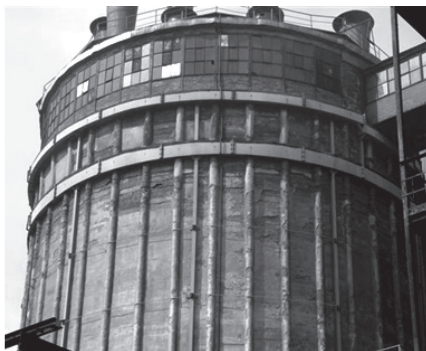
The tower had again degraded 4 years after its repair. The precast coating reinforced concrete elements (Fig. 6a) were significantly damaged. The concreting of the pillars of the foundation was seriously cracked and loose. One of the reasons for the damage was certainly the contractor's breach of technological regimes contained in the project and instructions for the use of materials for re-profiling. Undoubtedly, the main reason for the damage was contaminated concrete and the aggressive environment around the towers – this was caused

Fig. 6. a) damage of prefabricated shell elements four years after repair; b) exhaust chimney near the tower

by the location of exhaust chimneys in the immediate vicinity (Fig. 6b). Approx. 3 kg/h of ammonium nitrate (NH_4NO_3) is removed from the exhaust air coming from the chimneys. The contamination of concrete and its progress is presented in section 5.

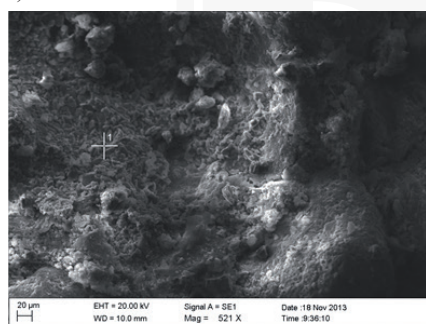
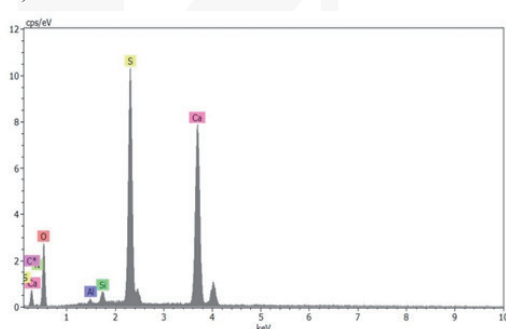
with chloride corrosion. In the considered period of seven years, a significant increase in SO_4^{2-} ions was identified – this proves the progressive corrosion of sulphate. The ion content, as compared to the weight of the binder in 2007, amounted to 2.5% in all three tested samples. Meanwhile, in the samples taken in 2013, that value ranged from 3.5 to 5.0 (with an average value of 4.38). Figure 7 presents the results of observation in the scanning electron microscope for one of the samples taken in 2013. The results present a leaky structure formed by the processes of dissolution and sulfate corrosion (Fig. 7a), as well as its confirmation in EDS analysis (ettringite formation – Fig. 7b).

Fig. 7. The results of the observation of the concrete sample in the scanning electron microscope:
a) leaky structure formed by the processes of dissolution and sulfate corrosion; b) EDS analysis results (ettringite formation)

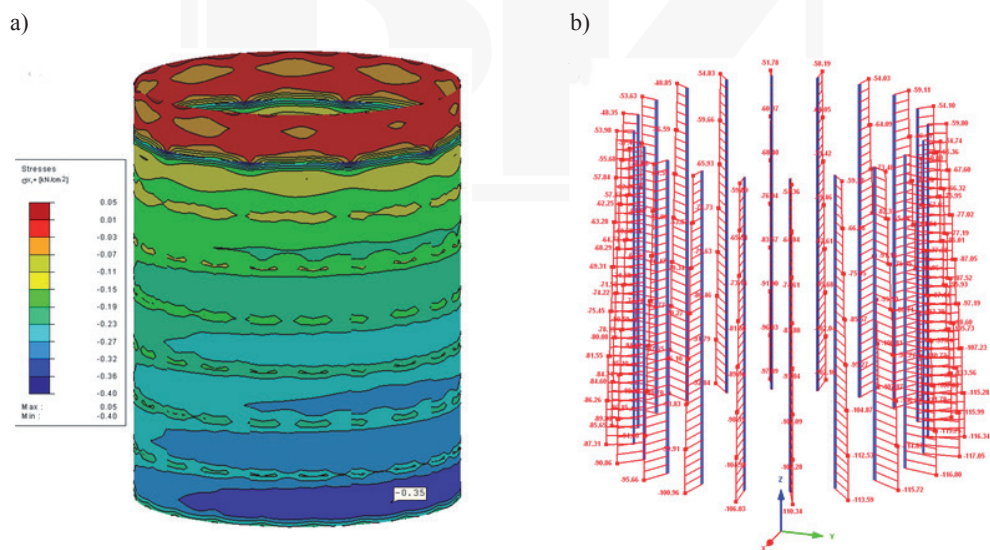
Fig. 8. The results of static analysis of the structure for Option 1: a) concrete shell vertical compression [kg/cm²]; b) steel pillar forces [kN]

slabs of the coating amounted to 3.5 MPa for Option 1 and 1.9 MPa for Option 2. Forces in the steel pillars amount to 117.1 and 65.0 kN, which generate compression in the steel sections equal to 30.2 and 16.8 MPa.

The conducted analysis of stress indicates a high level of compression in the concrete slabs (3.5 MPa) in Option 1. Given a dramatically low technical condition of the concrete, the loss of even half of thickness of the coating resulting the concrete stress increase can be considered. As a result, the compressive stresses can cause a loss in the stability of the reinforced concrete cylindrical shell and losses of concrete fragments.

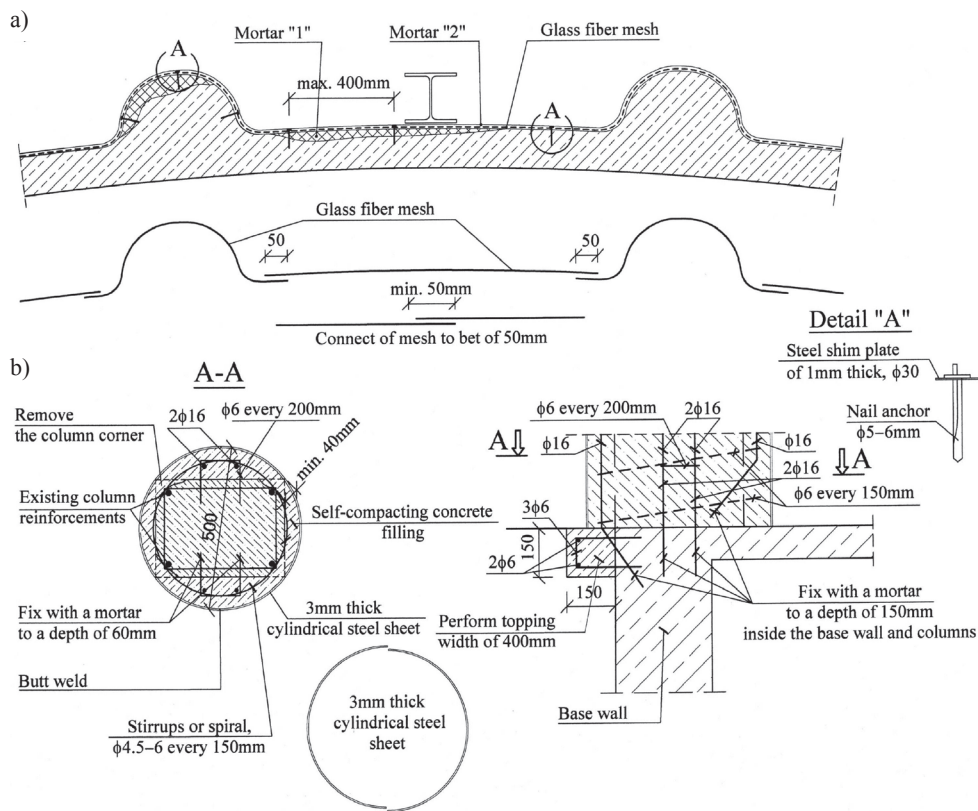
Fig. 9. a) details of protection of prefabricated concrete shell; b) reinforcement of foundation columns

Because of a high level of concrete stress, a low durability of previously conducted repairs and a long period of the planned operation of towers had to be used a good protection. The effectiveness of repairs to deeply damaged concrete elements depends on the bonding of the applied repair layer with a concrete base. For this reason, bonding layers are applied according to the 'wet on wet' principle, i.e. after the application of the bonding layer, prior to its bonding and drying, the surface should be repaired. This technological requirement hinders the execution of repairs. Defective execution of repairs decreases their efficiency and durability. Additionally, the effectiveness of repairs is worsened by the low strength and chemical contamination of concrete. In order to ensure long-term protection of the elements of the tower in a contaminated environment, it was necessary to find a more effective solution than the solution used previously. Among other proposals, the possibility of making an outer coating, made of stainless steel, was considered. Finally, the system of a reputable supplier of construction chemistry, not requiring the use of an additional bonding layer, was applied. After the removal of the corroded concrete particles and thorough cleaning of the concrete surface and reinforcing steel, it was recommended that the extensive loss of concrete be replaced with fine-grained, thixotropic repair mortar with controlled shrinkage, reinforced by synthetic fibers with an average compressive strength of 30 MPa (Fig. 9a – mortar '1'). The mortar is usually applied in layers with thicknesses of up to 25 mm. After the re-profiling of concrete cavities, the reinforced protective coating of 5–6 mm was applied all over the surface of the prefabricated wall. For this purpose, a two-component cement mortar with high strength and plasticity dedicated to strengthening of masonry structure (mortar "2") was used. This mortar includes fine aggregate, special additives and an aqueous dispersion of synthetic polymers. Due to the high content of synthetic resin, it forms a stable and durable layer which is impermeable to water and the aggressive components present in the atmosphere, and it is not a barrier to water vapour diffusion. The protective layer was reinforced with an alkali-resistant glass fibre mesh with meshes of 25×25 mm and a weight of 225 g/m², tensile strength of 45 kN/m and strain at rupture of less than 3%. Given the poor adhesion of the protective coating applied to the corroded concrete, the anchoring to the original wall of the tower was applied with the support of nail anchors spaced at not more than 400 mm in both directions.

Reinforced concrete foundation columns were encased in a 3mm thick steel layer (Fig. 9b) after all loose and cracked concrete parts were forged together. After prior reinforcement of concrete filling of a steel casing in accordance with Fig. 9b (4mm vertical bars ϕ 16, pasted into the parent concrete, transverse stirrups and pasted bonding inserts), the inside of the casing was flooded with self-compacting concrete.

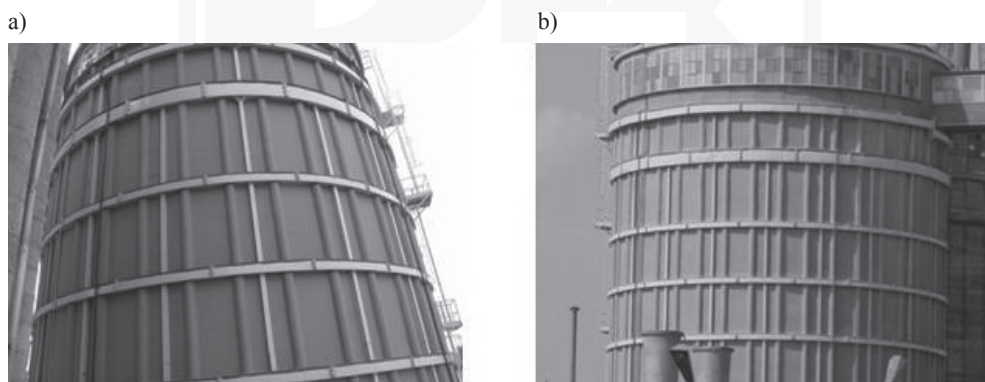
Fig. 10. a) the granulation tower shortly after renovation (mid-2012); b) the same tower after 2.5 years of operation

In addition to the complete repair and securing of protective coating, additional reinforcement was designed to increase the stiffness and stability of the wall. The number

of vertical HEA 160 steel posts was increased from 10 to 20 during the previous repair. Moreover, 6 reinforced peripheral tie beams with cross-sections of 300×300 mm, evenly spaced at 3.2 m, were designed. The tie beams were made from steel formwork (Fig. 10), armed longitudinally and transversely, and combined with the concrete wall.
