Mykola Orlenko

The significance of object restoration in the urban environment and restoration basics

2. RESTORATION OF THE NATIONAL PHILHARMONIC OF UKRAINE

3. RESTORATION OF THE ODESSA NATIONAL ACADEMIC THEATRE OF OPERA AND BALLET

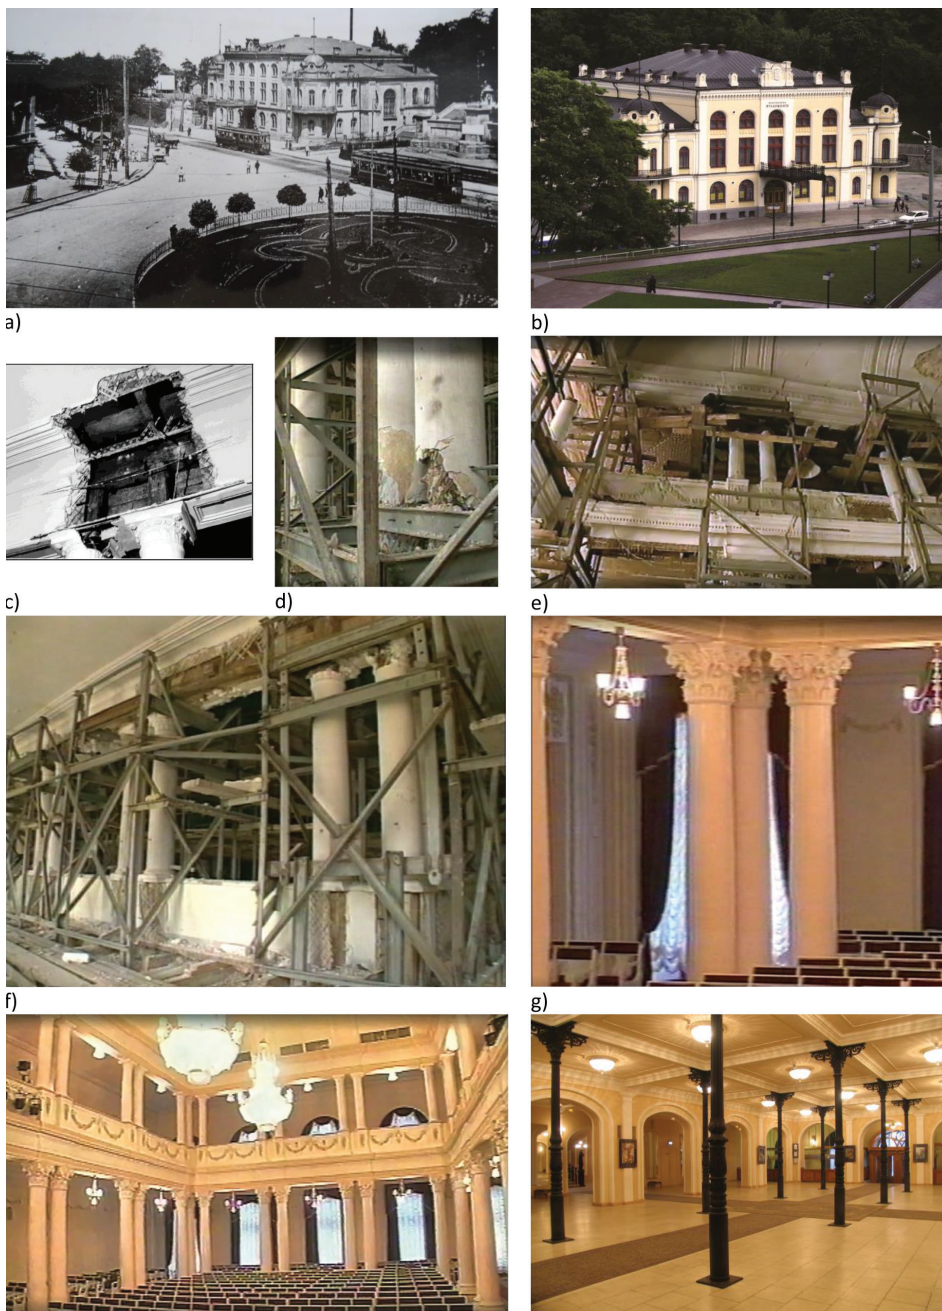
As a result of the above, we can say that the building of the Merchants' Assembly Club is a characteristic object of the second half of the 19th century in its architectural, stylistic and constructive solution and decorative elements and methods of decorating facades and interiors. The problem of its critical state was related to the fact that as a result of accidents of the water supply and sewage systems, the balance of the 'footing-foundation-building' system was disturbed, basement deformation occurred, and this led to the occurrence of through-traversing/full-depth cracks in the exterior walls and deformation of the floors by up to 20 cm vertically⁵. The vaults of the hall and the ceilings of all the rooms were covered with cracks, the plaster crumbled and the destruction of wooden elements was observed⁶. The vaults of the hall and foyer were noticeably deformed with vertical displacement of some sections being up to 20–25 cm. Due to the subsidental deformations of the foundations and basement, subsidence of the gallery columns, ledger strips and tie beams of the gallery was identified; in some places, there was subsidence of up to 30 cm. During visual inspection, it was found out that the wooden elements of the suspended ceiling and the trusses were damaged by wood-destroying insects and, during previous repairs, they were already strengthened by padding overlays and the installation of additional metal and wooden elements⁷. Due to sedimentary deformations, the wetting of roof elements and garret floors occurred.

The original external appearance of the main facade was also mangled: the balcony over the main entrance was demolished, two balconies of the first floor on the corner semi-circular avant-corps were not preserved, the decorative finishes of cupolas were lost during repair and the form of the coating was changed – 30% of the original appearance was lost.

Fig. 1. The National Philharmonic of Ukraine: a) archival photos of the 19th century; c-f) before the restoration; b, g-i) a modern look

As priority measures, it was proposed to eliminate deformations of the footings and foundations of the building (taking into account the fact that the base was loose filled soil and the foundations were shallow lying, which resulted in the deformations), to stabilise the deformation processes and to conduct comprehensive repair and restoration work on the monument⁸. The footings and foundations were strengthened with needle piles and jacked piles. In order to restore the firmness of masonry of the walls, it was proposed to use the Italian method 'reticolo cementato' (stitching) - to inject open cracks with mortar and to reinforce masonry. We used the prosthetic method and managed to level the deformed constructions which were not subject to replacement on account of the acoustic properties of the hall (first of all, all wooden columns and beams). On the main façade, all the lost elements and the cartouche with the Archangel Michael on the pediment were restored; the ceremonial marble staircases were decorated with marble figures of Apollo and Aphrodite in decorated niches; a marble fountain with a cherub appeared in the centre of the foyer. In November 1996, the National Philharmonic building was put into operation.

The primary measures were as follows: elimination of the deformation of the footings and foundations of the building by strengthening with needle piles and jacked piles; restoration of solidity of masonry walls by the mortar injection of open cracks, annealing of the deformed structures which could not be replaced due to the acoustic properties of the hall (primarily, all of the wooden columns).

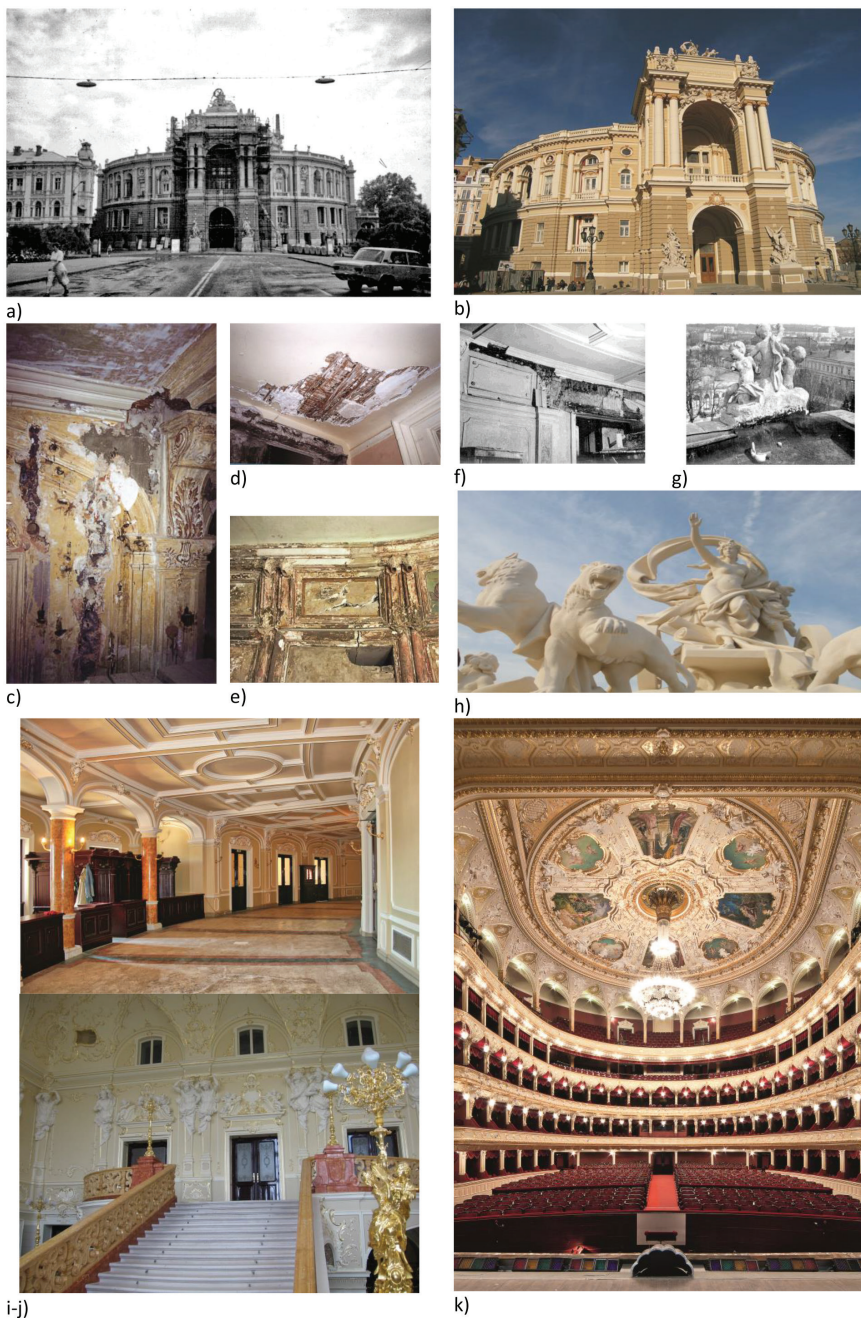
In the 1980s, the entire building was in the most critical condition; it split into 36 separate blocks, the slope of the walls towards the sea was 20 cm, the opening width of numerous cracks was 6 cm, the floor beams of the second and the third tiers moved and subsided by 30 cm. The surveying of the state of the building in the years 1997 and 1998 showed that the deformations did not stop.

- 1) During its lifetime, the building has been subjected to numerous deformations, as a result of which, cracks appeared in its components.
- 2) The appearance of cracks in the walls led to a split of the building between the stage and spectator sections and the division into four parts of the walls of the spectator section.

- 3) Deep longitudinal cracks were fixed on the ceilings of the tiers, the ceilings shifted along the annular walls resulting in the formation of annular cracks. The floor of the foyers of the tiers leaned towards the outer walls.

- 4) Due to the subsidence and destruction of the outer annular walls, the floor beams of the second and third tiers moved out of the supporting sections of the masonry, the supporting areas laying under the beams were destroyed, and as a result, the beams subsided by 30 cm.

- 5) On the radial trusses of the ceiling, the plates on the columns to which the trusses are attached were curved and swollen. An annular metal I-bar along the top of the wall of the auditorium, on which the trusses of the upper ceiling rest, broke along the line of the bolt holes.

- 6) The beams of the monolithic ribbed slab of the covering of the stage area enclosure in the places of the basing upon the walls of the stage there were numerous cracks and chips with a width of opening of up to 20 mm.

- 7) At the time of the survey, the north-eastern corner of the theatre building was 175 mm below the north-western corner. The largest subsidence was fixed at the eastern foyer and was 375 mm. All the stairwells of the spectator part were tilted towards the south. The portal of the main entrance was tilted towards the south and east by 200 mm and the walls of the scene have a slope in the northeastern direction by 200 mm.

Fig. 2. Odessa National Academic Theatre of Opera and Ballet
 a) archival photos of the 19th century; c-g) before the restoration; b, h-k) a modern look

For elimination of the critical condition of the Odessa Opera House building, we identified the priority measures aimed at stabilisation of the spatial stability of the building, strengthening of the long-span supporting structures of the flooring of scenic openings of party walls and long-span ceiling trusses of the auditorium and the structures of monolithic reinforced flooring in all sanitary facilities; the ceiling structures of all tiers and the ceiling frames of loges and balconies, accident response and recovery, the prevention of emergency situations, ensuring the further operation of the building, compliance with the modern standards and requirements for theatre buildings, to begin with strengthening of footings and foundations, basements and ground structures of the main portico of the stage box and their protruding gable parts. Partial rebuilding of the vaults was envisaged in the western emergency portico⁹.

Primary measures were restricted as follows. Since the method of the foundations strengthening by the method of silicatisation had no effect, the measures were aimed at stabilising the spatial stability of the building by, first of all, strengthening with needle piles together with jacked piles of the footings, foundations and superstructure of the main portico of the stage box and their protruding gabled parts. In the western emergency portico, partial rebuilding of the vaults was envisaged as was strengthening of the long-span
