TECHNICAL TRANSACTIONS 11/2019 ARCHITECTURE AND URBAN PLANNING

The second life of a shooting range – the conservation and adaptation of the historic shooting range at Wola Justowska in Krakow for its new function

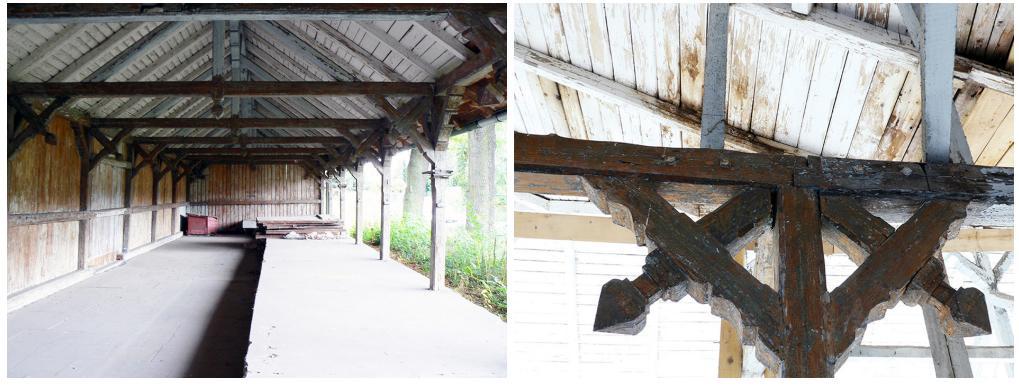
Fig. 6. View of the eastern segment interior eastwards; on the left and in the background there are the walls with a half-timbered structure, on the right there are posts of the open wall of the hall immersed in a concrete shooting bench (post-war) – the other side presents the original level of the hall (concrete pavement slabs, possibly from the inter-war period). This is the condition before the adaptation of the pavilion (Source: Author's archive)

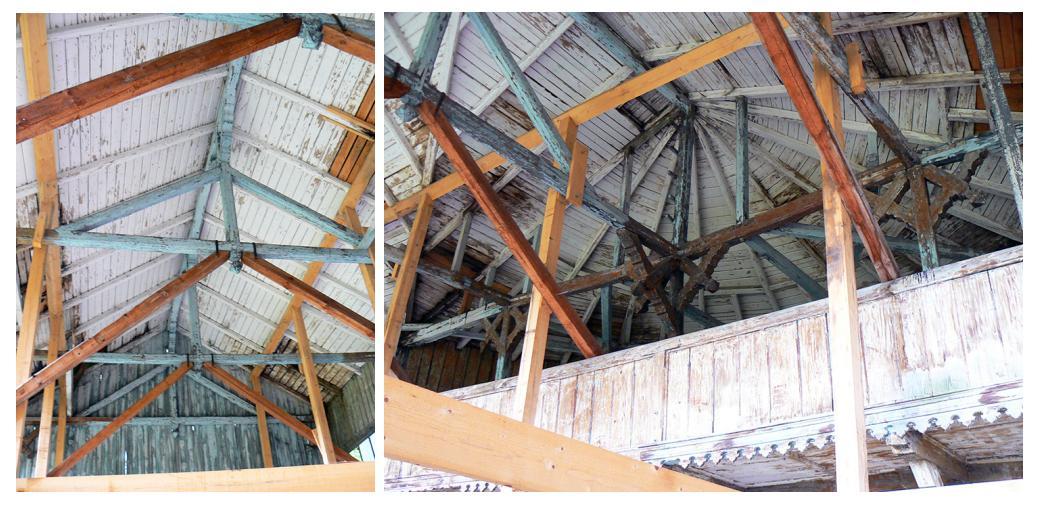
Fig. 8. Interior of the middle segment - view of the western wall - the open roof truss, single-frame with struts and king posts supporting the ridge. A view of the interior of the avant-corps – the closed balcony balustrade, the avant-corps roof truss and secondary reinforcement of the original structure are visible. This is the condition before the adaptation of the pavilion (Source: Author's archive)

The southern elevation of the central section, including the avant-corps, is glazed with two rows of windows placed between the ground floor posts and the mezzanine floor. The single loom windows have several quarters. The colour of the wooden frame is clearly distinguishable on the northern façade and is darker than the wall surface elements (Fig. 5). The carpentry of struts and crosses was also designed in a decorative way. The avant-corps has an exposed frame, and the post heads are profiled. Its roof is multi-hipped and flattened and the surfaces of gable roofs are topped with decorative wooden pinnacles. The central section is entirely open to the south. High construction posts sitting on pedestals have decoratively finished capitals. At the turn of the 20th and 21st century, the upper part of the building was supported, which preserved the stability of the original wooden frame [2] (Fig. 8).

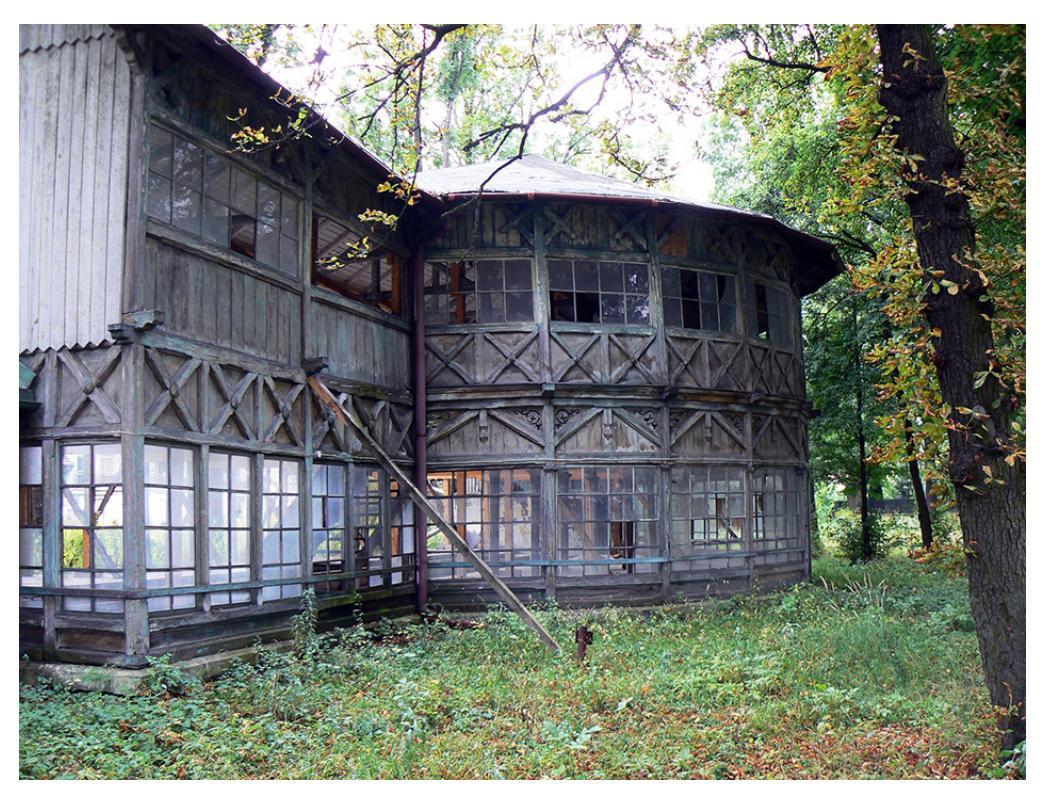
The main cause of the poor condition of the wooden framing was leaky roof coverings and damage to the metal-sheet work. In many places, the wood had darkened and was covered with stains; white patches of salt were apparent on the borders. (Fig. 9). The mould had spead on the structural frame elements, the decorative details and the covering boards. Significant changes to the geometry of the wooden frame system were visible (22 cm deviation from the perpendicular position of the posts). Deformations, breaks, numerous cracks and the delamination of oil paint coatings were also spotted. The window and door wings were warped, and the glazing was destroyed. The ironwork elements were corroded and incomplete [2].

Fig. 9. The critical condition of the shooting range pavilion showing a view of the central section from the southern side. This shows the condition before the adaptation of the pavilion (Source: Author's archive)

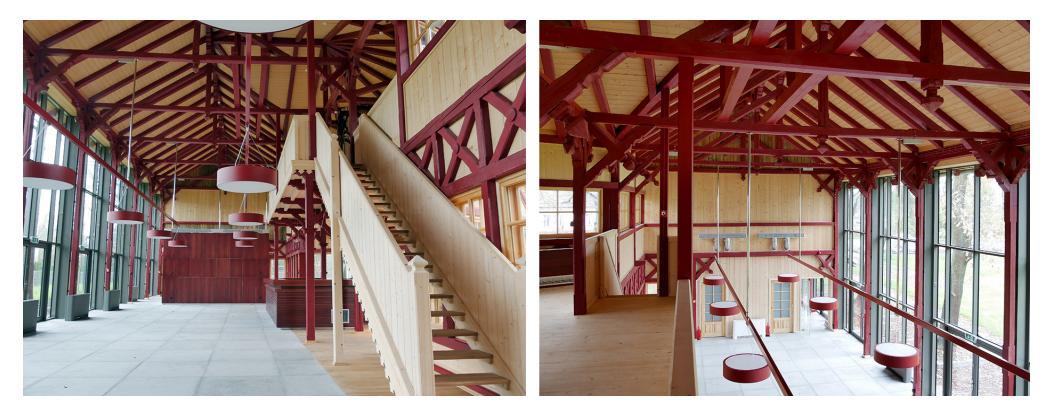
Fig. 10. View of the interior of the central segment. The open roof truss was restored by decorating it in the original colour scheme. The southern wall has been glazed to the entire height of the pavilion which was feasible after installation of a steel support structure (Source: Author's archive)

As a result of professional inquiries conducted in the field of construction, stratigraphy and micro-chemistry at the design stage of the project (including the schedule of conservation works) and with consideration to the planned construction of the basement, the decision to dismantle and reassemble the entire wooden frame and foundations was made. This enabled performing conservation procedures on the original structural elements and making necessary replacements. The dismantling started with the removal of the old roofing and was followed by the deglazing of windows. The original glazing was secured and re-used as "witnesses". Initially, the structural elements of the upper part of the avant-corps were dismantled. Each element of the dismantled truss was recorded and was examined by an authorised mycologist

in order to determine which should be kept and which should be replaced. The disassembled elements of the trusses were laid out in sets to form complete trusses. Surface pre-cleaning was also performed, and all of the elements were then secured for the duration of further works. The wooden elements went through a preservation procedure: they were disinfected, cleaned, stripped of their secondary oil coatings, reinforced or repaired according to their condition, and protected against weather conditions, microbiological decomposition and damage caused by insects. Rejected elements of the structure were replaced with components made from seasoned wood in accordance with the original parameters relating to wood type, grain direction and dimensions. The original pavilion structure had been made of native conifer species, primarily fir but also pine and spruce⁴.

With regard to the need for adapting the building to applicable legal regulations, it was also necessary to increase the cross sections of the wooden structural elements of the trusses. The whole wooden structure of the central segment that included preserved and new wooden or steel components was placed on a 15-cm steel-reinforced concrete slab laid above the new basement. The curtain wall supporting structure consists of I 300 steel columns at intervals adjusted to the dimensions of the wooden trusses (approximately every 325 cm). The excavation was secured with a Larsen-type sheet wall. Due to the vicinity of the legally protected old trees on the southern side of the building, the wall was left in the ground, constituting a part of the foundation. In other places, the wall was extracted out of the ground. The dismantling of the structure was also followed by the construction of the planned basement under the central and eastern parts of the complex. The basement was made in the form of a tight reinforced-concrete basin with a bottom plate and external 25-cm-thick walls. Due to the relative proximity of old trees with an estimated age of over 100 years, some of them required correcting cuts of their crowns in addition to regular care procedures [2].

Interior and exterior decorating works included the reconstruction of the earliest colour scheme of the object (Fig. 10). For this purpose, the framing elements were painted with red-

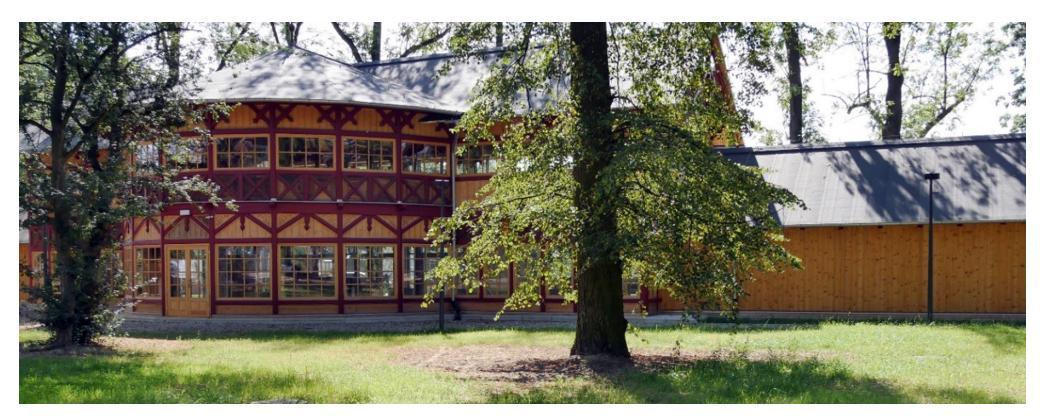
Fig. 11. View of the central segment of the pavilion with the apse from the southern side. This shows the condition after adaptation (Source: Author's archive)

brick paint and the wall surface sections were left the colour of natural wood. The preserved elements of the original ironwork were subjected to metal conservation. The roof surface was insulated from the outside in order to keep the elements of the roof truss visible from the inside. The wooden decorative detail was reconstructed in the original form and vertically planked. Decorative constructions of the avant-corps and the apse were also made [2] (Figs. 11–14).
