ALEKSANDER URBAŃSKI\*, LESZEK OPYRCHAŁ\*\*

## ANALYSIS OF MECHANICAL EFFECTS OF LOW- AND HIGH-FREQUENCY TEMPERATURE CHANGES IN A MASSIVE CONCRETE DAM

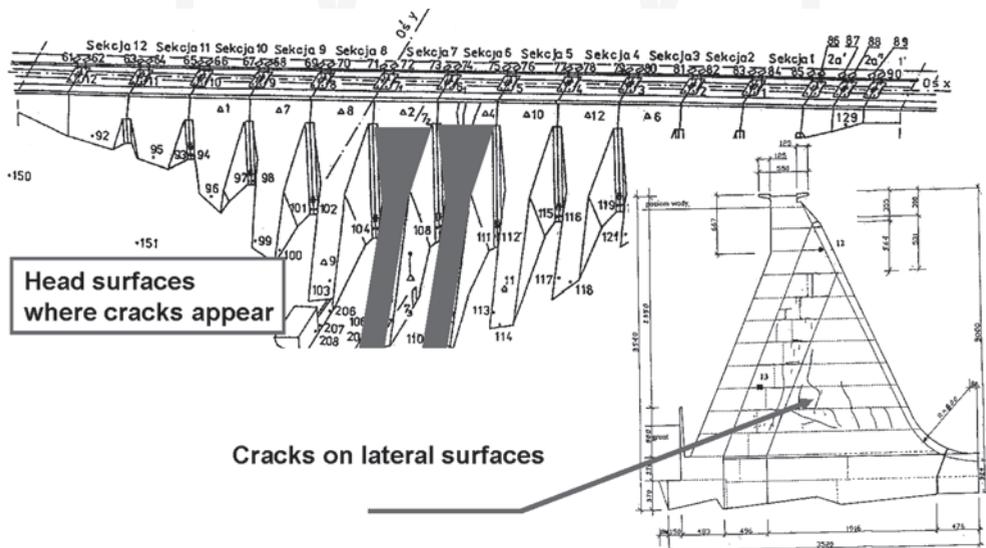
In the year 1998 [3], i.e. after 34 years of exploitation, cracks and fissures in the buttress and transition zones of the highest sections of the dam (nr 6 and 7), as shown in Fig. 1, were noted during a technical inspection. In the year 2013 surface cracking of the concrete was also detected on the head surfaces of the buttress. An explanation for the observed phenomena has become vital for the safety assessment of the dam and design of the rehabilitation procedure. The crack pattern indicates that the possible reason for cracking is the influence of the thermal stress field.

Fig. 1. a) View of the dam from the downstream site b) View of the right wall of the buttress of the 6-th section of the dam with cracks, after [3].

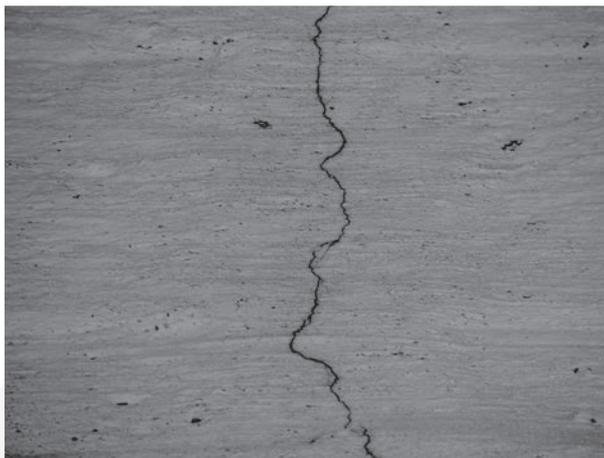
Typical cracks appearing on the head surface of the buttress are shown in Fig. 2.

Fig. 2. Crack on the head surface

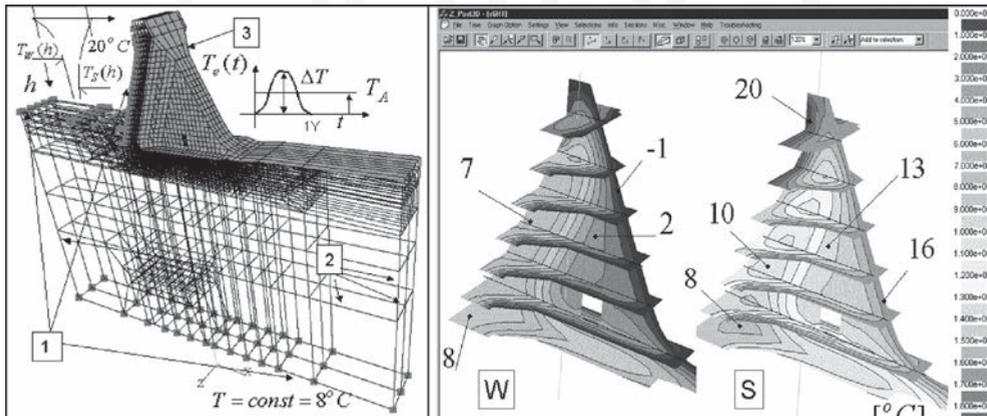
In the analysis, all 3 types of boundary conditions (BC) were used (Fig.3a):

Fig. 3 shows the FE model (rough mesh is shown) with BC used in the 3D analysis of heat problem and the resulting temperature distribution in [°C] in winter [W] and in summer [S].

Fig. 3. a) Heat transfer BC. b) Temperature distribution in winter [W] and summer [S]

The temperature field shown in Fig. 3b and Fig. 4 was obtained during the first computational analysis of the dam, conducted by the first author of this paper in 2002 and reported in [5, 6]. In the present analysis, the FE mesh was densified, see Fig. 5, giving however practically the same output.

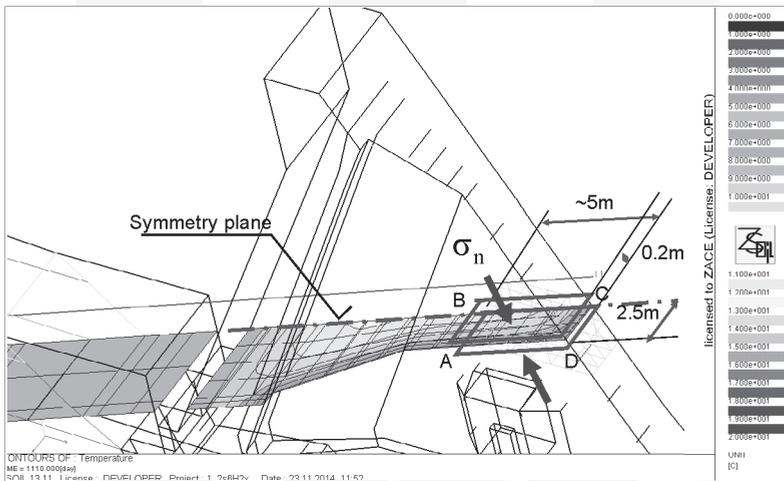
In attempting to explain the origin of the multiple cracking of the concrete appearing on the head surface of the buttress, which cannot be result of the yearly temperature cycle, an analysis of daily (high-frequency) environmental temperature variation was undertaken. This is set in the 3D/2D domain which is representative of the whole region close to the head surface. This is shown in Fig. 6. An analysis of high-frequency temperature changes for full model of the section requires also a much denser FE discretisation (estimated size of element in near-surface zone ~10 cm) and time stepping  $dt = 0.1$  day (10 steps per day). These would result in an unacceptably long computation time (few days). Therefore an approximate procedure has been chosen.

Fig. 6. Localization of the domain for high-frequency thermal and mechanical analysis

Boundary conditions for thermal analysis for the fragment of the dam were adopted as follows:

- along the segment AB – 1-st type of BC, by adopting nodal temperatures as a function of time obtained from the low-frequency solution;
- along the segment BC, on the symmetry plane, 2-nd type of BC (adiabatic,  $q_T = 0$ );
- along the segments CD and AD, 3-rd type of BC (convection). The function of ambient temperature  $T_{eHF}(t)$  describes diurnal variability throughout the year, with yearly averaged temperature  $T_A = 8^\circ\text{C}$  and  $\Delta T = 18^\circ\text{C}$  being the amplitude of daily averages. A term describing the diurnal fluctuation has been added.
