MICHAŁ WOJENKA

**THE OCTAGONAL TOWER AT CASTLE OJCÓW –
A COMMEMORATIVE REALISATION OF KING
KASIMIR III THE GREAT?**

Key words: castle Ojców, tower, Kasimir III the Great, architectural detail, commemorative realisations

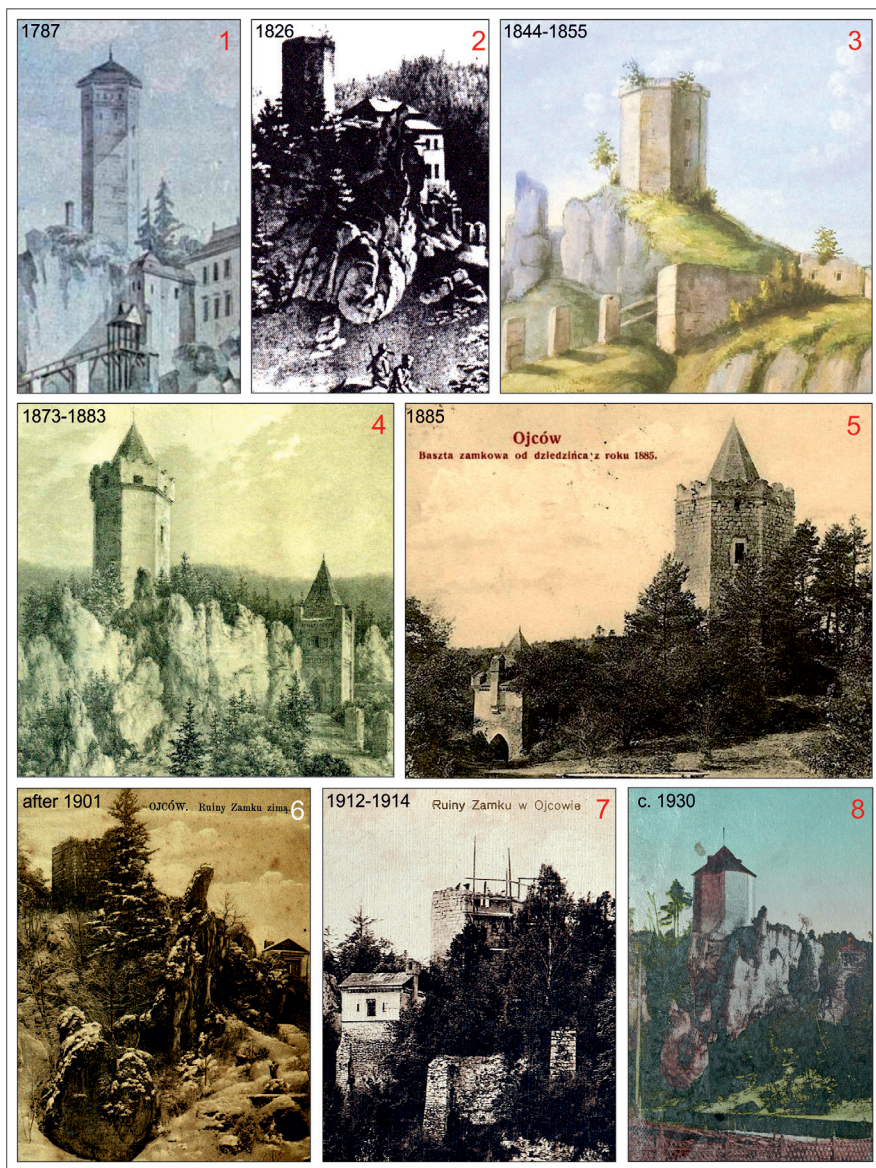
Fig. 3. The octagonal tower at castle Ojców in the iconographic material. 1 – a watercolour of Z. Vogel, 1787; 2 – a watercolour of J.N. Głowacki, 1826; 3 – a litography of K. Stronczyński, 1844-1855; 4 – a litography of N. Orda, 1873-1883; 5 – the octagonal tower in 1885, a postcard; 6 – the tower in the early 20th c., a postcard; 7 – the tower during restoration works in 1912-1914, a postcard; 8 – the tower in the early 1930s, a postcard.

As we can see, in the written accounts of the early 1800s the tower is only marginally described, and the scarce available data does not allow for a precise determination of its appearance and internal design. To some extent this disadvantage is compensated for by the iconographic sources dated to the late 18th c., which demonstrate the tower as a high landscape-dominant building, with a couple of windows and an octagonal gable roof of „Polish” type. Below the roof line there was a row of rectangular window-like openings (Fig. 3:1; Nowacki 1958, 14).

Soon after the castle is abandoned, the original elements of the tower begin to blur (Fig. 3:2). Due to the state of repair, its upper section was dismantled by Ludwik Krasiński between 1893 and 1895. His ambitious plan was to rebuild it, ended with his early death in 1895 (Fig. 3:6; see Ziarkowski 2015). The look of the tower as can be seen at present (Fig. 3:8) results from extensive restoration work carried out by his daughter Maria Ludwika, in 1912-1914 (Fig. 3:7; Ziarkowski 2015, 235; Falniowska-Gradowska 1999, 81). It is most likely that around the same time a new door and window framings were placed (Frazik 1966, 31). A bit earlier it might have looked quite different. Thanks to Kazimierz Wróblewski, the author of a guidebook for the Prądnik river valley travellers’ from the turn of the 20th c., we are able to get a glimpse into the tower’s inside before it was partially dismantled by Krasiński. As he reports, yet in 1893 the entrance to the tower was narrow³ and vaulted. The passage led to the inside of a ground level, without any window, and next to the doorway there were remains of a chimney and two smaller niches – the right yet with shelves, which suggests its storage function, and the left one, which was regarded by Wróblewski as a bouldered passage to a dungeon (this is a significant point to which we will return later). As of today, a stairway on

the left, yet at the end of the 19th c. concealed by a thin wall, led to the first floor of the tower, which had one window (facing south; see Fig. 3:3-4) and included a finely decorated fireplace (Fig. 6.2). The second floor had two windows (facing south and east; Fig. 3:3-5), while the third was equipped with eight T-shaped openings (Fig. 3:4-5), doubtlessly loop-holes (Wróblewski 1907, 132-136). As regards window openings, in light of iconographic sources it is likely that it was only the third floor which originated from the restoration works of Przewdziecki; the number of windows seen at the first and the second level probably resembles the original pattern from the times of the tower's residual function.

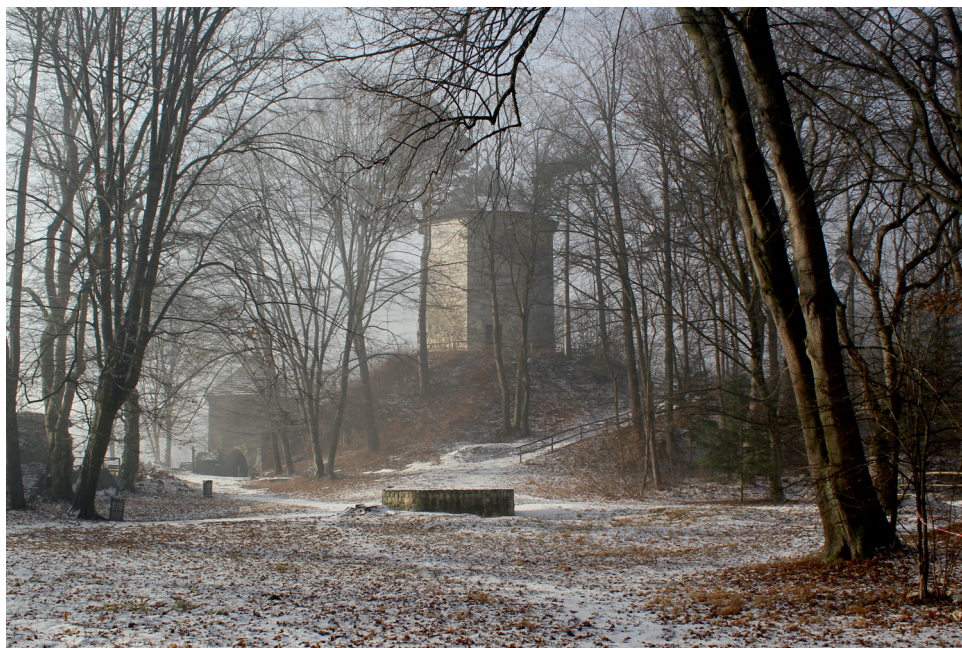
Fig. 4. The octagonal tower at castle Ojców. View from the east. Photo by M. Wojenka

The tower (Fig. 4, 5) is an octagon in plan, has 11.55 m in diameter, and walls that are ca. 2.7-2.8 m thick. On the inside it is round, has 6.2 m in diameter (Fig. 6:1). At the moment the structure is around 13 m high, but since it was extensively

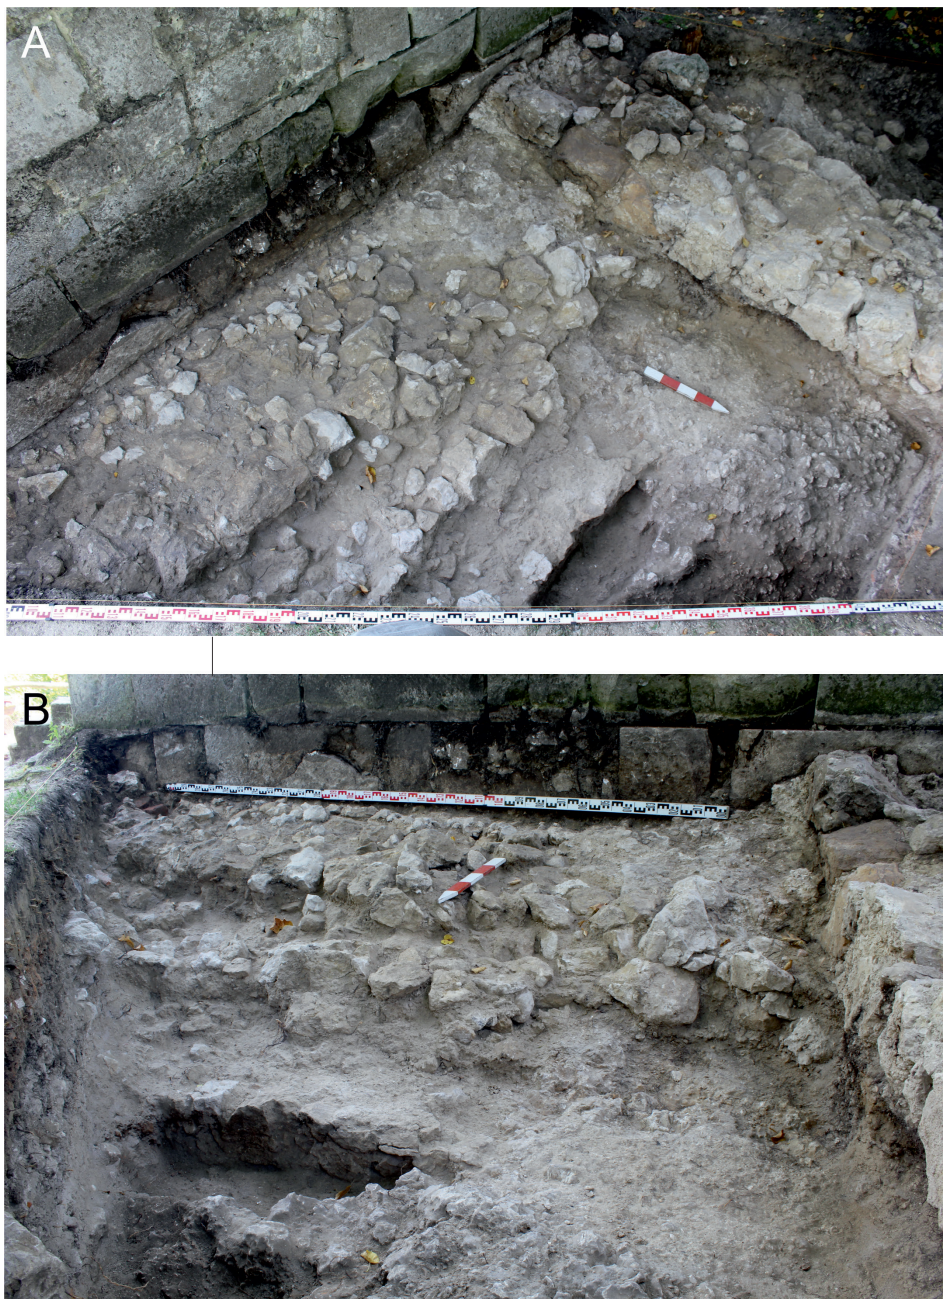
Fig. 9. Trench VII. Remains of a stair-like limestone construction. A – view from the east;
B – view from the north. Photo by M. Wojenka

Both layer 7 and 8 were lying directly on the bedrock or were covering the another masonry structure, which deserves special attention. These were the remains build up by small limestone rocks (ca. 10-15 cm), set in lime mortar. The structure was unearthed below mortar layers 6 and 7 at the bottom part of trench, practically at the level of bedrock. It took a stair-like form with the height of each single "step" ca. 20 cm (Fig. 9:A-B). It is difficult to draw conclusion on its function. Obviously, it is tempting to regard this structure as remains of medieval stairway leading to the entrance of the tower. On the other side, the stair-like form of the structure may have been seen in context of natural form of the bedrock, which in many places of the hill is characterized by an irregular course with frequently occurring natural fissures (*cf.* Fig. 6:6 and Fig. 10). Thus, it may as well be presumed that the stair-like structure resulted from necessity to fill the natural fissure in order to keep the tower's basement firm and even. In light of observations made in the trench VII it would also appear that the stone wall which was seen by Krystyna Kruczek in 1991, forms part of the same construction (see Kruczek 2001, 398).
