KATARZYNA NOWAK\*, KATARZYNA NOWAK-DZIESZKO\*

## IMPACT OF PREPARATION PROCEDURES ON RESULTS OF AIRTIGHTNESS TESTS

Requirements connected with the designing of low-energy and passive buildings impose an obligation to conduct airtightness tests during the building process and after the completion of building works. Proper building preparation is required before initiating an airtightness test. In case of commercial buildings with complicated HVAC systems, the proper preparation may appear to be very complicated and can unfavorably affect the tests results. On the example of tests conducted in the low-energy office buildings in Wrocław, the authors describe the problems met during airtightness tests.

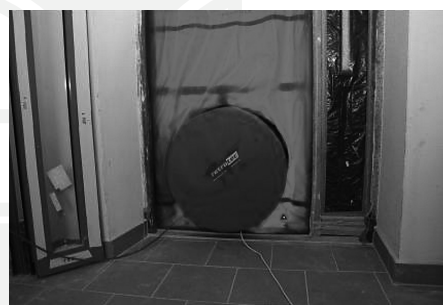
Tests were conducted using the Blowerdoor set (Fig. 2) with the digital controller Retrotec 3000 and Fantastic program to analyze test data.

Fig. 2b. Blowerdoor set –internal view

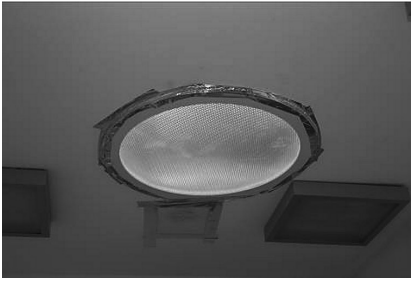
The buildings were prepared for the tests (method B), all openings in the building envelope such as windows, doors, ventilation ducts and openings next to the lightning devices were closed. Inside the building with the mechanical ventilation system, there is a lift shaft with a separate mechanical ventilation system. For the purpose of testing, the elevator shaft was cut off from the analyzed building volume. Figs. 3, 4 present the preparation of different building parts.

Fig. 3. Preparation of lighting fixtures

The problem of a too high  $n_{50}$  value in both buildings was mainly connected with the suspended ceilings in the buildings. Unfortunately, the roof construction above the ceiling was not tight – the air leakages were noticeable next to lighting fixtures mounted in the ceiling construction, however, direct monitoring of the roof construction was not possible.

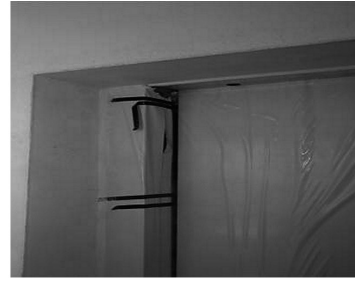
Fig. 4. Preparation of lift shaft

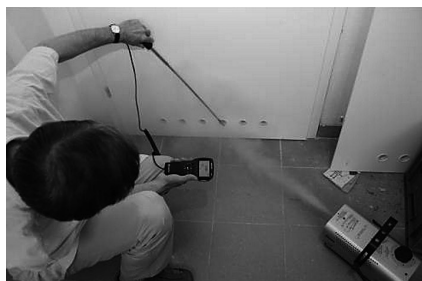
During the tests, all air leakages were monitored using a fog generator, an anemometer and an infrared camera. It allowed for the detection of both openings in the building envelope caused by inaccurate erection as well as the inaccurate building preparation (Figures 5 and 6). To make the monitoring possible and to increase the air flow through the openings, a pressure difference of up to 100 Pa was forced. It revealed the location of leaks but also loosened the sealed openings. This is the reason why the constant monitoring of all sealed openings should be done.

Fig. 5. Detection of leakages with fog generator and anemometer

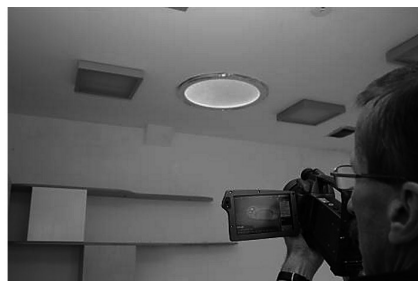
Fig. 6. Detection of leakages with infrared camera

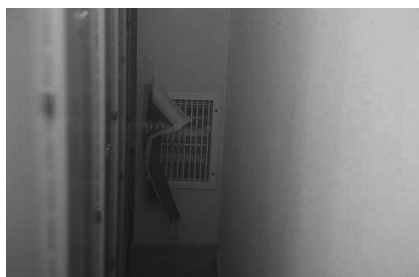
Fig. 7. Loosened sealed opening during the airtightness test

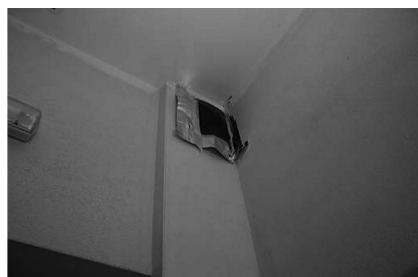
Fig. 8. Loosened sealed opening during the airtightness test
