ZBIGNIEW WIKŁACZ\*

## SUPERSTRUCTURES OF MODERNIST TENEMENT HOUSES – CHANCES AND THREATS

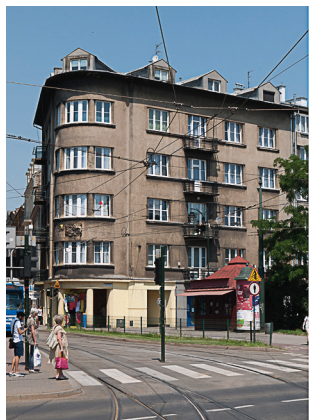
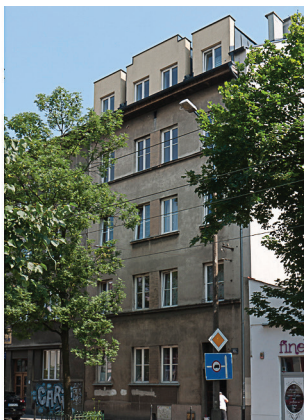
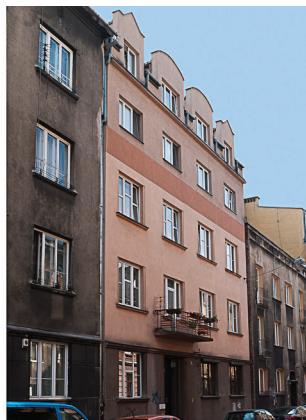
III. 1. From the left: tenement house at 22 Starowiślna street, 52b Kościuszki street and 4 Kraszewskiego street

The problem referred to above is illustrated in a corner tenement houses at the intersection of Dietla street and Starowiślna street (Ill. 1), which has become an icon of a wrong attitude towards transformations within the area of the roof. Dormers, in a form which is suitable for homestead housing rather than a downtown tenement house, have ruined an elegant form of a strongly exposed building. Regrettably, this unsuccessful intervention, executed quite a long time ago, has not taught any lesson to authors of next superstructures and preservation services. It seems that the most cases of undesirable transformations of tenement houses from the inter-war period can be found in a small quarter of Cracow – Zwirzyniec. In this quarter, at 52b Kościuszki street (Ill. 1) there is yet another example of a superstructure executed by adding dormers. Three dormers with a step finial do not correspond to a simple composition of the modernist facade at all. The authors have not even taken the trouble to locate them in the axes of the existing windows. Other bad examples of using dormers could be found at 4 Kraszewskiego street (Ill. 1) and at 6 Prusa street. In the former case, triangular and semicircular finials do not belong to the modernist architecture at all, in the latter case, on the other hand, unnaturally tall, rectangular dormers unnecessarily emphasize this part of the building, which should remain a mere background for the historic facade. Another example of an unsuccessful superstructure is located at 4 Komorowskiego street, where – for a change – two large triangular dormers have been used, which in aesthetic terms belong rather to the architecture of the Podhale region. Placed next to the original facade, they constitute quite a bizarre addition.

Powyższy problem pokazuje kamienica narożna u zbiegu ulicy Dietla i ulicy Starowiślnej (Il. 1), która stała się ikoną złego podejścia do przekształceń w obrębie dachu. Lukarny o formie właściwej raczej dla architektury zagrodowej niż śródmiejskiej kamienicy zrujnowały elegancką formę mocno eksponowanego budynku. Niestety, ta – dość już odległa w czasie – nieudana interwencja nie stała się nauką ani dla autorów kolejnych nadbudów, ani dla władz konserwatorskich. Wydaje się, że najwięcej przypadków niekorzystnych przekształceń kamienic międzywojennych znaleźć można w niedużej krakowskiej dzielnicy Zwierzyniec. To tutaj, przy ulicy Kościuszki nr 52 b (Il. 1), znajduje się kolejny przykład nadbudowy zrealizowanej przez dodanie lukarn. Trzy schodkowo zwieńczone lukarny zupełnie nie współgrają z prostą kompozycją modernistycznej fasady. Nie postarano się nawet o umiejscowienie ich w osiach istniejących okien. Inne, równie złe przykłady użycia lukarn znaleźć można już przy ulicy Kraszewskiego nr 4 (Il. 1) oraz przy ulicy Prusa nr 6. W pierwszym przypadku trójkątne i półokrągłe zwieńczenia są całkowicie obce architekturze modernizmu, w drugim zaś nienaturalnie wysokie, prostokątne lukarny niepotrzebnie akcentują tę część budynku, która powinna pozostać tłem dla historycznej fasady. Kolejny przykład nieudanej nadbudowy znajduje się przy ulicy Komorowskiego nr 4, gdzie zastosowano dla odmiany dwie duże lukarny trójkątne, które estetycznie przynależą raczej do architektury Podhala. W zestawieniu z oryginalną fasadą stanowią dość kuriozalne uzupełnienie.

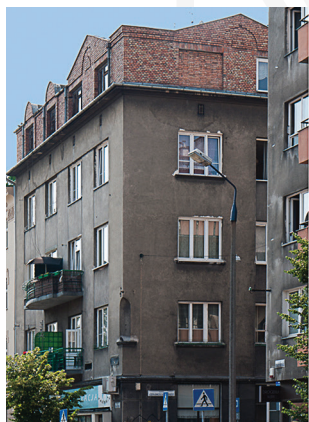
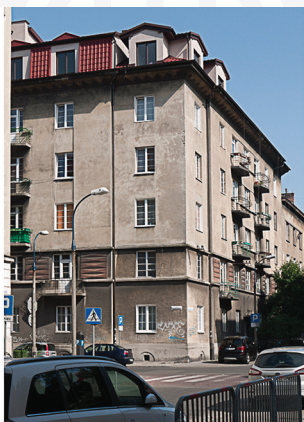
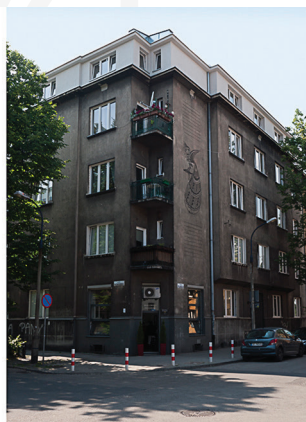
III. 2. From the left: tenement house at 2 Kraszewskiego street, 16 Salvatorska street and 16 Filarecka street

house at the intersection of 1 Kraszewskiego street and Senatorska street, never plastered to date (Ill. 2). Totally unnecessary triangular and semicircular finials have completely changed the composition and the initial style of this building. The implementation located at 10 Prusa street looks very bad, too, with huge windows of the superstructure clashing with the windows of the interwar facade. The tenement house located at 12 Filarecka street is not much better, either. In this case the eave which protrudes way too much and the edge windows totally out of the axis ruin the effect. Better results have been obtained by the author of the superstructure of a beautiful corner tenement house at 16 Filarecka street, decorated with a sgraffito with a motif of a peacock (Ill. 2). Nevertheless, it would be much more beneficial if the added superstructure was a bit retracted towards the elevation below and had a different texture of plaster. It should be hoped that the renovation of the elevation will bring about a sort of unification of the original facade and the superstructure, at least in terms of the colours. Undesired changes in the body of the building as a result of adding a superstructure have reached their climax in a representative tenement at the intersection of Salwatorska street and Prusa street (Ill. 2). This exposed corner building has been decorated with three dormers and a superstructure, hidden beneath a false mansard. Successful implementations comprise the superstructure of the tenement house at 9 Komorowskiego street (Ill. 3) and at 4 Salwatorska street (Ill. 3). A narrow belt of windows running along the entire width of the elevation does not change the composition of the modernist facade at all and is the most discrete solution out of all the ones described above. A similarly good impression is made by the recently renovated tenement house at 11 Tatarska street, with an added superstructure (Ill. 3). The superstructure, covered with aluminium sheet metal arranged in standing seams and equipped with smaller windows than the ones below, formally belongs to the roof and does not compete with the original facade, maintaining its articulation at the same time.

mieć nadzieję, że renowacja elewacji przynajmniej kolorystycznie scali oryginalną fasadę z nadbudową. Niekorzystne zmiany bryły budynku w wyniku nadbudowy swoją kulminację osiągnęły w reprezentacyjnej kamienicy u zbiegu ulicy Salwatorskiej i ulicy Prusa (Il. 2). Eksponowany narożny budynek udekorowany został trzema lukarnami i nadbudową ukrytą za fałszywą mansardą. Do udanych realizacji można zaliczyć nadbudowę kamienicy przy ulicy Komorowskiego nr 9 (Il. 3) oraz przy ulicy Salwatorskiej nr 4 (Il. 3). Wąski pas okien przez całą szerokość elewacji w żaden sposób nie zmienia kompozycji modernistycznej fasady i jest najbardziej dyskretnym rozwiązaniem ze wszystkich opisanych powyżej. Podobnie korzystnie prezentuje się niedawno nadbudowana i odrestaurowana kamienica przy ulicy Tatarskiej nr 11 (Il. 3). Nadbudowa pokryta, układaną na rąbek stojącą blachą aluminiową i wyposażona w okna mniejsze niż na piętrach poniżej, przynależy formalnie do dachu i nie konkuruje z oryginalną fasadą, jednocześnie zachowując jej artykulację.

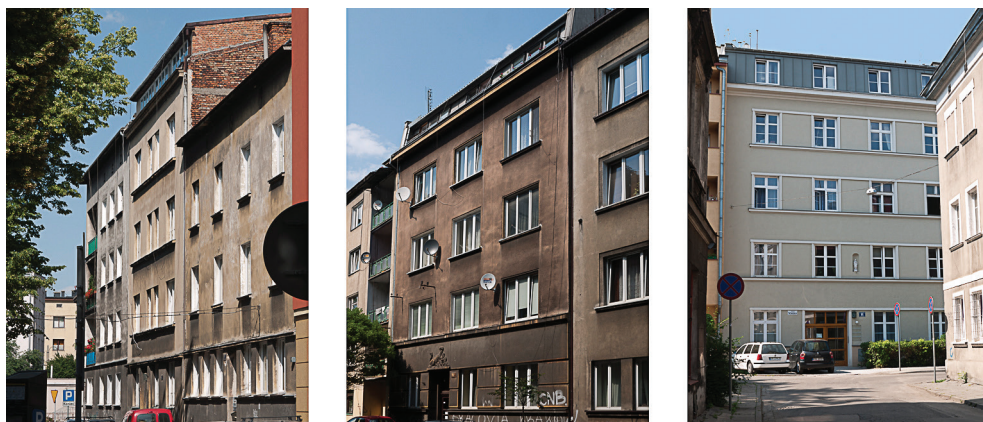
III. 3. From the left: tenement houses at 4 Salvatorska street, 9 Komorowskiego street and 11 Tatarska street
