JOANNA BOGAJEWSKA-DANEK*

HISTORIC PARK AT SMUSZEWO PALACE – PROBLEMS AND OPPORTUNITIES FOR REVALUATION

In this article the author discusses the historic landscape park located around the palace in Smuszewo (Wielkopolskie Province) dating back to the 2nd half of the 19th century. Making reference to historic research regarding the estate, analyses of the park composition and its current condition and problems encountered during the process of designing. Additionally design solutions which will allow for the facility revitalization are presented.

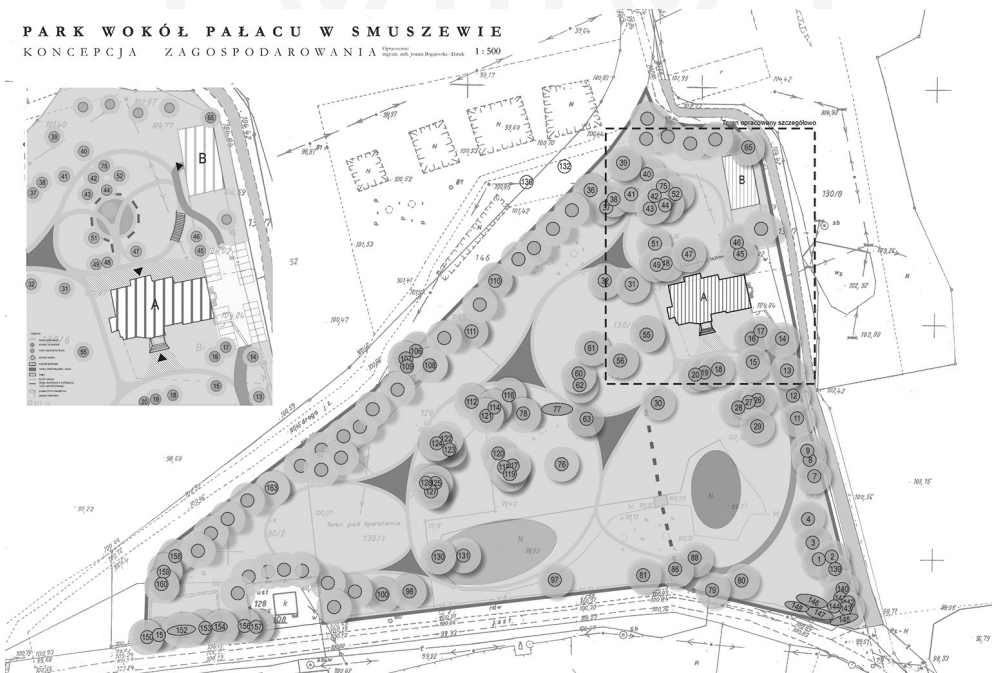
The park revitalization concept was prepared based on the aforementioned source material. Setting out of walking alleys in the calligraphic system, referring to the system existing in the 19th century is envisaged and biologically active grey Hanse Grand material is proposed to be the pavement.

The envisaged function of the palace, a retirement home, requires good access. An access road to the building suggested for the eastern boundary of the plot. A parking square on the eastern side, at the level of the palace, is also recommended. Bearing in mind the future function of the facility, a relaxation zone was proposed in the location of the former fruit tree formation, repeating the calligraphic layout at a smaller scale. Landscape architecture elements: benches, pergola etc. were envisaged. Grass with a waterhole was proposed in the middle of this part of the park. The proposal of the park revitalization concept is presented graphically in the second illustration.

III. 2. The concept of the park around Smuszewo palace developed by the architect Joanna Bogajewska-Danek M.Sc. Eng. and Hanna Wdowicka (author J. Bogajewska-Danek)

As a result of the tree survey, numerous losses in the tree stand were found, in particular in the south-western part (most probably the local inhabitants cut out the trees (Ill. 2)). At the park area can be found: European Ash (32.65%), horse-chestnut (17.01%), small-leaved lime (14.29%), black locust (13.61%), poplar (12.24%) and a single specimen of the European white elm, Norway maple, the large-lived linden and Norway spruce. Dendrological analysis demonstrated that a significant percentage of trees have deep lost, sometimes in large amounts. The occurrence of numerous self-seeding plants is the effect of long-term negligence. The common feature of the majority of trees is the lack of formation of a tree habit characteristic of a given species, which results from long-term compaction. Thus, in most cases it is impossible to determine the crown diameter.

The concept of the park revitalization provides for the removal of a large quantity of self-seeding plants, leaving the most valuable ones (well developed, not colliding with the transport system). Exposing hidden trees, control of some tree crowns and sanitary cutting.

For the purpose of isolating from the commune club room, intensive planting of high greenery at the shared border is proposed. The extension of an assortment of species commonly occurring in the 19th century naturalist gardens is envisaged in the park², and at the concurrence of alleys bush clusters are proposed.

It was decided against the restoration of the ponds to their original form, and only to signal their existence by single-species perennial plants³.

ku, powtarzając w mniejszej skali układ kaligraficzny. Przewidziano tu elementy małej architektury: ławki, pergolę itp. Na środku tej części parku zaproponowano gazon z oczkiem wodnym. Propozycję koncepcji rewaloryzacji parku przedstawiono graficznie na ilustracji 2.
