Department of Hydraulic Engineering and Hydraulics, Faculty of Environmental Engineering, Warsaw University of Technology

ANALYSIS OF THE TECHNICAL CONDITION OF THE SEWAGE COLLECTOR WITH THE USE OF NUMERICAL SIMULATION

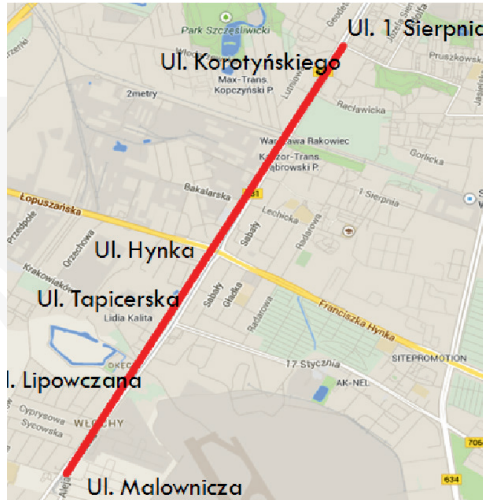
Fig. 1. Construction scheme of the collector (source: own elaboration)

The object of conducted researches and analysis is the bricksewage collector constructed at the end of the 1960s and the beginning of the 1970s, located in Warsaw between Malownicza Street and 1 Sierpnia Street (Fig. 1).

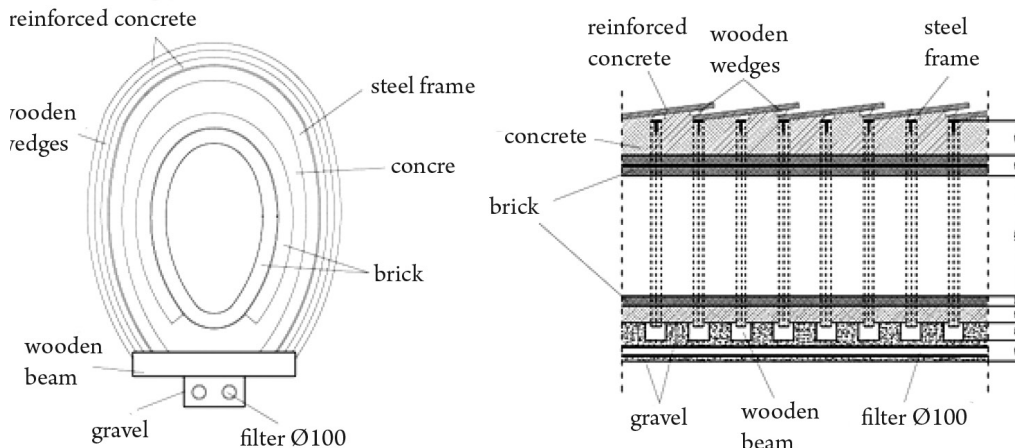
Fig. 2. Construction scheme of the collector (source: own elaboration)

cladding was constructed of A-type facing, made of prefabricated reinforce concrete boards with the dimensions of $125 \times 11 \times 6$ cm, 6 cm thick wooden wedges and T-beam shaped steel frames with the dimensions of $11,5 \times 13$ cm. The steel frames were supported on the base constructed of wooden beams with the dimensions of $135 \times 20 \times 24$ cm. The walls of the collector were built of two layers of “150” class sewer brick and “80” mark mortar. According to the project assumptions, the space between the brick layer and the reinforced concrete cladding was filled with concrete of $R_w = 140$ at. Corresponding construction schemes of the collector were presented in Fig. 2.

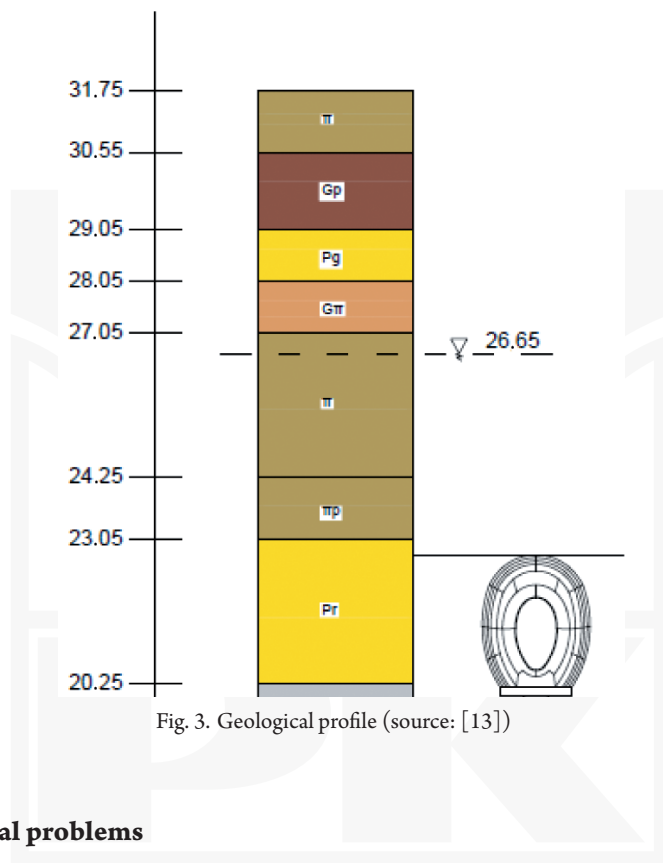
Fig. 3. Geological profile (source: [13])

Geological conditions in the subsoil are created mainly by quaternary structures. Occurrence of sandy clay, loamy sand and silt layer was observed. Gravel layers of a small

thickness were formed deeper in the subsoil. The ground water level was localized at the depth of 26.65 m above the level of the Vistula River (Fig. 3). The ground water shows qualities of sulphate and carbonate aggression towards the concrete.

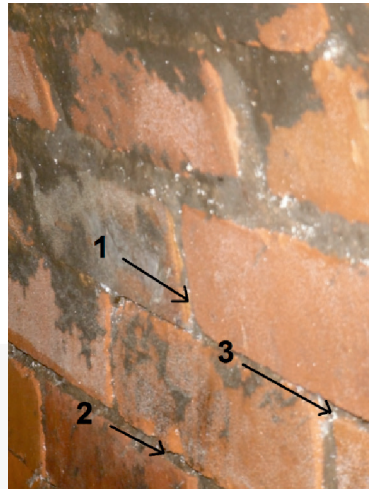
The considered sewage collector causes many operational problems. Its present technical condition can be defined as unsatisfactory. While conducting field research, numerous damages of collector walls, including 3–15 mm wide cracks, were noticed. In addition, a significant loss of bricks and mortar was observed in some places (Fig. 4).

Fig. 4. The wall of the collector. No 1, 2, 3 are places of mortar loss (source: [13])

In these conditions, the optimal solution is using local compaction grouting technology in sites, which are most endangered by groundwater infiltration, along with applying thermosetting lining on the walls of the collector. Instead of thermosetting lining, mortar rich with highly penetrating compounds may be used. The introduction of this solution would provide construction tightness as well as an increase of the strength parameter values of the whole lining and soil surrounding of the collector.

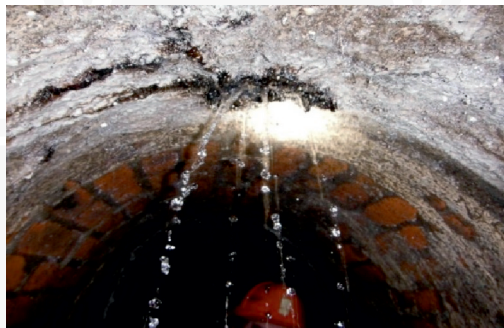
Significant problems with the collector’s tightness were observed. Numerous accretions indicate that water strongly infiltrates inside the object (Fig. 5). A large number of accretions and a tight structure (Fig. 6) limit the possible sewage flow and cause problems with the capacity of the collector.

Accretion forming is caused by mortar and concrete leaching from the construction, which is a result of chemical aggression. Occurrence of empty spaces within the collector cladding, which cause change in static scheme of the cladding work, should be assumed. Significant

cracks and scratches result in the necessity of constant carrying of groundwater flow load by the already weakened construction. Attempts of impact removal of the accretions resulted in strong outflow of highly pressurized water.

Fig. 5. Leakage into the collector (source: [13])

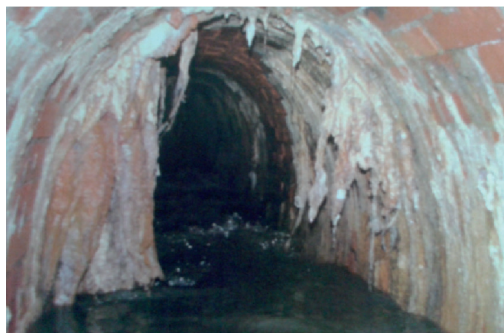
Fig. 6. Strongly developed accretions on the collector wall (source: [13])

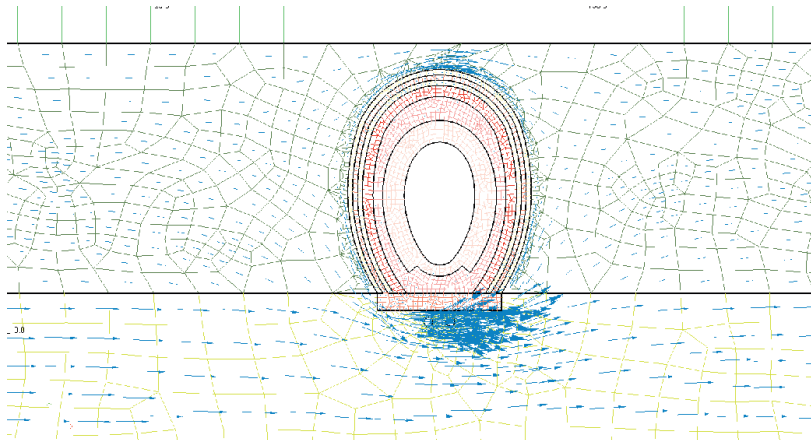
Fig. 8. Vectors of water flow velocity (source: own elaboration)

The calculations were carried out for several different scenarios. In the first one, the process of steady filtration on the assumption of tight collector cladding was analyzed. Afterwards, the influence of local leakages on the course and intensity of the filtration phenomena was simulated. For this purpose, the material parameter values were locally reduced by increasing the value of the hydraulic conductivity coefficient. An elastic-plastic analysis of the construction was carried out in order to determine stress distribution and tensile stresses. To show damages and failures, appropriate material parameters were successively modified with reference to particular areas (E , φ , c). Tensile stresses are particularly dangerous to the collector cladding for they can lead to scratches and leakage in the construction. The results of filtration calculations are presented in Fig. 8 as velocity vectors within the analyzed model. The vectors indicate directions of water flow. Lengths of individual vectors are proportional to flow velocity. On the basis of the calculations, it can be noticed that the largest flow concentration occurs directly under the structure (gravel and drains) and in the soil layer above the collector. These are the places of potential suffusion processes, which can result in local deterioration of the material properties of the subsoil.

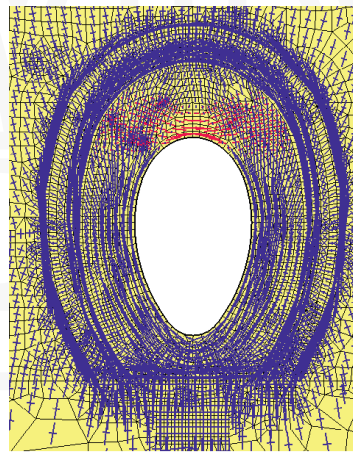
Fig. 9. Tensile stresses in the collector vault (source: own elaboration)

Stress distribution of the collector lining is presented in Fig. 9. Tensile stresses were marked in red. Occurrence of the tensile stresses in that area may cause chink forming in the mortar or its flaking off the bricks. Both these factors are conducive to forming of preferential leak paths. During field researches, leakages in the upper part of the collector were frequently observed.

In each of the analyzed cases, tensile stresses occurred in the upper parts of the collector. The usual indications of their formation are numerous cracks and scratches. These are the places of a particularly intensive groundwater leakage into the object. Results of analysis carried out with the use of the 3D model explain the reasons for ground collapse near Tapicerska Street, which was caused by suffosion processes in silty soils above the collector.

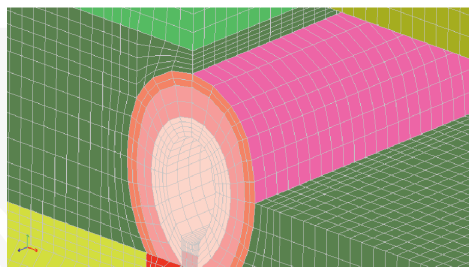
Fig. 10. The contact zone between the collector and the ground (source: own elaboration)

The boundary conditions in the calculations were used in the form of variable ground water levels and traffic loads (tram trackway is located directly above the collector). In the zone between the collector and the ground adjacent to it, the elements of interface type were used once more (Fig. 10). Soil loosening was also assumed in the calculations. For this

In the area of soil loosening, increased subsidences of the ground surface were noticed (Fig. 10). This confirms previous observations, taken near Tapicerska Street. This situation puts ground infrastructure safety at risk. What is more, it can also generate additional tensile stresses in the construction of the collector. Directly in the area of soil loosening, displacements of the upper surface of the model were noticed. These processes can be additionally intensified by both progressive suffosion and effects of dynamic factors. Consequently, there is a risk of ground surface collapse, which can result in building disaster.
