Stanisław Duży (stanislaw.duzy@polsl.pl)

Faculty of Mining and Geology, Silesian University of Technology

EVALUATION OF THE TECHNICAL CONDITION OF THE “FRYDERYK” ADIT  
IN TARNOWSKIE GÓRY FOR THE PURPOSE OF EVENTUAL REVITALIZATION

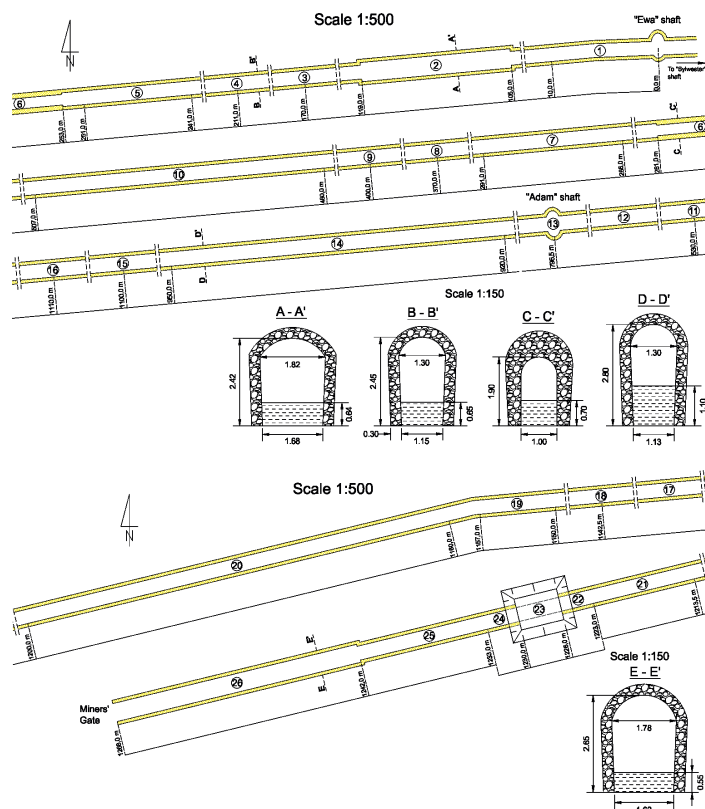
- ▶ it was found that damages to the support vary along the adit,
- ▶ within the distance of 0–45 m from the Miners’ Gate, there are losses in brickwork and mortar in the joints, loosened parts of the support and its deformation. In this section, there is a damage zone with a collapsed part of the tunnel, which was rebuilt with a wooden support (Fig. 5),

- ▶ the sections between 45–118 m, 126–143 m, 156–158 m, 632–739 m, 761–788 m, 969–979 and 1149 to 1163 meters from the Miners' Gate show earlier repairs of the support through its partial replacement with a masonry brick or monolithic concrete support. There are also a lot of biological contaminants – roots piercing the support, washing of the mortar joints by old water leaks, loosened parts of the support and washing of the sidewalls of the support (Fig. 6),
- ▶ the sections of the tunnel between 118–126 m, 143–156 m, 158–632 m, 739–761 m, 788–969 m, 979–1149 and 1163 to 1268 meters from the Miners' Gate show small losses of the support material, infiltration of salt, small flows of water, etc., which currently do not threaten the stability of the heading (Fig. 7).

Fig. 4. The approximate location of characteristic points and damages of the support along the heading [10]

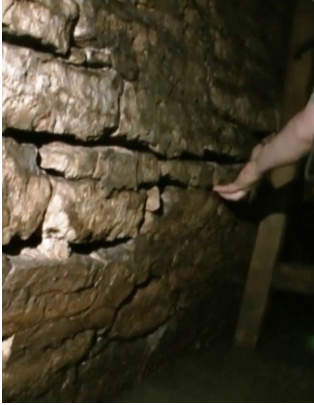
Fig. 5. View of "Fryderyk" adit in the area of point 25 on Fig. 4 [10]

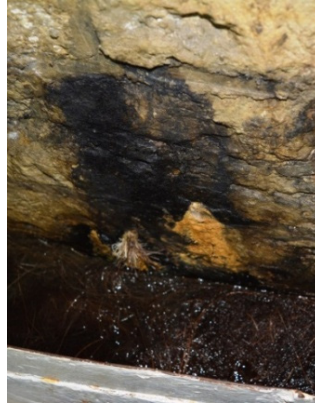
Fig. 6. View of "Fryderyk" adit in the area of point 20 on Fig. 4 [10]

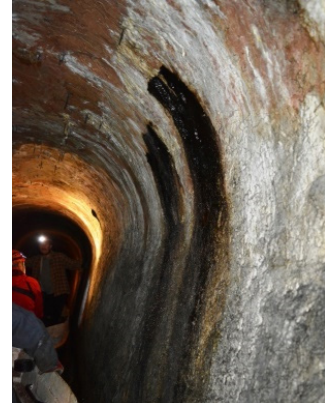
Fig. 7. View of "Fryderyk" adit in the area of point 9 on Fig. 4 [10]

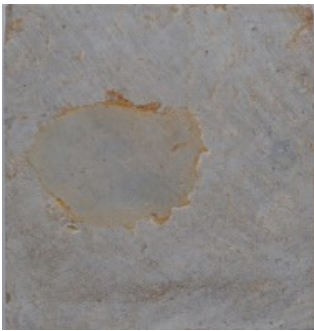
In order to determine the capacity of the support, material samples were taken from the wall. Petrographic studies showed that the rock from which the sample is made has carbonate origin: limestone with clear stratification planes. The cross-sections taken during sample cutting for strength testing showed horizontal slit aperture of about 0.1 mm filled with secondary mineral association with clearly dark yellow and rusty colours. Moreover, an individual focus of about 2–5 mm quartz grains is also visible (Fig. 4).

Fig. 8. Examples of sample cut surface views with visible gaps filled with a yellow-rust colored substance [10]

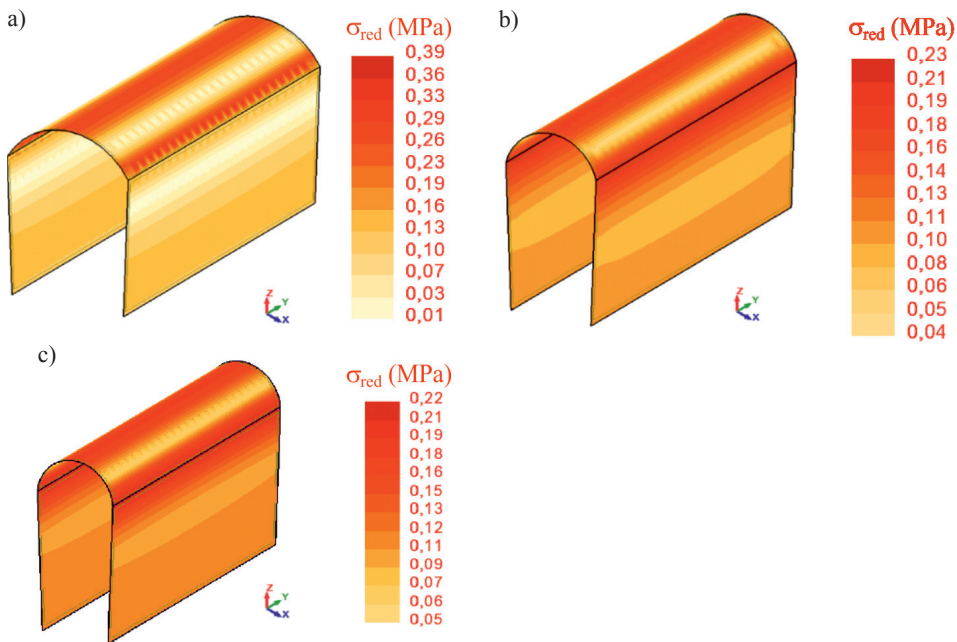
On the basis of the results of numerical modelling, the degree of security of 90 individual support segments of the analyzed heading was assessed. For this purpose, an indicator of exhaustion of structural load sections was used as expressed with a rate of exhaustion of its cross-section. The structure is considered to be safe if the ratio reaches a value of less than 1. The method of load calculation of the support used in this case and the simplified static diagram indicate that the structural elements of the support are mainly subject to compressive stress (Fig. 12 and 13).

Fig. 12. Shaping of tension values reduced in support elements in heading sections made in rocks: a) in cross-section A-A' (Fig. 4), b) in cross-section B-B' (Fig. 4), c) in cross-section D-D' (Fig. 4)

- ▶ in case of the sections made in hard rocks:
  - ▷ for A-A' cross-section  $k = 0.12$
  - ▷ for B-B' cross-section  $k = 0.07$
  - ▷ for D-D' cross-section  $k = 0.07$
- ▶ in case of the sections made in quaternary sediments:
  - ▷ for B-B' cross-section  $k = 0.47$
  - ▷ for E-E' cross-section  $k = 0.64$

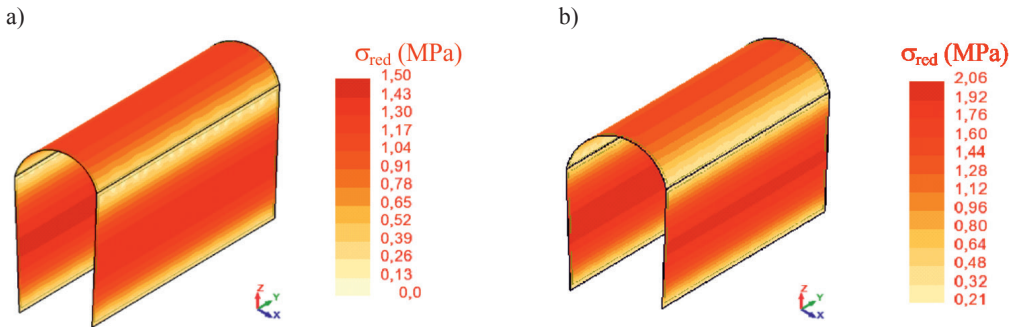
Fig. 13. Shaping of tension values reduced in support elements in heading sections made in quaternary sediments: a) in cross-section B-B' (Fig. 4.1), b) in cross-section E-E' (Fig. 4.1)

In summary, the calculation concluded that the assumptions made for the support meet the criterion of safety in view of the load-bearing capacity of the structure. The values of coefficients calculated for the sections of the heading made in the hard rocks leave a much higher safety margin than those calculated for hollow sections in the quaternary sediments.

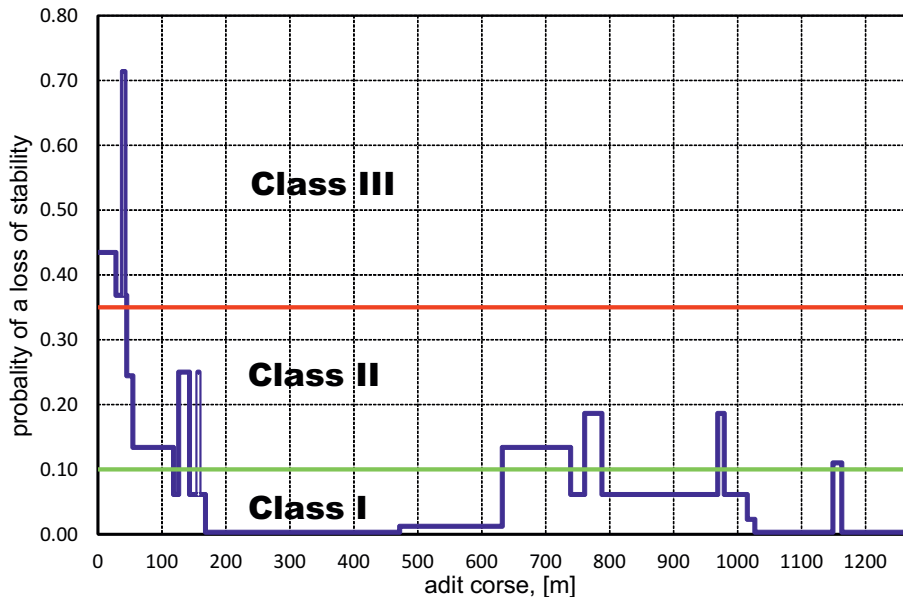
Having considered the overburden of the support and its load-bearing capacity as random variables with normal Gauss distribution of probability, the probability of the loss of stability along the support tunnel was determined. The calculations were made taking into account the variability of the load and the capacity of the support along the tunnel, therefore dividing it into sections characteristic in terms of the support capacity and the size of the projected load. The results of the calculations are presented in Fig. 14.

Class III (dangerous conditions – unacceptable) – 0–45 m from the Miners’ Gate,

Class II (sufficient conditions – acceptable) – 45–118 m; 126–143 m; 156–158 m; 632–739 m; 761–788 m; 969–979 m and 1149–1163 m from the Miners’ Gate,

Class I (safe conditions) – 118–126 m; 143–156 m; 158–632 m; 739–761 m; 788–969 m; 979–1149 m and 1163–1268 m from the Miners’ Gate.

Fig. 14. Graph of the adits stability loss probability at its length

- ▶ immediately take corrective action and protect the tunnel sections at risk of losing stability, observations of the behavior of the tunnel support and maintenance works should be carried out in the other sections,
- ▶ existing sinkholes should be secured before their further development advances.
