MORPHOMETRIC PARAMETERS OF THE WATER BODIES OF BAGRY WIELKIE AND BAGRY MAŁE IN THE BIODIVERSITY CONTEXT

Abstract

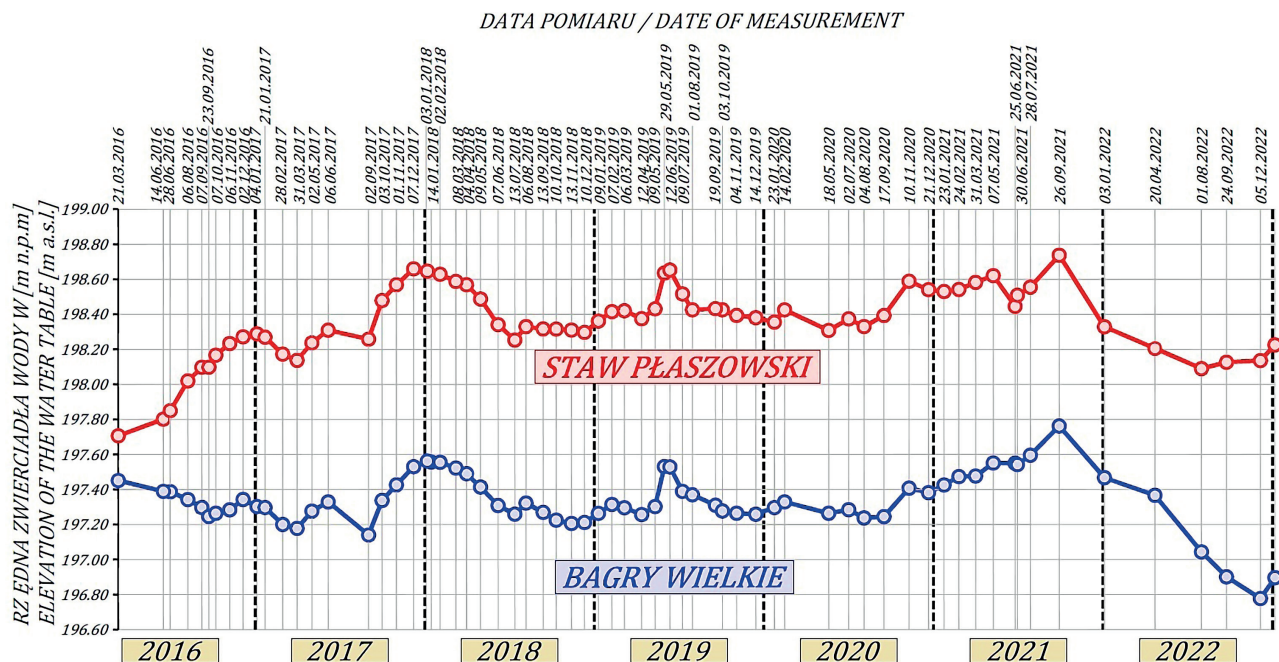
Fig. 2. Water table – chart of changes in the Bagry and Staw Płaszowski – March 2016 – January 2023

1. levelling measurements – water tables (Fig. 2);
2. GNSS measurements (RTK and RTN mode with the application of receiver R8s + controller TSC3 Trimble'a) shoreline, adjacent areas and positioning of a supersonic sonar during bathymetric measurements;
3. bathymetric measurements (acoustic sonars: Lawrence Elit-4 [15, 16] and Eagle Ultra II) made from a boat equipped with GNSS for precise positioning of the sonar.

back to good state (relatively constant). In October 2021 distinct reduction of the water level in both water bodies was observed (Fig. 2), which continued to be low until December 2022 (in case of Bagry Wielkie) and August 2022 (in case of Staw Płaszowski). It is suspected that the diminishing of the water table level was caused by intensive development in the neighbourhood of Bagry and the cable-stayed viaduct (streets: Żołnierska and Gromadzka) and their negative impact on the water resources of both water bodies (digging and drainage of deep excavations for the basements of the constructions). Sudden and/or distinct change of water tables, especially in case of drainless water bodies of stabi-
