MARTA KAŁUŻA, JAN KUBICA*

BEHAVIOUR OF UNREINFORCED AND REINFORCED MASONRY WALLETTES MADE OF ACC BLOCKS SUBJECTED TO DIAGONAL COMPRESION

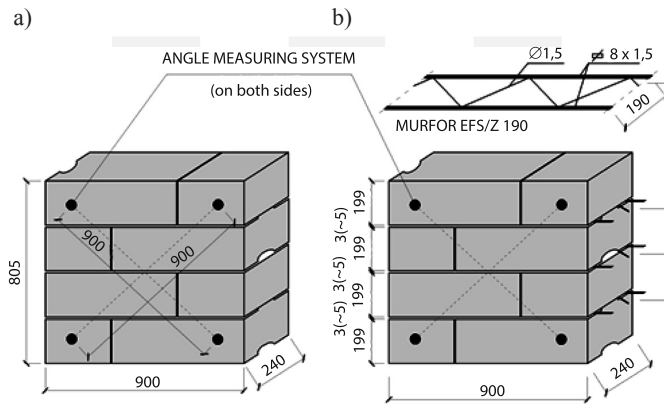
Fig. 1. Shape and overall dimensions of the test specimens: a) unreinforced specimens (Y-UR series), b) wallettes with truss type reinforcement in bed joints (Y-R-1 and Y-R-2 series)

Type of used prefabricated reinforcement, shape of tested specimens, their overall dimensions and localisation of measuring devices are shown in Fig. 1.

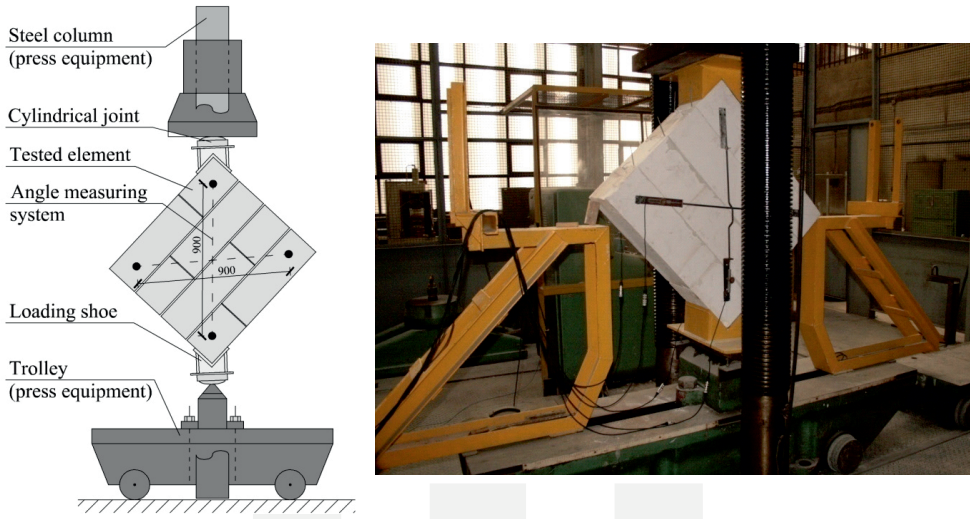
Fig. 2. Scheme of the test stand and view of the masonry wallettes ready to test

All specimens were subjected to a diagonally compressive load according to RILEM LUMB 6 [12]. This international standard also provides the procedures for the explanation of results and their analysis. The compressive load was applied using a hydraulic press machine with the range up to 2000 kN through steel blocks positioned on two diagonally opposite corners of the specimen. The load was applied in one cycle – from zero up to the failure. The diagram of the test stand is shown in Fig. 2 and the view of the specimen prepared and ready to be tested is shown in Fig. 3.

When testing each specimen, the load force level and the displacements were measured with LDV gauges. The gauges were fixed to both surfaces of each wallette (using stiff resin-epoxy glue) along two diagonals of each model. The length of the base was 900 mm taken according to the guidelines of American Standard ASTM E519-81 [13], and should cover the greater part of the length of the specimens. Additionally, at failure, the crack pattern of each specimen was observed and recorded.

To measure the in-plane deformability of each specimen during load application, inductive, measurement (LDV) system was mounted on both surfaces of the tested wallette (Fig. 2).

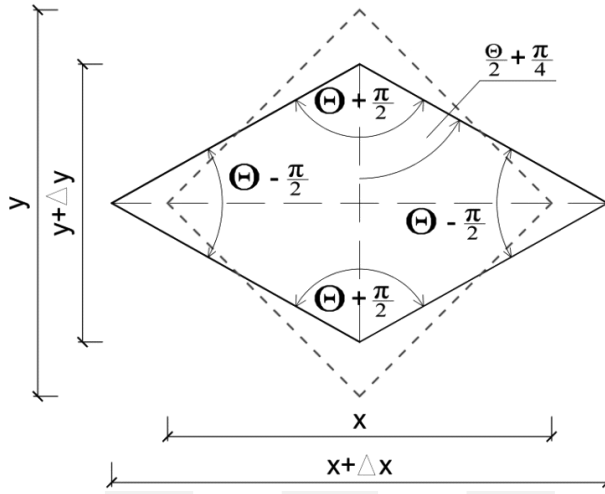
Fig. 3. Scheme for determination of non-dilatational strain angle (shear strain)

The values of the non-dilatational strain angle (shear strain) Θ_i were calculated on the basis of the horizontal and vertical length changes according to trigonometric (deformed base measurement) relationship, separated as shown in Fig. 3.

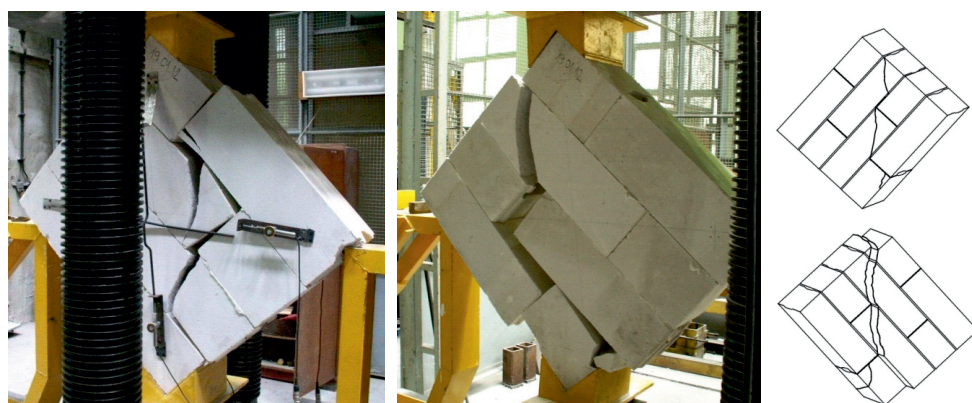
Fig. 4. View of typical modes of failure in case of unreinforced specimens

The modes of failure of unreinforced specimens (Y-UR) were typical for the diagonally compressed elements. In all masonry wallettes, the crack was running diagonally across the whole specimen. This crack was oriented perpendicularly to the direction of principal tensile stresses. Fig. 4 shows an exemplary view of unreinforced elements with visible diagonal cracks.

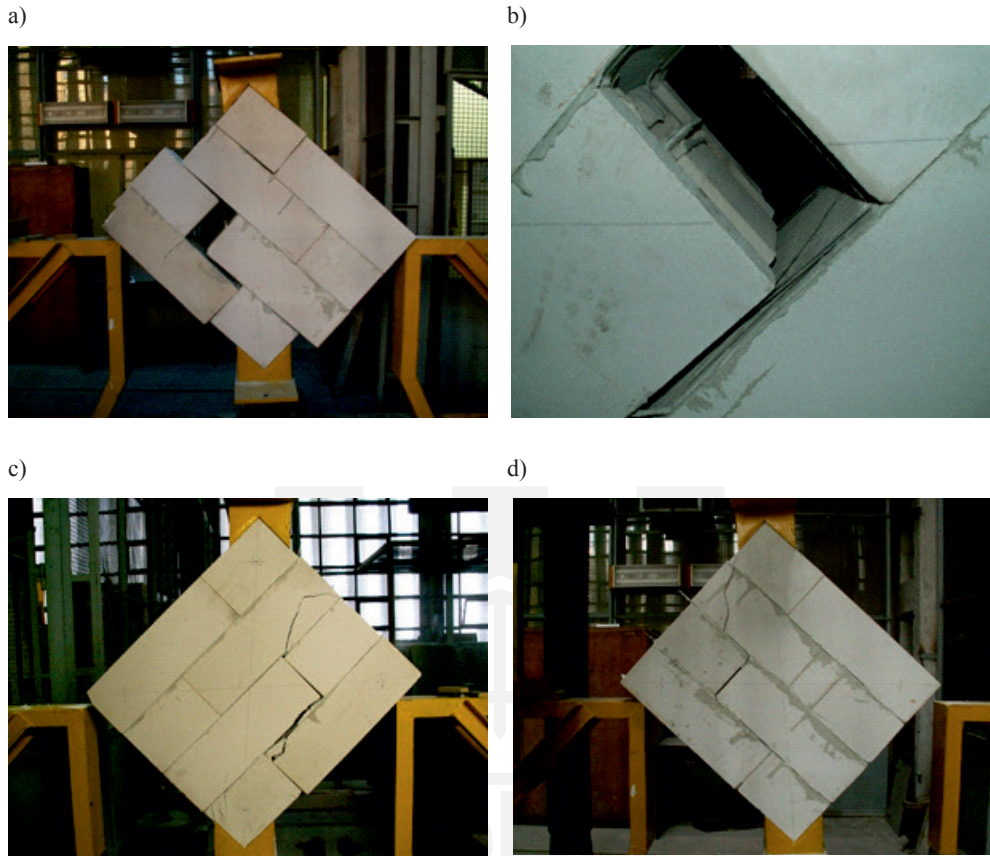
Fig. 5. Typical modes of failure of reinforced specimens: a) specimens made with one mortar layer (Y-R-1), b) splitting surface with visible reinforcement non-covered by mortar, c) and d) specimens made using two layers of mortar (Y-R-2)

consisted of only one layer of mortar (**Y-R-1**), the damage was caused by splitting. The splitting occurred between the masonry units and reinforcement, always in the location where the mortar coating did not suitably cover the whole surface of the reinforcement (flat steel longitudinal rods of the truss-type reinforcement). This type of failure shows that using only one layer of mortar in reinforced masonry was not sufficient to guarantee a full connection (adhesion) between the reinforcement and mortar. Additionally, based on the deformation observed, the resulting damage was dangerous for the stability of the whole structure.

In (**Y-R-2**) series, a completely different mechanism of failure for all specimens with two layers of mortar coating was observed. No splitting effect between the reinforcement and masonry units was noticed. The damage was caused by a roughly vertical crack, which was always running through the non-filled perpend joints. As in the case of cracks observed in unreinforced specimens (the failure which is typical for the elements subjected to diagonal compression), the crack was located along the axis which was perpendicular to the direction of the diagonal tensile stresses. The failure was pronounced when the crack width exceeded 1 mm. A vertical crack, with the width smaller than 0.1 mm was considered to be a secondary cracking state because no other type of damage was noticed at that time. The failure mode of all specimens of (**Y-R-2**) series can be considered safe, with no visible significant deformation and rapid action. The failure mode observed demonstrated a better behaviour of the bond between the reinforcement and masonry mortar when two layers of mortar were used. This situation was different than the modes of failure noticed in specimens in (**Y-R-1**) series, where the destabilisation of the elements inside the walette occurred.

The pictures of damaged reinforced specimens are shown in Fig. 5. Fig. 5a and 5b present elements with one layer of mortar (**Y-R-1**), while Fig. 5c and 5d show modes of failure of walleTTes with two layers of covering mortar (**Y-R-2**). Additionally, in Fig. 5b the splitting surface and the reinforcement without covering mortar are clearly visible.

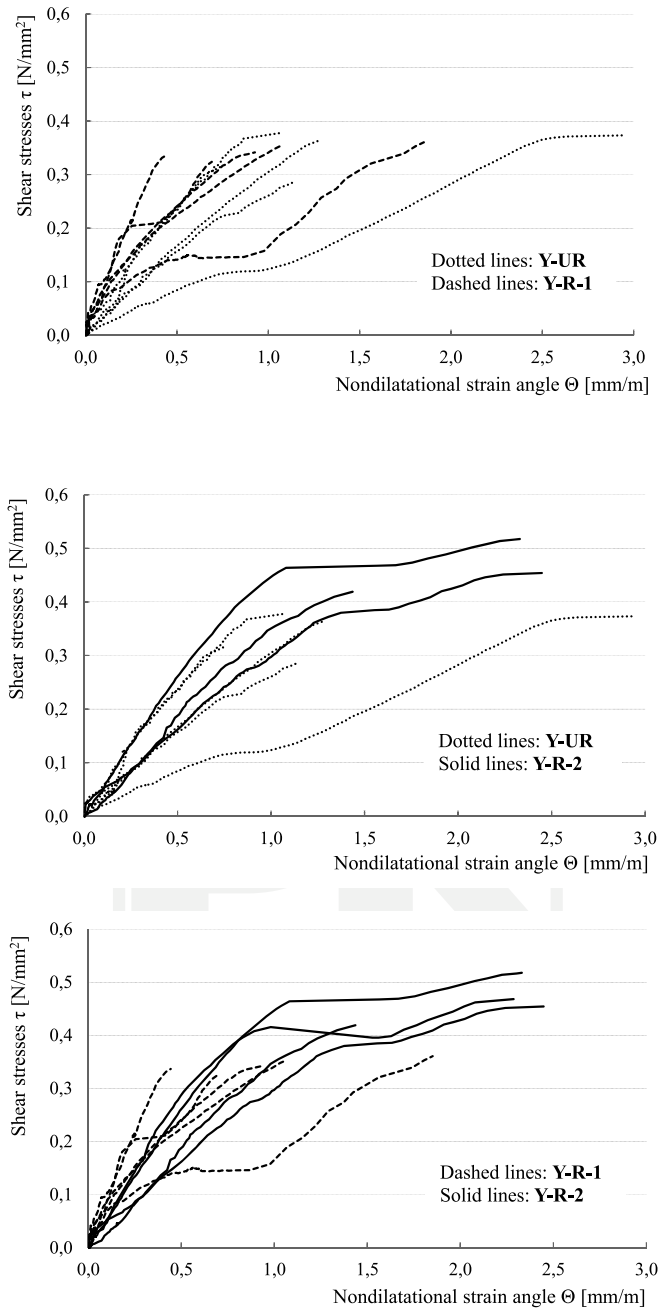
Fig. 6. Comparison of shear stress – non-dilatational strain angle ($\tau - \Theta$) relationships for: a) unreinforced specimens (Y-UR) and reinforced specimens with one layer of mortar (Y-R-1), b) unreinforced specimens (Y-UR) and reinforced specimens with two mortar's layers (Y-R-2) c) both reinforced specimens (Y-R-1 and Y-R-2)

In order to show noticed above remarks and observations, some diagrams with shear stress – shear strain ($\tau - \Theta$) relationships of all specimens were presented. Figures 4a and 4b show the behaviour of deformation of unreinforced specimens (**Y-UR**) in comparison with reinforced specimens with one layer of mortar (**Y-R-1**) and with two layers of mortar (**Y-R-2**). In the Fig. 4c the comparison of both reinforced specimens was presented.
