ELŻBIETA PILECKA, MAGDALENA BIAŁEK\*, TOMASZ MANTERYS\*\*

## THE INFLUENCE OF GEOTECHNICAL CONDITIONS ON THE INSTABILITY OF ROAD EMBANKMENTS AND METHODS OF PROTECTING THEM

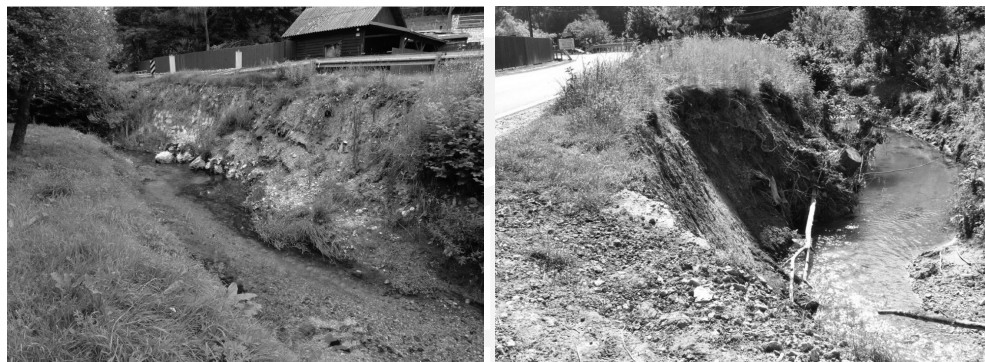
Fig. 1. A damaged fragment of the fill slope and the Prądnik (Białucha) stream undercutting it (Source: [5])

In this area in September 2014, a fragment of the embankment was damaged. The fragment was located at the junction of a provincial road with the Prądnik stream in Wernyhora street. The slope fragment runs along an asphalt road within which there is the Prądnik stream. The fill slope forms the left side of the stream valley slope and in this area, it is partly crumbled. At the top of the embankment, on its northern side runs, the provincial road (Fig. 1).

The embankment is located at the bottom part of the slope. Its height is around 3.1m and the whole length is around 20 m. A segment of around 8m was strengthened with a lime retaining wall of about 1.5 m in height at the bottom part the embankment. The inclination of the embankment in the places without the retaining wall varies from  $55^{\circ}$  to  $60^{\circ}$ . In the upper areas of the fill slope and in the segment with the retaining wall, the inclination angle is  $70\text{--}80^{\circ}$  [5].

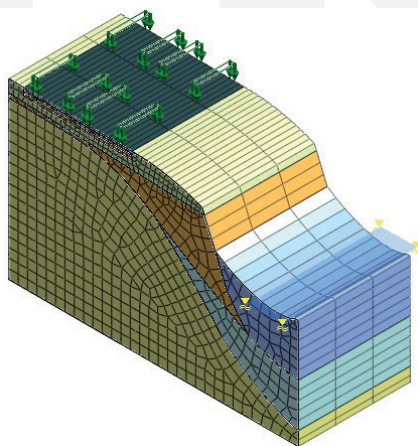
Fig. 2. Computer model of a road embankment (Source: the authors' own study)

Computer model of the embankment and material data used to model are presented below (Fig. 2, tab. 1).

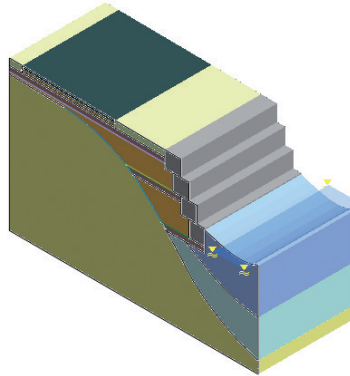
Fig. 9. Computer model of a road embankment  
(Source: the authors' own study)

To protect the unstable slope by the Prądnik stream, the priority is to limit washing and undercutting of the slope. An original solution was proposed and verified by calculations in the MIDAS programme. The protection was modelled in the form of a gabion consisting of four baskets of 1.0×1.0 m in dimension. The height of the whole designed structure is 4 m. Additionally, three layers of geosynthetics were laid directly under the building embankment;

their purpose task was to order water conditions in the area being stabilised, and protect it against uneven settling. Each geosynthetic layer was laid on a 30 cm strengthened substratum which could carry vibrations and loads caused by vehicle traffic on the province road and partly increase the load-bearing capacity and durability of the structure. The bottom geosynthetic layer was stretched along the rock layer for a length of 7 m to ensure durable strengthening under the embankment soil. Computer models of the reinforced embankment are presented below (Fig. 9).

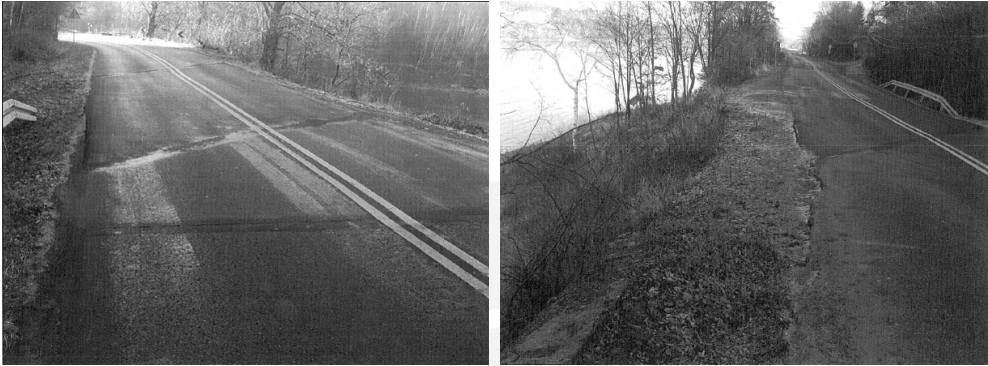
Fig. 16. Damage to provincial road no. 975 as a result of landslide movements  
(Source: [3])

Landslide movement has caused the destruction of a significant proportion of provincial road in recent years (Fig. 16). It is worth mentioning that the discussed landslide occurred within an older and deeper landslide covering a larger area.

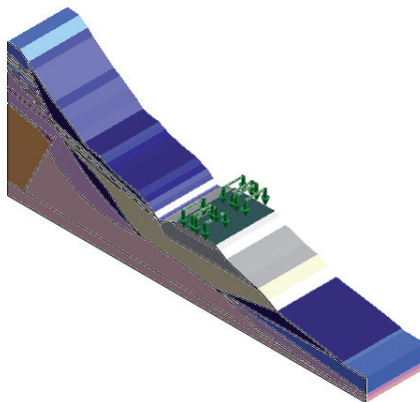
Fig. 17. Landslide computer model  
(Source: the authors' own study)

Three kinds of analysis of slope stability were carried out. The first analysis assumes the occurrence of a dry period (lack of water filtering from waterfall infiltration). The other analysis assumes the occurrence of a transitory period in which there appears, on a moderate level, waters from waterfall infiltrations. The third analysis was carried out under the assumption of the occurrence of a wet period with total saturation of the soil layers. The strength and deformational parameters of the soils remained unchanged. The simulation was performed under drained conditions. The computer model of the embankment and the material data used for modelling are presented below (Fig. 17, Table 2).

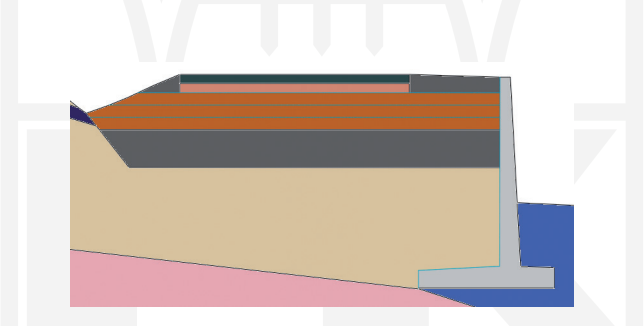
Fig. 18. Approximation of road embankment strengthening (2D view)  
(Source: the authors' own study)

As we are dealing with an unstable road embankment located within an older and deeper landslide, a protection strategy was designed in the form of a reinforced concrete retaining wall (slab and angle) located on the Rożnowskie lake side (Fig. 18). The designed retaining wall, sunken to a minimum of 1.5 m below the lowest slide surface, has to transfer the pressure on the soil, caused by vehicles on the provincial road. Additionally, three layers of geosynthetics were laid directly under the building embankment – this was to order water conditions and limit uneven settlements. Each of the three layers of geosynthetics was laid on a 30 cm thick strengthened substratum layer, the purpose of which was to help to transfer vibrations and quasi-static loads caused by vehicle movement on the provincial road. For construction reasons, the layer of geosynthetics was also laid along the whole length of the retaining wall together with the bottom slab. A water drain was located above the bottom slab.

The dimensions of the retaining wall:

- height 8.9 m
- wall thickness 45–85 cm
- width of base – 5.85 m
- thickness of bottom plate – 90 cm

Proposed solution made the fill slope adequately protected. Stability coefficients increased significantly for all three calculation cases –  $FoS = 2.36$  (dry period),  $FoS = 2.05$  (transitory period),  $FoS = 1.66$  (wet period) – this explicitly proves the accuracy of the realised solution. The displacements of the analysed solid (Fig. 28, 29, 31, 32, 34, 35) and maximum shear strains (Fig. 30, 33, 36) show that if the loss of stability occurs, then it will occur behind the road embankment strengthened by the retaining construction.
