Tadeusz Majcherczyk

AGH University of Science and Technology, Faculty of Mining and Geoengineering,
Cracow, Poland

MINING INFLUENCE IN THE AREA OF THE PSZCZYNKA RIVER AND THE METHOD OF RIVERBED RESTORATION

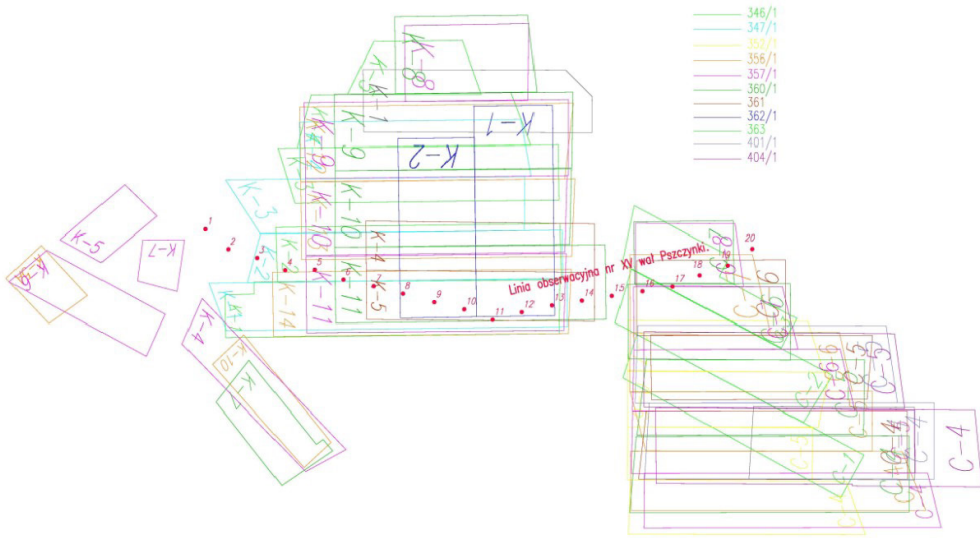
Fig. 1. Excavation in the area of the Pszczynka river and the positioning of the observation line

Fig. 1 presents the distribution and shape of particular walls and the positioning of the measurement line where the measurements were performed from 2005.

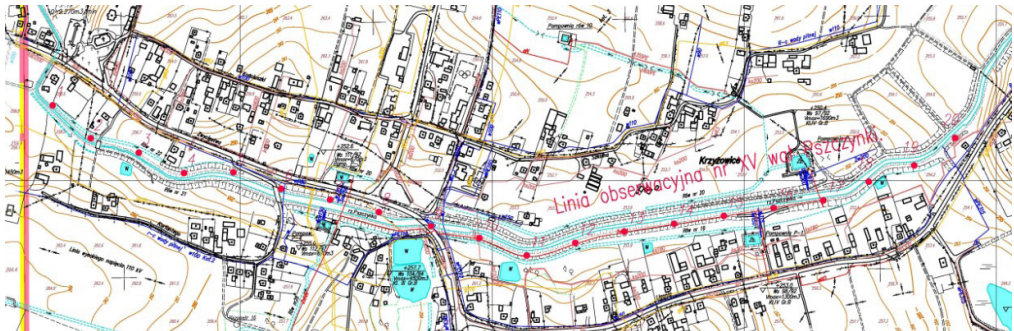
Fig. 2. Map of the analysed area and positioning of the measurement line

relatively close to the riverbed. A map showing the distribution of the measurement points in the area of the bed of the Pszczynka river is presented in Fig. 2.

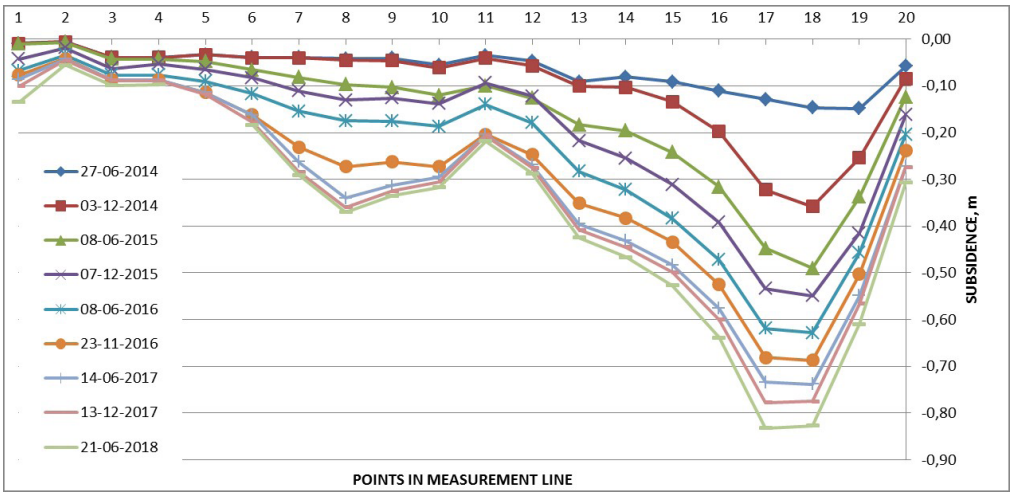
Fig. 3. Subsidence of points on the measurement line in the area of the Pszczyńska river in the period June 2005–June 2018

Altitude monitoring made it possible to interpret the process of deformation. During the period of thirteen years of measurements, the maximal surface subsidence created two subsidence troughs with maximum values of 1.79 m at point No. 8 of the measurement line and 1.79 m at point No. 18 of the line. Undoubtedly, the walls excavated directly below the measurement line exerted a crucial impact on the volume and rate of subsidence. The values of subsidence at the end points of the observation line in the western direction indicate a clearly decreased character (subsidence of only 0.23 m in point No. 1). The subsidence also decreases eastbound (0.73 m at point No. 20). In the middle of the measurement line (point No. 11), the subsidence reached the value of 0.28 m. The increase of subsidence is presented in Fig. 3.

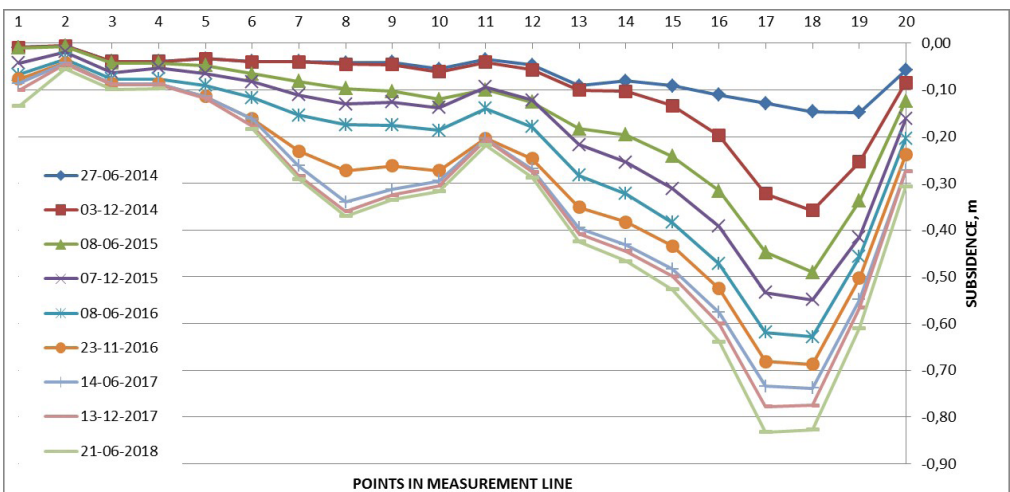
Fig. 4. Subsidence of points on the measurement line in the area of the Pszczyńska river in the period November 2013–June 2018

In the next stage of the study, a period of low exploitation intensity (November 2013–June 2018) was examined, when five longwalls in three seams (362/2, 401/1 and 404/1) were extracted. Surface subsidence reached values approaching 0.83 m at points Nos. 17 and 18, which is presented in Fig. 4. From the west, mining exploitation was also executed in walls C-4 and C-5 in seam 401/1, and in walls C-4 and C-5 in seam 404/1, which is illustrated by the subsidence at points Nos. 15–20 on the measurement line. The line remained within the exploitation area, thus it is impossible to record the entire subsidence trough. The measurement line indicates the reduction of subsidence mainly from the west side (exploitation of one wall K-1 in seam 362/1).

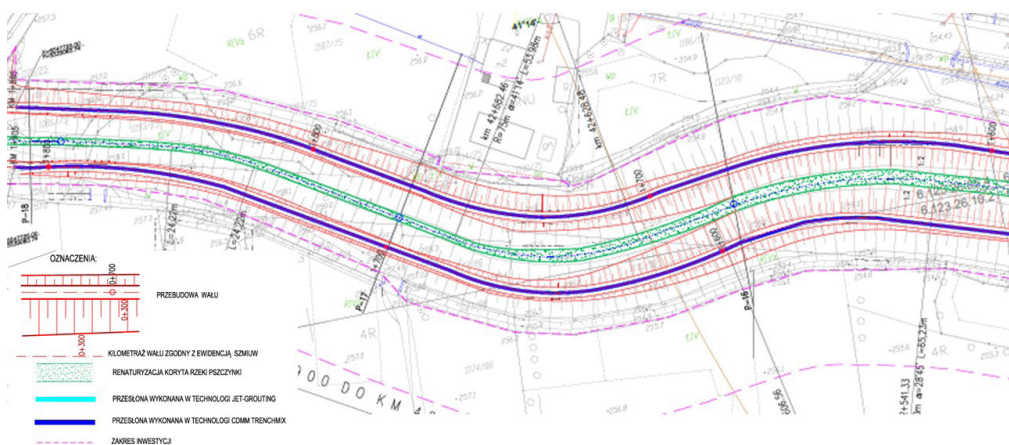
Fig. 5. Fragment of topographical map: river section with inserted design solutions

investment buildings. Therefore, particular construction works were undertaken in relation to the requirements of flood safety, proper water streaming in the riverbed and the preservation of satisfactory technical and hydraulic parameters (Fig. 5). These works involved [5]:

- ▶ repairing the existing flood protection dykes by raising the levee crowns and levee corpus development;
- ▶ raising and broadening the left and right levee corpus in the section with the largest surface subsidence;
- ▶ rebuilding perimeter drainage ditches colliding with the renovated flood protection dykes;
- ▶ rebuilding outlets of the drainage pump stations;
- ▶ rebuilding and protecting the hitherto-existing technical infrastructure intersecting with the flood protection dykes and the Pszczynka river in the discussed section.

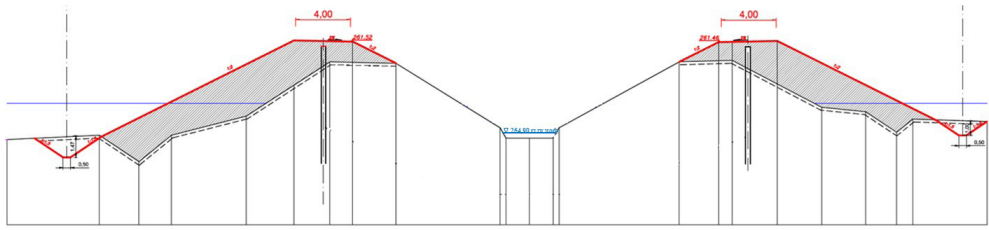
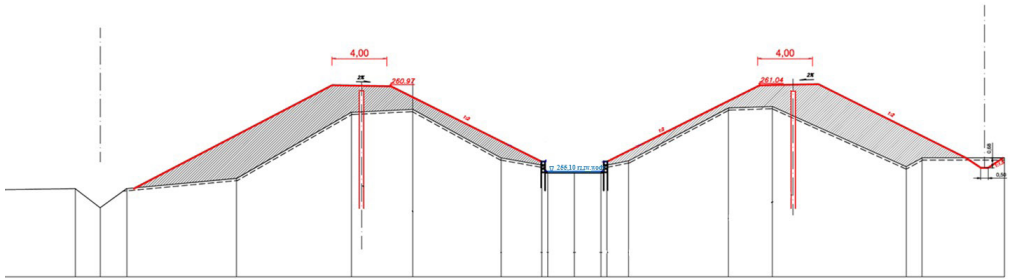
Fig. 6. Characteristic cross section of left and right embankment of the river Pszczyńska

Irregular subsidence of the riverbed of the Pszczynka causing a lack of adequate gravitation slope and serious decrease of the water flow velocity resulted in the creation of the water ponding zone. Therefore, the riverbed had to be stabilised in the section of 1 km. As part of the re-profiling process, the river bottom was reinforced with stone riprap, assuming a waterbed with a maximum bottom width of 4.0 m (Fig. 6) [5].

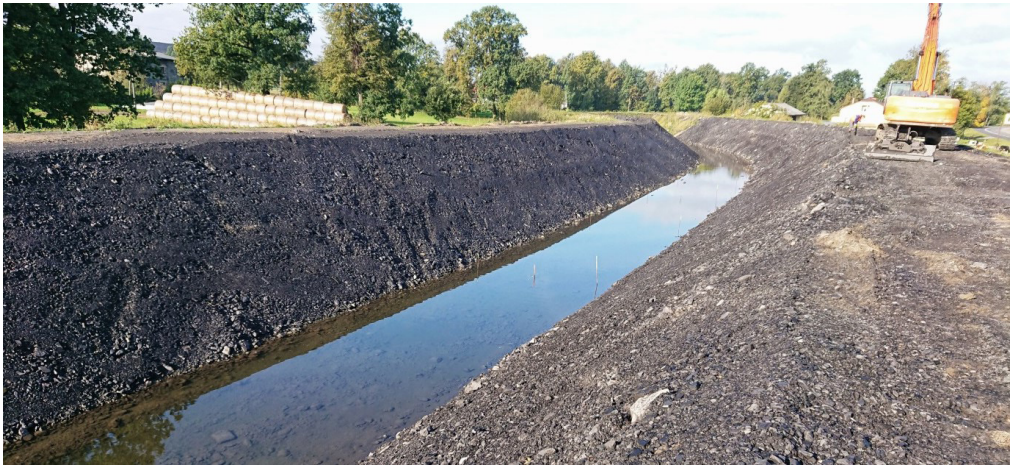
Fig. 7. Preparing riverbed for restoration

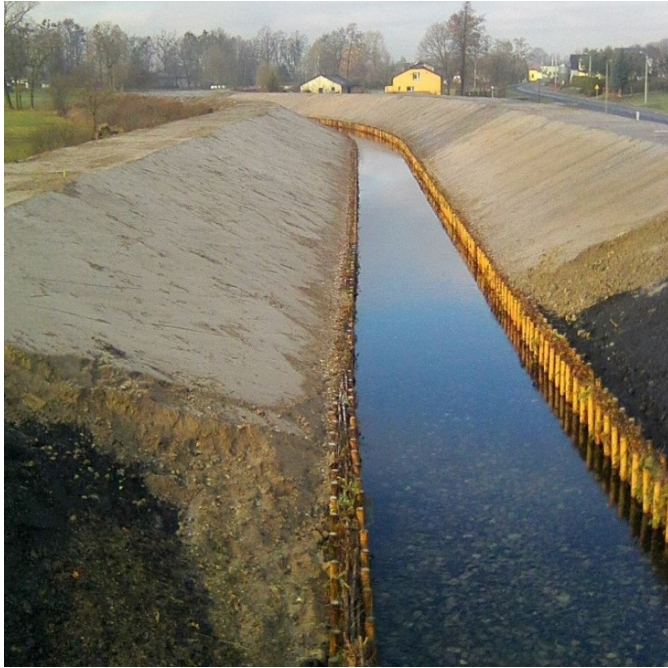
Fig. 8. Topsoiling of slopes

The restoration of the river Pszczynka will help to re-establish the original width of the riverbed from before the process of subsidence. In order to make the works in the river current possible, a special steel wall will be installed at depth of 6.0 m along the riverbed and the works will be executed on both sides of the wall interchangeably (Fig. 8).

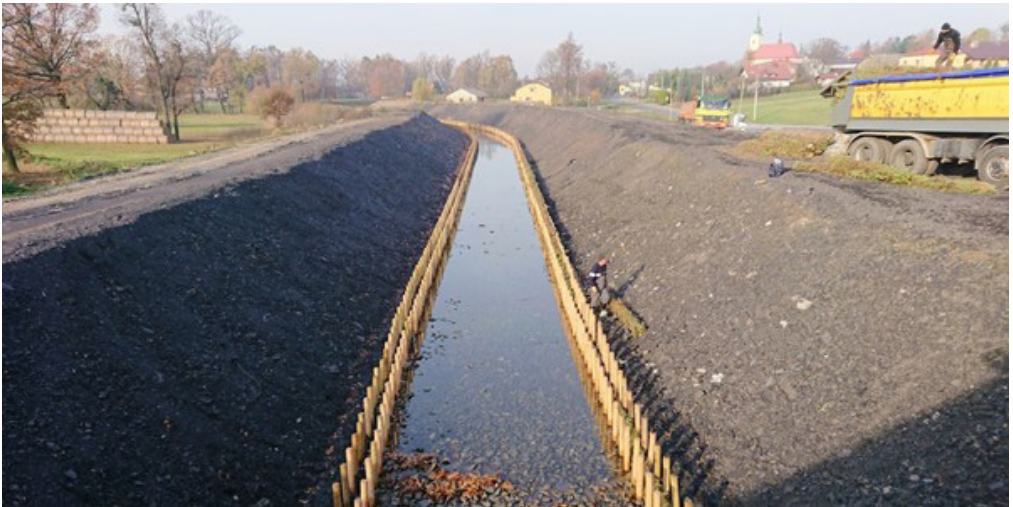
Fig. 9. Fascine construction works

As soon as the river bottom is stabilised, the \varnothing 25 cm fascine bands will be laid between the rows of poles in the footing of the slopes, followed by the formation of the slopes of the embankment. Most importantly, the fascine will be made after the river bottom stabilisation and before forming the embankment slopes. The total length of the fascine bands is 4 km (Fig. 9).

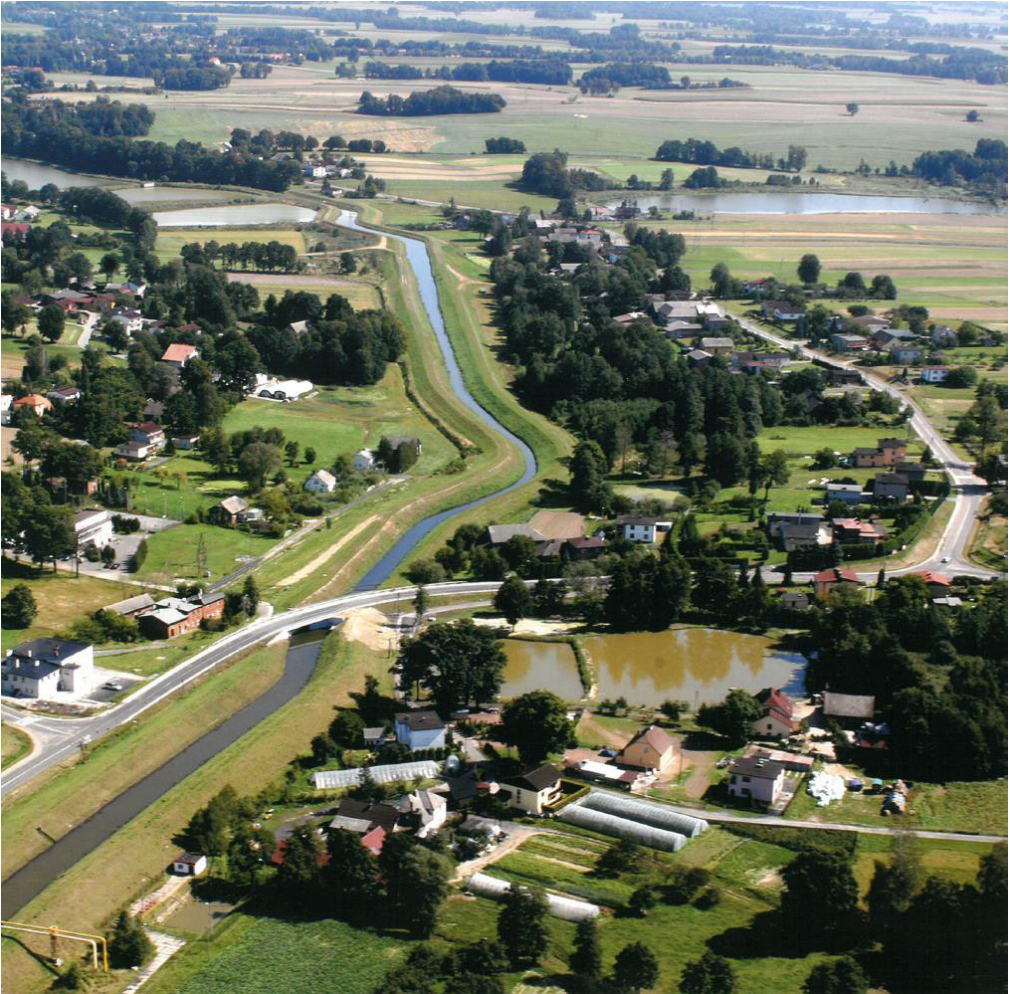
Fig. 10. Completed works after the most recent restoration

The method of restoration presented above proved most effective in the given local conditions (Fig. 10).
