ANALYSIS OF FACTORS THAT INFLUENCE LONGEVITY AND SAFETY OF THE THIN-WALLED CONCRETE CONSTRUCTIONS

This article has generalized data due to the results of examinations of some thin-walled building sites of tower type (cooling towers, pipes, silages) which are made by the authors within the period from 2006 to 2011, specifically:

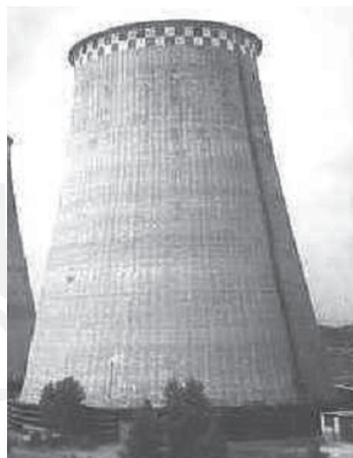
III. 2. Iron concrete monolithic cooling tower station #1 Kyiv Combined heat and Power Plant-6

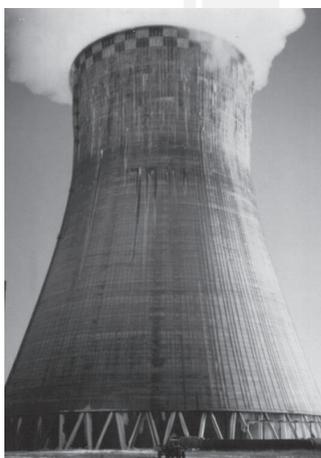
III. 3. Iron concrete monolithic cooling tower station #2 Zuyiv Thermal Power Plant

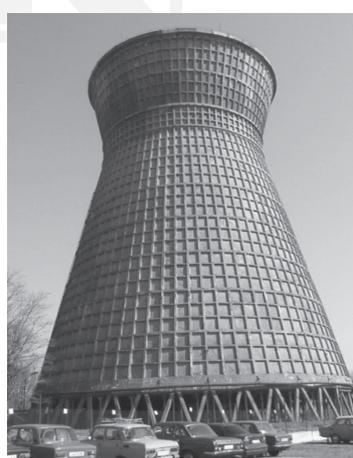
III. 4. Iron concrete prefabricated cooling tower station #4 Darnytsia Combined heat and Power Plant in Kyiv City

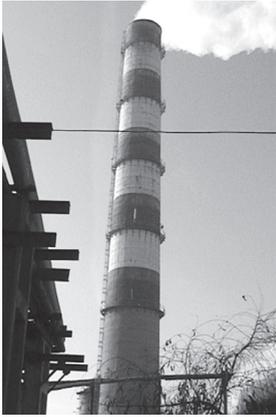
Ill. 5. Iron concrete monolithic pipe $H = 120$ m
Kyiv Station #2

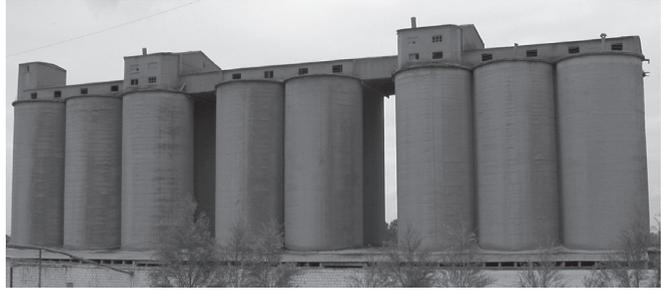
Ill. 6. Iron concrete monolithic silages of the building #6 Open Joint
Stock Company 'Mykolaiv Cement'

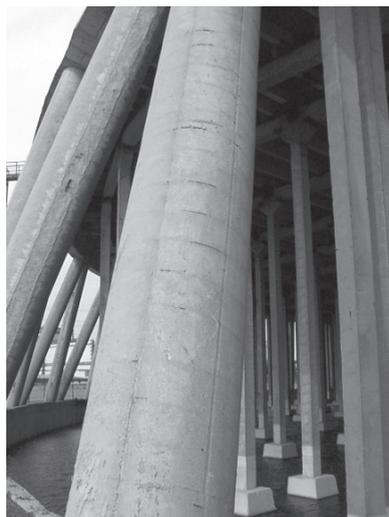
Actual class of concrete pillars ($\varnothing 900$ mm) leaning colonnade of spray cooling towers of Rivne Power Station vary from $B_f 32.5$ to $B_f 55$ (coefficient of variation $U_f = 3.25 \div 14.48\%$) within the project class B30, which affirms good monitoring of quality of their manufacturing. However, during instrumental research of cracking, the lengthwise shrink and cross-cut cracks in each pillar (Ill. 7) in depth immersion h_{cr} mainly up to 60 mm have been indentified, which result in steel reinforcement corrosion.

Ill. 7. The lengthwise and cross-cut cracks in pillars of leaning colonnade of cooling tower station #5 of Rivne Power Station

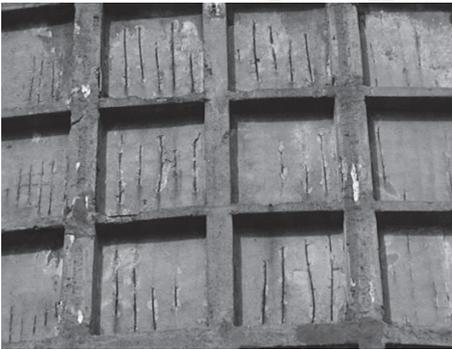
Actual class of concrete prefabricated iron concrete keyed slabs of the cover of cooling tower #4 of Darnytsia Combined heat and power plant varies between B_f30 to B_f50 (coefficient of variation $U_f = 5,56 \div 20,87\%$) with the project class B25. Even though the actual class of concrete is larger than the designed one, changeability of coefficients of variation tell us about the lack of quality of its manufacturing. Furthermore, disparity of thickness of protective layers of concrete has been recorded: $0 \div 14$ mm (Ill. 11) for steel reinforcement in the shelves of keyed slabs (according the project 18.5 mm) and $10 \div 60$ mm (Ill. 12) for working steel reinforcement in keys of slabs (under the project 30 mm).

Ill. 11. Steel reinforcement corrosion and destruction of concrete of upper belt of firmness of the cooling tower #4 at Darnytsia Combined heat and Power Plant, protective layer of concrete is lower than designed

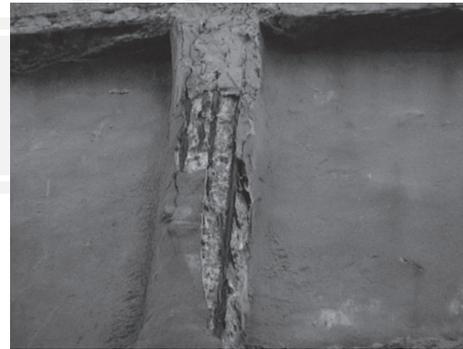
Ill. 12. Steel reinforcement corrosion and destruction of concrete of vertical ribs of prefabricated slabs of cover of cooling tower #4 at Darnytsia Combined heat and Power Plant, protective layer of concrete is lower than designed

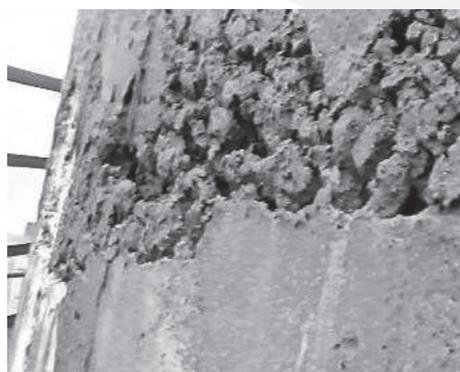
Actual class of concrete monolithic stem of pipe at different levels of height varies within $B_f 17.5$ to $B_f 22.5$ (coefficient of variation $U_f = 17,7 \div 29,2\%$) under the designed class B25. Insufficient firmness of concrete and decent changeability are due to insufficient monitoring of firmness characteristics of concrete and technologies of its stacking during the installation of stem pipes. Besides, during the process of examination, the spots of insufficiently compressed concrete have been determined, as well as sulfate corrosion of concrete and deflation (Ill. 13, 14).

Ill. 13. Insufficiently compressed concrete at the joint of tier of concreting

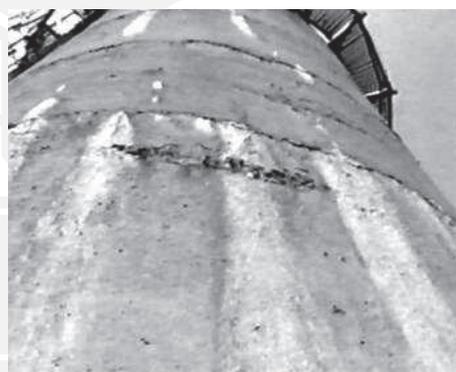
Ill. 14. Sulfate corrosion of concrete, filtration of moisture at the joint of concreting
