BARBARA MARIA DEJA*

RENOVATION OF THE HISTORIC OLSZTYN VILLA CASABLANCA

The paper outlines the details of the design and difficulties that had to be overcome in the course of the renovation and adaptation of a rich German factory owner's residence from 1912, which in 1988 was entered into the register of historic buildings of the Warmia and Mazury region.

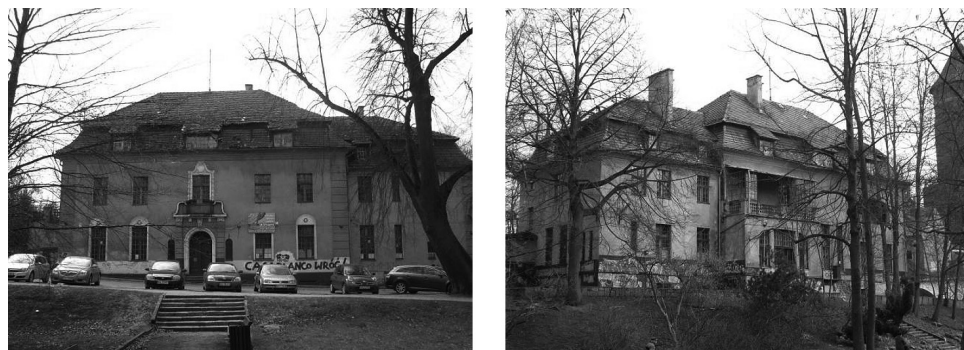
Fig. 1, 2. The front and back elevations of Villa Casablanca, before the renovation in 2006

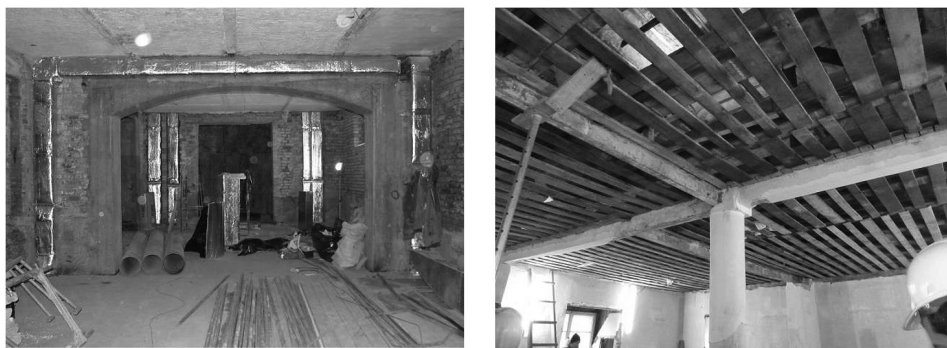
Fig. 4, 5. The brick ceiling above the basement and the timber ceiling (above the attic) supported by steel binding joists and a steel column, 2011

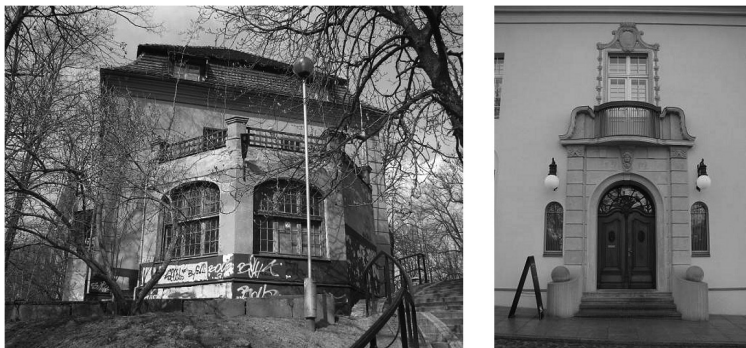
Fig. 10, 11. The eastern Casablanca elevation before renovation (2006) and the main entrance after the renovation (2014)

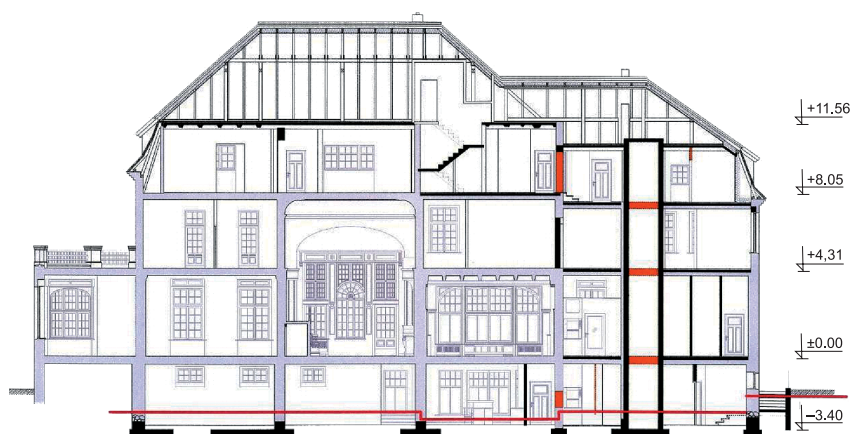
Fig. 19. Longitudinal section of the Villa Casablanca, 2010. The red line indicates the cellar floor level before the deepening of the basement

The decision of locating a restaurant in the cellar required the removal of some of the walls and the lowering of the floor level, hence lowering of the foundations. In the foundation design (proceeded according to Eurocode 7 [12]) there were many elements that had to be considered, and namely the relocation of bearing walls and bigger load of the building as a result of the functional changes and the allocation of the ventilation channels under the floor of the cellar (Fig. 21).

In order to make the usable height of the underground rooms greater than 1.0 m, the cellar walls were partially undercut and founded on the monolithic walls and the strip foundation (Fig. 22). Work was conducted with a high degree of diligence in order to avoid damaging the ceramic, segmental ceilings above the cellar.

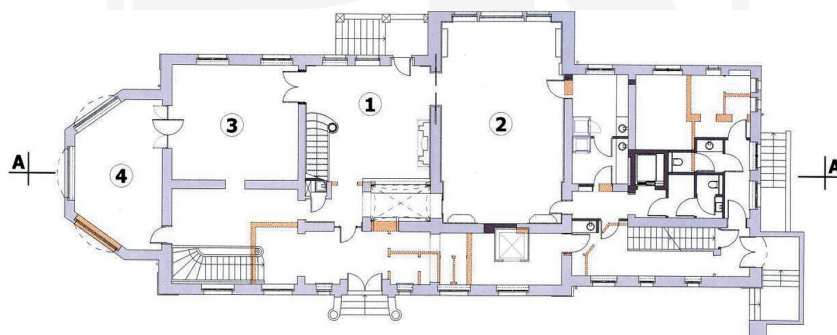
Fig. 20. A ground floor plan: 1 – fireplace ballroom; 2, 4 – conference halls; 3 – secretary office. Existing walls and ceilings – grey; walls devoted for demolition – orange; new walls and ceilings – black

In the cellar and on the ground floor, the design assumed the demolition of parts of the load bearing walls and the replacement of them with a column-rafter system. The pillars were shaped in the grooves previously made in the walls, and they were designed as reinforced concrete columns (in accordance with Eurocode 2 [13], these were made with C 16/20 class concrete, and steel bars 34 GS), adjusting the dimensions of their cross-sections to the walls thickness. Steel double binding joists (designed acc. to Eurocode 3 [14]) were made of a rolled steel profile of varied dimensions depending on the length between the bearings, and on the designed doorways and window openings as well as on the load of the structure. The walls were demolished below the binding joist not earlier than after finishing placing all of the joists within one tract on all the floors.

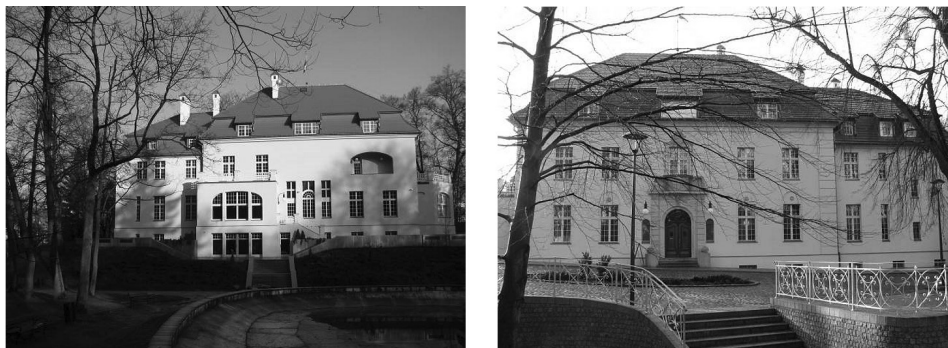
Fig. 27, 28. The front and southern Casablanca elevations after the renovation, 2014

The old, damaged plaster of the diverse structure covering the external walls, which was successively repaired by applying more new layers in the past, was removed, and after scrupulous stratigraphic studies, the original colour of the elevation was restored.

The surroundings of the villa were cleaned up. The historic Jewish mazewas from the park side slope were moved to the funerary house at Zyndram of Myszkowice Street, and the slope was strengthened and planted with new greenery (Fig. 27). In front of the building, the street was cobblestoned, and a car park and a new descent to the square were built (Fig. 28).
