Faculty of Mining and Geoengineering, AGH University of Science and Technology

Jastrzębska Spółka Węglowa S.A.

THREATS OF FLOODING OF SELECTED MINING AREAS – REPAIR MEASURES

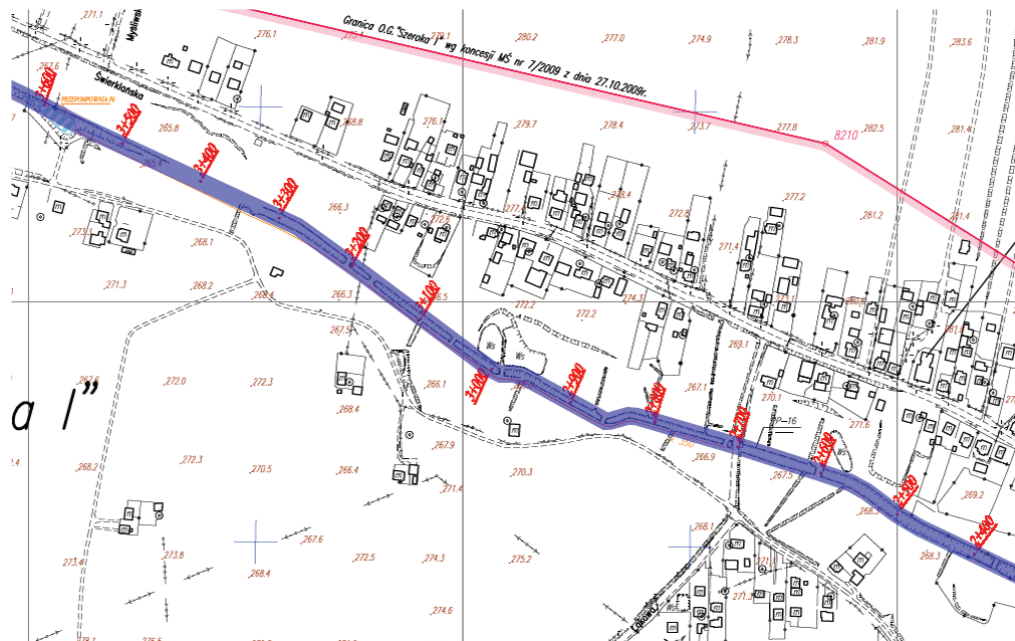
Fig. 1. The layout plan of the analysed area showing the Boryński stream

The Boryński stream flows from the north – west to the south – east and is the largest tributary of the river Pszczyńska. It belongs to the hydrometric network of the Vistula river catchment area.

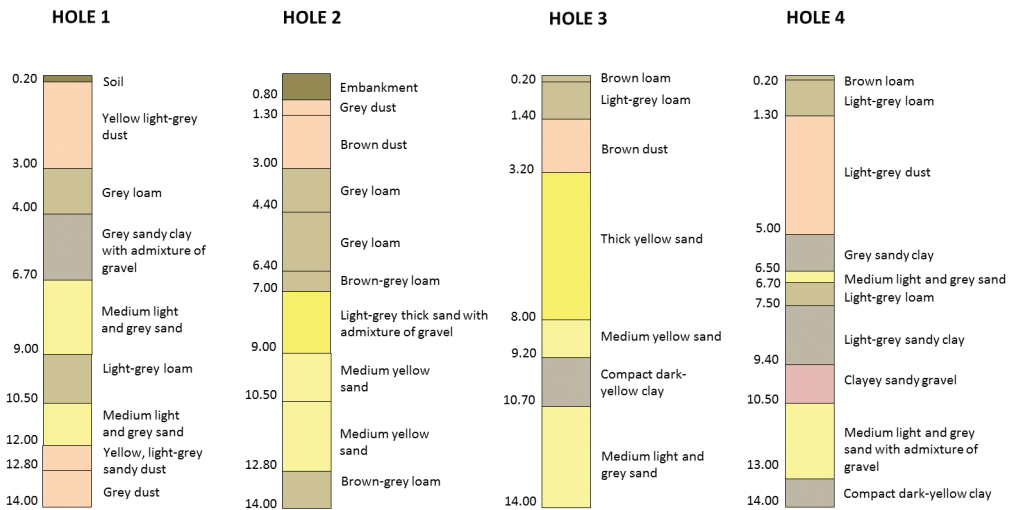
Fig. 2. The geotechnical layers in the Boryński stream area

Based on the geotechnical surveys performed in the area of the Boryński stream, the following soil layers were distinguished: yellow light – grey dust, sandy dust, light – grey loam, grey sandy clay with admixture of gravel, compact dark – yellow clay, medium light and grey sand, medium sand with admixture of gravel, thick yellow sand, light grey – yellow sand, and clayey sandy gravel (Fig. 2).

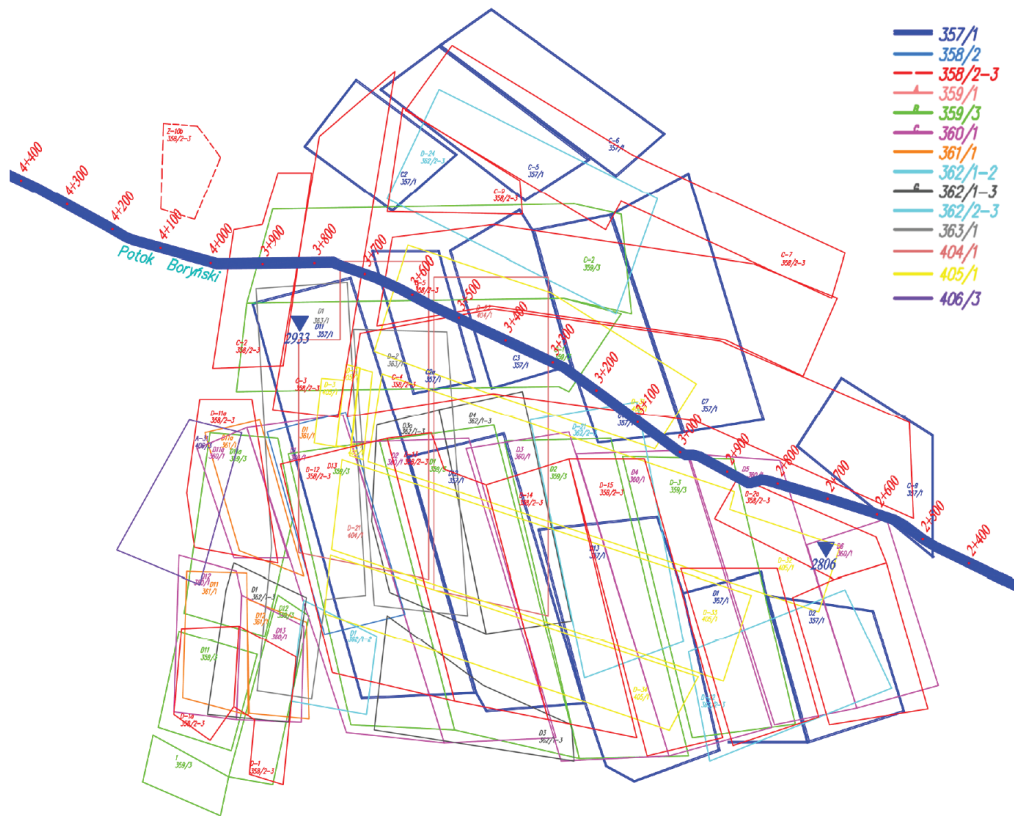
Fig. 3. Mining in the Boryński stream area in the period 1972–2018 and the location of benchmarks

In the area of the Boryński stream, mining has been conducted in seventy longwalls in fourteen seams since 1972. These are: seam 357/1 of walls D1÷D2, D11÷D13, C2a, C2÷C4, C7, C9; seam 358/2 of wall E4; seam 358/2 – 3 of walls C2÷C5, C7, C9, D1a÷D2a, D2, D11a, D12÷D14, Z10b; seam 359/1 of walls E1÷E2; seam 359/3 of walls 1, C1÷C2, D1÷D3, D11a, D11÷D13; seam 360/1 of walls D1÷D6, D11a, D12÷D13; seam 361/1 of walls 1, D11a, D11÷D12; seam 362/1 – 2 of walls D1; seam 362/1 – 3 of walls D1, D3a, D3÷D4; seam 362/2 – 3 of walls D21÷D22, D24; seam 363/1 of walls D1÷D2; seam 404/1 of walls D21÷D22; seam 405/1 of walls D1÷D3, D11÷D34; seam 406/3 of wall A31. Figure 3 presents the locations and shapes of the individual mining parcels.

The mining operations of 1978 to 2019 resulted in category IV to V surface deformations. The smallest subsidence was observed in the locations of gravity flow, while the greatest occurred near a pumping station, where the hydraulic continuity of the stream was interrupted.
