REPAIR PROCESS IN THE PITHEAD BUILDING AND ITS INFRASTRUCTURE AS AN EXAMPLE OF REPAIR WORKS IN INDUSTRIAL FACILITIES

Abstract

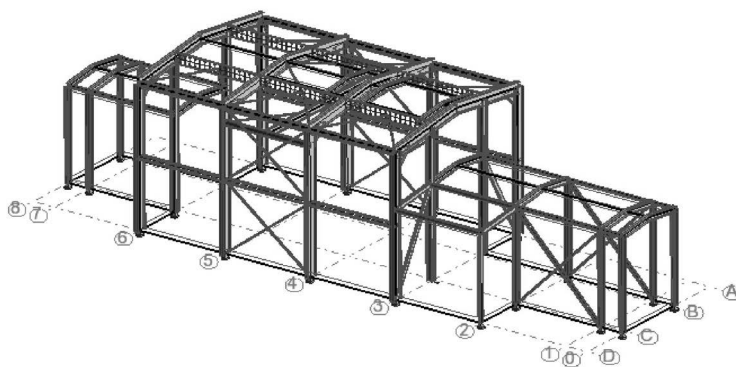
Fig. 1. Supporting structure of the pithead building

The main load-bearing structure of the building is made of a single-nave, single-storey steel frames hinge-joined with the foundation every 6.0 m. The walls are made of prefabricated reinforced concrete slabs welded to the structural columns using suitable fasteners. The roof structure is made of typical prefabricated A-4/K ceiling slabs supported by the rafters of the framework. A general view of the support structure of the pithead building and the building itself are shown in Figure 1.
