Tomasz Niemiec¹, Piotr Gruchlik²

RECTIFICATION OF THE CHURCH BUILDING IN BYTOM MIECHOWICE AND THE RESULTS OF LASER SCANNING 3D

Keywords: mining operation, building tilt, 3D laser scanning, rectification

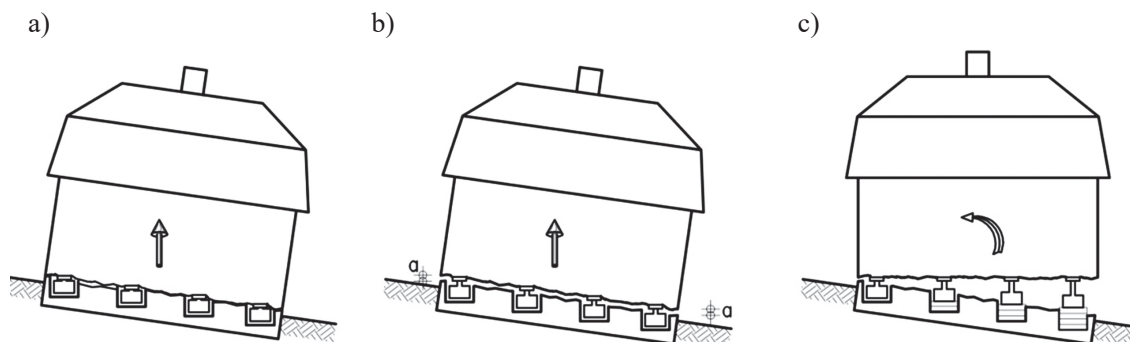
Fig. 1. Rectification phases by uneven lifting a) burst, b) translation, c) rotation

Rectification process which involves using hydraulic jacks consists of three phases (fig. 1) (Gromysz, Niemiec 2010). First phase is to let the building to burst – as a result horizontal gap between jacks is created. For buildings with reinforced concrete walls the

Third phase is reduced to lift the building up unevenly, namely rotation around the axe beyond the outline of the foundation and perpendicular to inclination vector of the building.

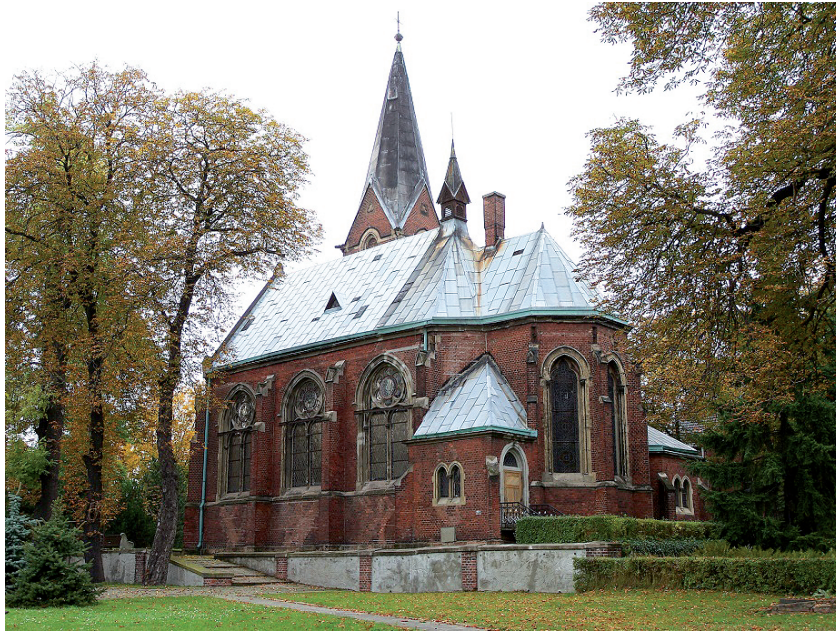
Fig. 2. General view of the church's body (information about church, wikipedia)

The church is a part of historic complex of buildings from the late XIX century. Small church was built in neo-gothic style in 1896 (fig. 2). It was made from bricks, has two naves layout and partial basement. Aisle is situated on the north side.

Apart from significant inclination, church's design elements are damaged – many wall and vault cracks 15 mm width can be observed (Gromysz 2015). Because

of these cracks construction supervision has excluded the object from the use. Since 1987, the church is subject to the supervision of the conservator. For this reason, all works related to the rectification were planned below ground level.

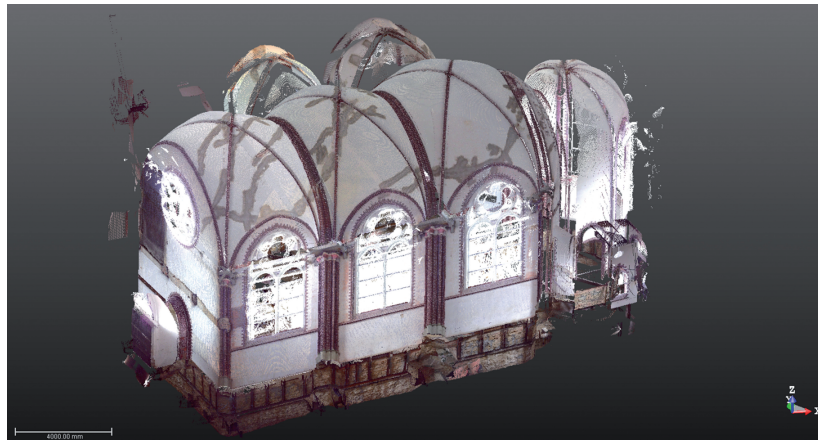
Fig. 8. Church's 3D model based on measurements performer in interiors

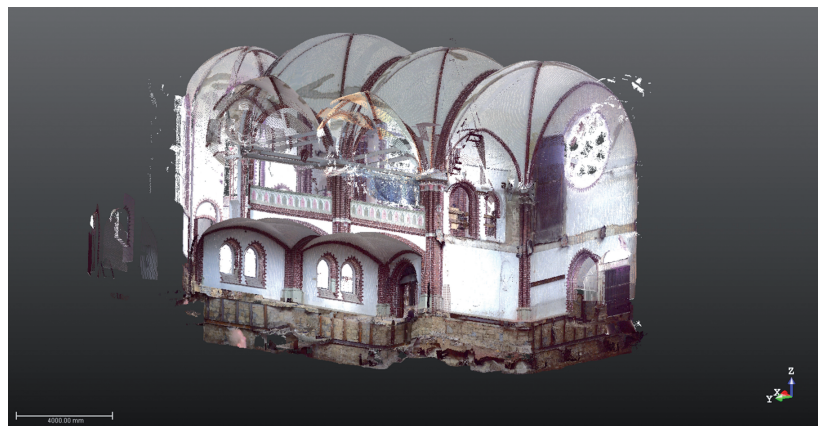
Fig. 9. Church's 3D model based on measurements performer in interiors
