Sławomir Kowalski (skowalski@pwsz-ns.edu.pl)
The State Higher Vocational School in Nowy Sącz, Poland

THE INFLUENCE OF A CrN+a-C:H:W COATING ON THE DEVELOPMENT
OF FRETTING WEAR IN A MODEL OF A WHEEL–AXLE PRESS-FIT JOINT
ON A WHEEL SET OF A RAILWAY VEHICLE

Keywords: PVD coating, CrN+a-C:H:W, rotational bending, fretting wear, press-fit joint, wheel set

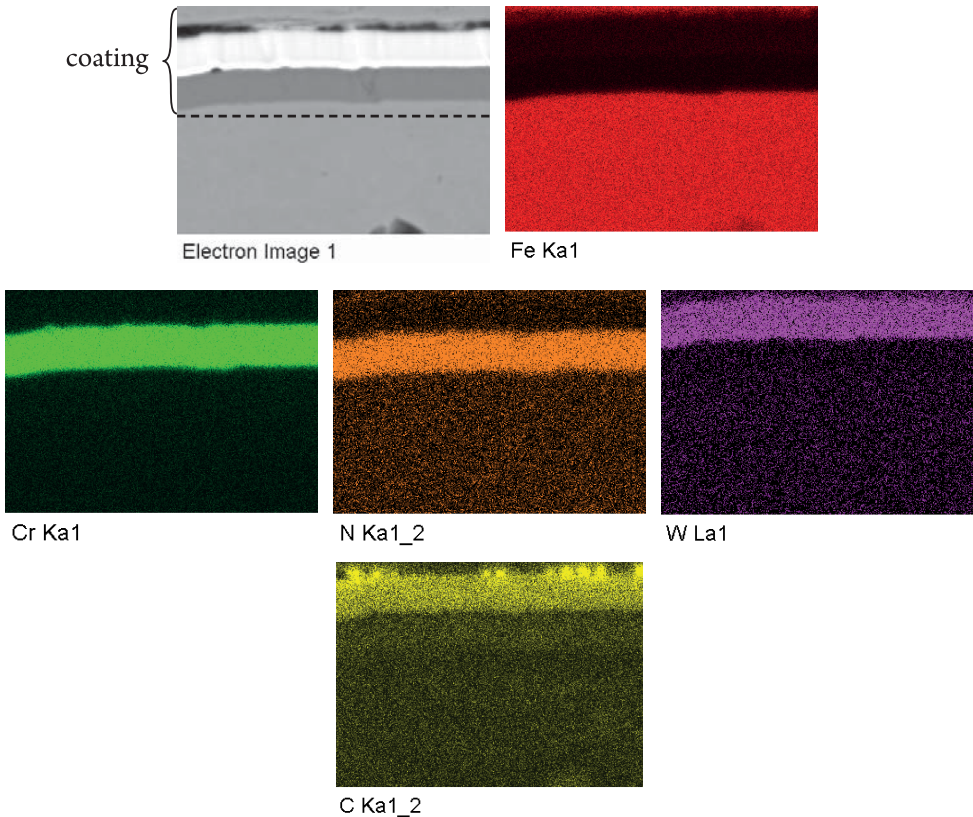
Fig. 1. Element distribution maps showing the chemical composition of the coating

The coating was applied to the shafts by means of the reactive spraying method in a PVD process. The coating structure and chemical composition in the form of a chemical element distribution map is presented in Fig. 1. The coating consists of three layers and is colloquially called WC/C. The first layer is chromium nitride (CrN), the task of which is to improve coating adhesion to the surface of the steel base. The next layer is tungsten carbide (WC), which protects the surface of the base against abrasion and is responsible for the transfer of high pressures. The third layer, called the external layer, directly mates with the sleeve. According to literature, the atomic composition of this layer is as follows: 12% W, 70% C, 15% H, 3% Ni [15–16]. Nickel is an outcome of the coating generation process.

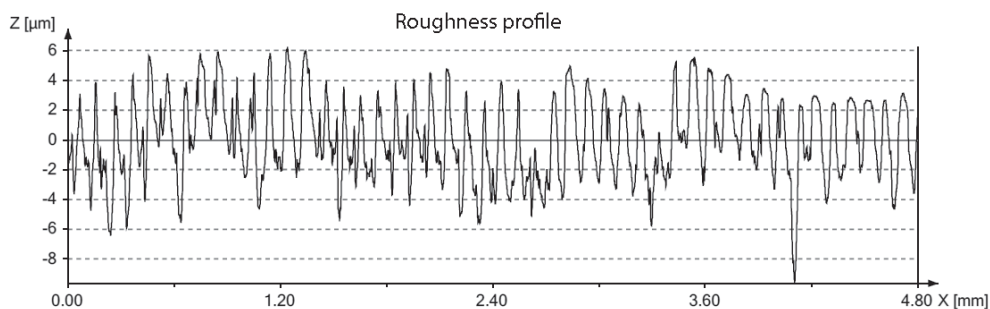
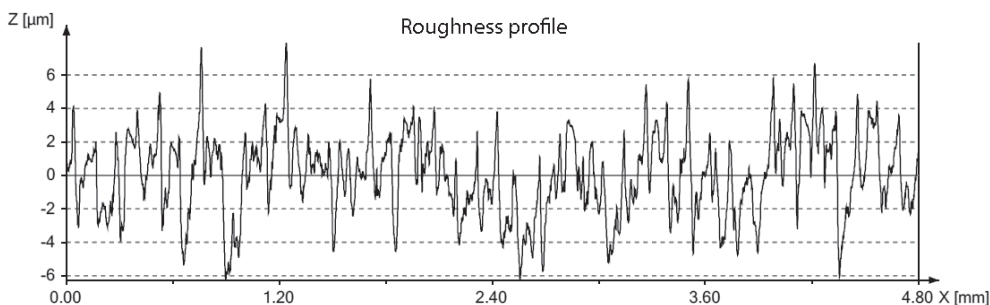
In the case of the tests of fretting wear in a press-fit joint, the appropriate hardness of the top layer and its roughness parameters prior to joint assembly play an important role. The roughness profile and selected parameters of the uncoated (a) and coated (b) top layer of the shaft are shown in Fig. 2.

a) uncoated shaft

Ra	2.06 μm	Rz	11.15 μm	Rmr(c=2.78 μm)	18.062 %
----	--------------------	----	---------------------	----------------------------	----------

b) coated shaft

Ra	1.68 μm	Rz	11.57 μm	Rmr(c=2.78 μm)	1.300 %
----	--------------------	----	---------------------	----------------------------	---------

Fig. 2. Roughness profile of the shaft surface

Test results confirmed the tests conducted by other authors specifically that input parameters of the top layer of the elements being connected have significant influence on the development of fretting wear. Appropriate roughness and hardness parameters reduce wear intensity. Tested coatings have, indeed, slightly lower roughness parameters in comparison with the uncoated shaft, but increasing top layer hardness by 25% proved sufficient for the reduction of adhesion and also of fretting wear.

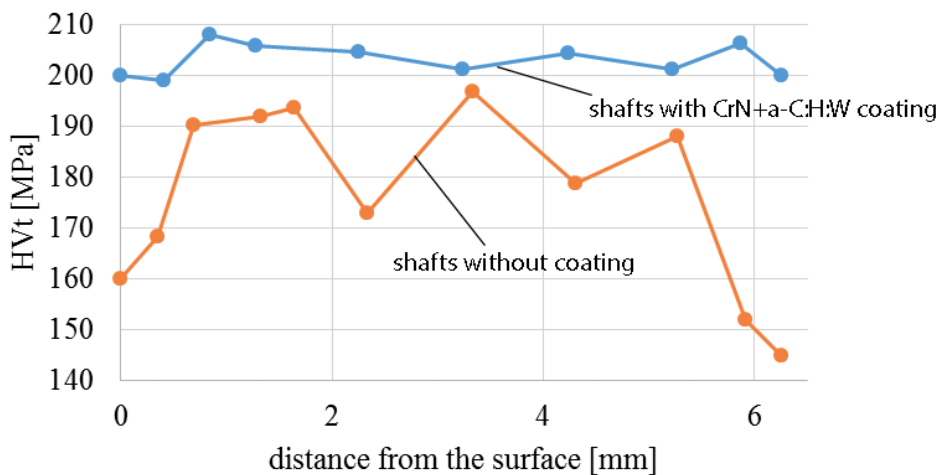
The diagram showing shaft microhardness in the function of the distance from the surface is presented in Fig. 3.

Fig. 3. Microhardness distribution

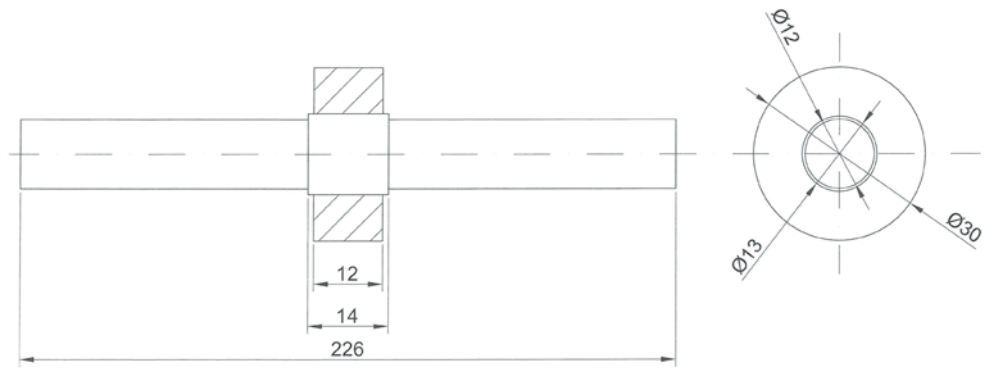
Wear tests were conducted on a model of a wheel/axle push fit joint of a railway vehicle wheel set. The model consists of a sleeve forced onto a shaft with 0.02 mm negative allowance.

The model was designed in such a manner that the dimensional similarity to the real wheel set is retained. Retained – this primarily concerned the shaft and sleeve connection zone. The shaft length and diameter were dependent upon the fatigue testing machine structure. The diagram of the sample with dimensions is presented in Fig. 4.

Fig. 4. Diagram of the test model with dimensions

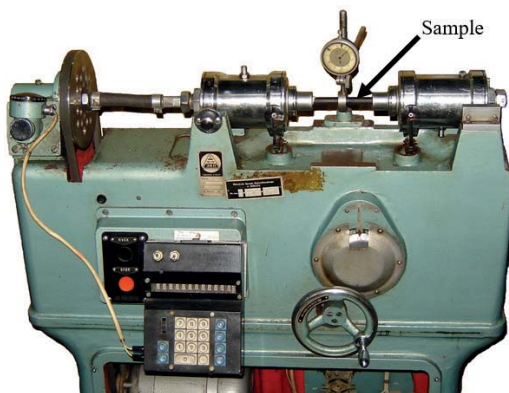
In addition to an appropriate test model, the selection of a wear test station – which will, to the maximum extent, reflect the wheel set operational conditions described in the introduction – is an important issue. Primarily, the test station should enable the oscillatory tangential displacement of the mating surfaces. One such machines which meets the criteria is a MUJ fatigue testing machine, the structure of which is presented in Fig. 5.

Fig. 5. The structure of a fatigue testing machine

The machine structure enables the generation of a periodically variable load with pure bending of a rotating model. Railway vehicle wheel sets rolling on a straight track (a situation when a railway vehicle does not move on a bend and hunting oscillation does not take place) are subjected to similar conditions. A situation in which a vehicle is on a bend was not covered in the tests.

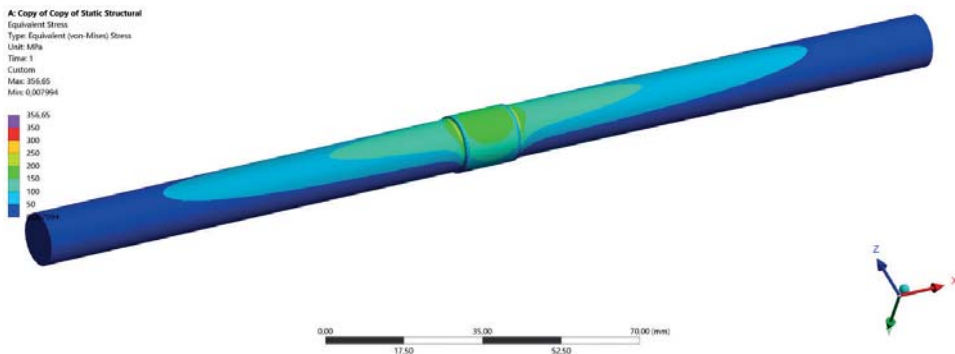
The FEM analysis performed in the ANSYS software permitted the selection of the maximum value of a force which causes shaft deflection without leading to plastic deformation. The assumed 550 N force causes the maximum stresses to be reduced to 356 MPa (Fig. 6) and leads to maximum sample deflection, which is 0.52 mm. The most important parameters of wear tests are summarised in Table 2.

Fig. 6. Distribution of reduced stresses

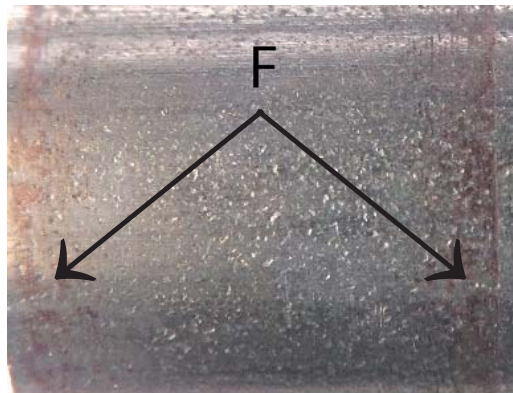
Macrographic observations (Fig. 7) of the uncoated shaft surface confirm the test results obtained by the authors of [6, 17, 18], which show that fretting occurs at joint edges in the case of press-fit joints.

Fig. 7. The macrographic image of the shaft surface, F – fretting wear

In the case under analysis, fretting wear occurs around the entire circumference of the shaft axle seat. The width of the ring affected by wear reaches 2-3 mm and is the same on each side of the axle seat. Wear occurs at a distance of 2-5 mm from the axle seat edges. The tests of the topography of the top layer at the place of fretting wear indicates a considerable increase of the roughness parameters. The probable cause of the roughness increase is the wear products.

The tests demonstrated that in the case of a joint in which the shaft top layer was not covered with the relevant coating, fretting wear occurs around the entire circumference in the form of a ring, the width and distance of which from the joint edge are different at each side. Fretting wear, of considerably lower intensity, however, was also observed on the surface of the coated shafts. Fretting wear occurred over the entire circumference, covered small areas of various shapes, and was spaced at random.

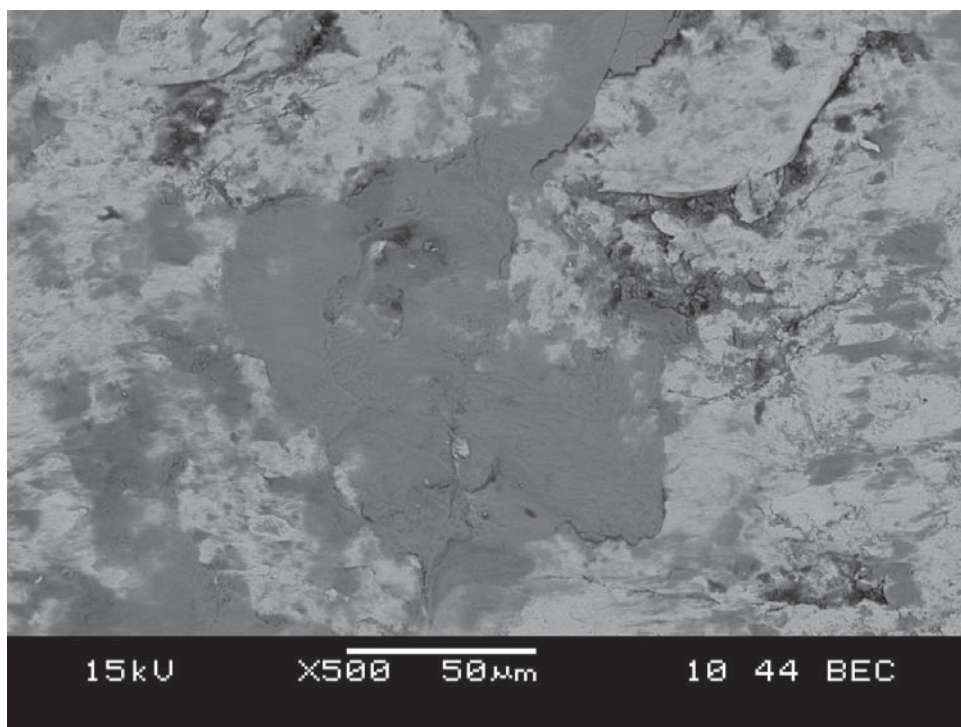
Microscopic observations with the use of an SEM confirm that the responsibility for the increase of roughness parameters rests to a large extent with material build-up at the shaft surface in the fretting wear zone visible in Fig. 8. Further observations show occasional occurrences of microcracks and micro-abrasion.

Fig. 8. The SEM image of the shaft surface in the fretting wear zone

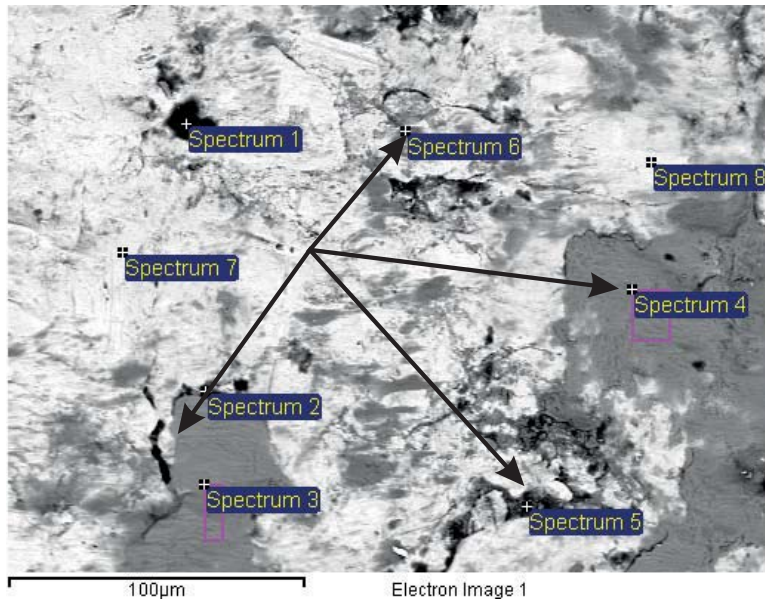
Spectrum	Fe	O	C	Na	Si	S	Cl	K	Ca	Mn	Total
Spectrum 1	21.8	13.2	59.2	1.3	0.8	0.9	1.2	0.6	1.0	–	100.0
Spectrum 2	51.4	16.7	26.4	1.4	1.3	0.5	0.8	0.5	0.5	0.4	100.0
Spectrum 3	64.4	34.8	–	–	0.3	–	–	–	–	0.5	100.0
Spectrum 4	60.7	38.5	–	–	0.4	–	–	–	–	0.4	100.0
Spectrum 5	56.2	27.7	14.7	–	0.3	–	–	0.2	0.4	0.5	100.0
Spectrum 6	61.9	31.6	3.7	–	1.7	–	–	0.5	–	0.5	100.0
Spectrum 7	99.3	–	–	–	–	–	–	–	–	0.7	100.0
Spectrum 8	99.4	–	–	–	–	–	–	–	–	0.6	100.0

Fig. 9. EDS analysis of the elements at the shaft surface in the fretting wear zone

A peculiar feature of fretting damage is the brown colour typical of steel corrosion. This follows from the fact that wear products damage that has come into being as a result of adhesive bonds and, subsequently, plastic deformation, are susceptible to oxidation. This fact is confirmed by the EDS analysis of the chemical composition of wear products in the place of fretting wear. In Fig. 9, places marked with arrows show fretting damage in the form of material build-up. These places have an oxygen content from 27% to 40%; therefore, iron oxides come into being. The remaining measured places also contain oxygen, but its concentration is considerably lower.

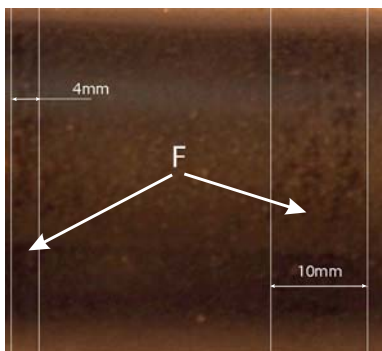
Macroscopic observations of the coated top layer of the shaft after wear tests demonstrated fretting wear traces (the 'F' in Fig. 10). As in the previous case, these are located by both joint edges. The first traces appear 2 mm from the edge. Wear affects is randomly located at the axle seat circumference. The smallest surface area affected by wear is 0.5 mm², and the largest is approximately 14 mm². The width of the 'strip' affected by wear is different on each side.

Fig. 10. The surface of a shaft with a CrN+a-C:H:W coating after wear tests

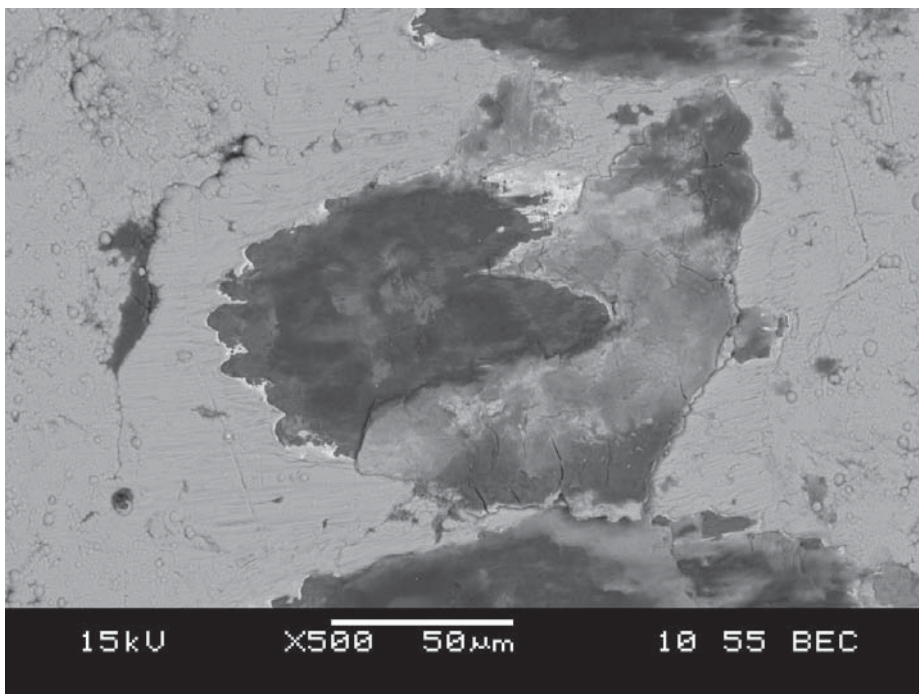
Fretting comprises, to a large extent, material build-up most probably originating from the tearing off of the sleeve top layer micro-irregularities (Fig. 11). The inferior properties of the sleeve hub top layer in relation to the coated shaft axle seat cause precisely the sleeve hub surface to be susceptible to damage during joint assembly.

Fig. 11. Fretting in the form of material build-up on the coated shaft surface

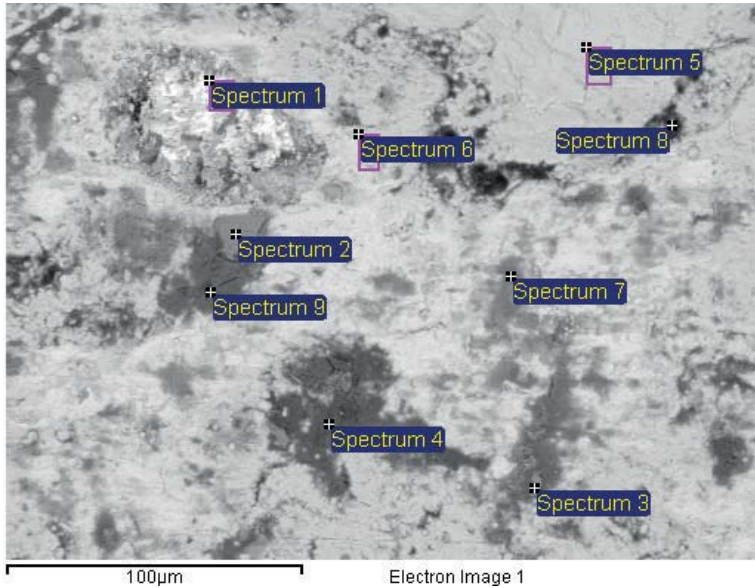
This assumption is confirmed by the analysis of the elements occurring on the shaft surface in the fretting wear zone. The results of the analysis of the chemical composition at selected points of the shaft surface within the fretting zone are presented in Fig. 12.

Spectrum	Elements related to the coating and sleeve structure					Elements related to the process of sample preparation for laboratory tests				Total
	Fe	O	C	W	Cr	Si	Ca	Mn	Ni	
Spectrum 1	7.1	5.4	19.4	53.7	10.6		–		3.8	100.0
Spectrum 2	94.6	–	3.4	–	0.9	0.4	–	0.7	–	100.0
Spectrum 3	93.8	–	4.1	–	1.0	0.4	–	0.7	–	100.0
Spectrum 4	41.2	26.5	–	29.5	1.0	–	–	–	1.7	100.0
Spectrum 5	0.6	1.0	26.1	66.8	0.9	–	–	–	4.6	100.0
Spectrum 6	3.1	20.1	–	71.0	1.0	–	–	–	4.8	100.0
Spectrum 7	40.3	29.1	6.2	21.9	1.3	–	–	–	1.2	100.0
Spectrum 8	15.0	15.1	48.6	17.7	2.6	–	0.4	–	0.5	100.0
Spectrum 9	42.4	26.1	–	28.5	1.0	–	0.5	–	1.6	100.0

Fig. 12. EDS analysis of the elements on the shaft surface in the fretting wear zone

During the analysis of the chemical composition for a selected area affected by wear, macroscopic observations have demonstrated that wear is random in nature and is not continuous. This is proved by the chemical composition at the survey points 'Spectrum 1' and 'Spectrum 5'. It is mainly the elements related to the coating structure (carbon and tungsten) that occur there. In the case of the 'Spectrum 1' survey point, a small amount of chromium is also observed. This is caused by the micro-abrasion of the working part of the coating, which led to the uncovering of the first coating layer containing chromium. The total destruction of the coating did not, however, take place. Iron occurring at that point probably originates from the sleeve hub. Nickel occurring in that part is an effect of the manufacturing process of the coating.

The survey points 'Spectrum 2' and 'Spectrum 3' are the proof of the shearing of the micro-irregularities on the top layer of the sleeve hub during joint assembly. During forcing, torn-off micro-irregularities creating the so-called 'third body' were moving along the joint and filling the natural microcavities in the coating. Hence, the chemical composition in these places is primarily iron. These wear products did not undergo plastic deformation and were not oxidised. They did not take part in the rise of fretting, either.

The remaining survey points demonstrate the occurrence of fretting wear. In the case of the 'Spectrum 6' survey point, material build-up mainly consisting of tungsten is observed. This is evidence of the tearing off of micro-irregularities of coating as a result of adhesion, and of the creation of build-up which underwent plastic deformation during the latter part of assembly or operation. This deformed build-up was oxidised, hence the analysis of the chemical composition also showing the occurrence of oxygen. The 'Spectrum 8' survey point also signifies damage to the coating. Material build-up at this point is composed of carbon and tungsten (i.e. elements related to the coating structure) and of a small amount of iron. This build-up also underwent plastic deformation and, at a further stage, oxidation.

Wear products see above note analysed at the 'Spectrum 4', 'Spectrum 7' and 'Spectrum 9' survey points are the material build-up in which chemical composition is a mixture of elements originating from the top layer of the sleeve hub and of the coating. However, the occurrence of iron is noted in the vast majority of cases – this means that mainly the sleeve top layer was damaged. During operation, this build-up gradually underwent plastic deformation and oxidation. The analysis of the chemical composition in these survey points showed the presence of the same or similar amount of oxygen to that of tungsten. The presence of carbon is not noted.

Trace amounts of chromium observed in the 'Spectrum 2' to 'Spectrum 9' survey points originate from the local microdamage of the working part of the coating. The remaining chemical elements – such as silicon, calcium, manganese and nickel – are the result of the surface preparation for laboratory tests or the outcome of the coating production process.
