Andrzej Legendziewicz

orcid.org/0000-0002-9228-296X  
andrzej.legendziewicz@pwr.edu.pl  
Faculty of Architecture, Wrocław University of Technology

## THE ARCHITECTURAL TRANSFORMATION OF THE VON WENTZKY FAMILY'S BAROQUE PALACE AT RYCHNÓW NEAR NAMYSŁÓW

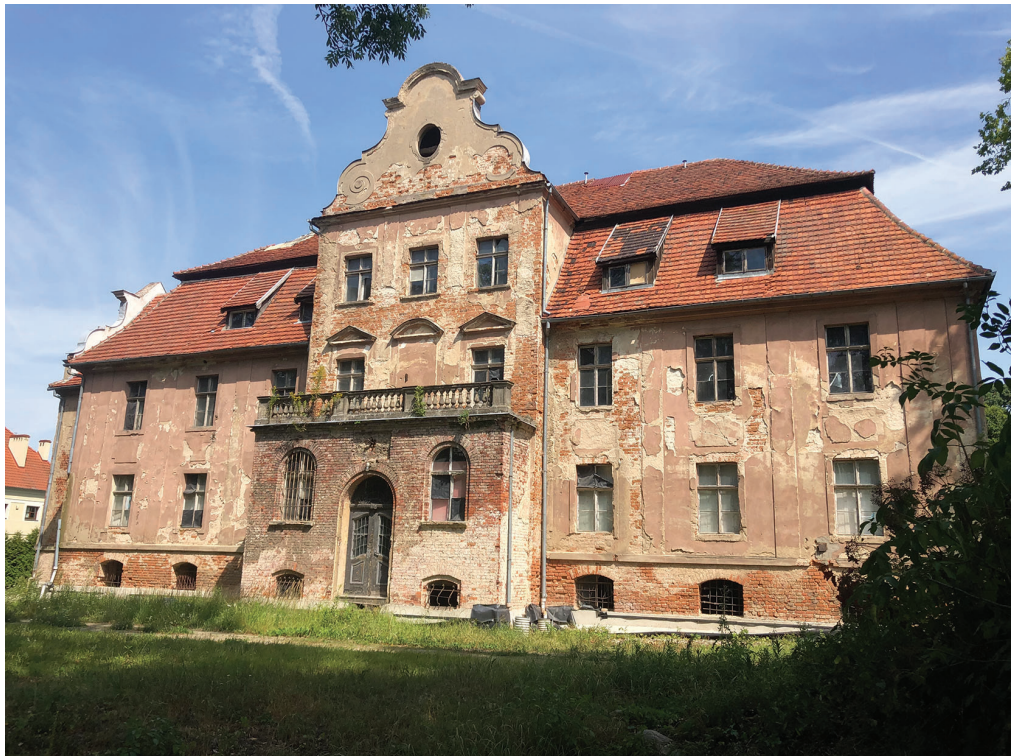
Fig. 1. Rychnów (dep. Namysłów), palace, view from the south-east, present state (photo by A. Legendziewicz)

a pair of pilasters to accentuate the middle bay. The openings are framed with smooth window trims and rectangular plates are arranged under the first-floor window sills. The west elevation is crowned with a gable end, which is embraced with volute curves with a triangular head on a pair of pilasters in Tuscan order. Between them, there are two, smoothly trimmed windows, one rectangular and one elliptical (Figs. 1–3).

Protruding about 70 cm in front of the elevation face, the *avant-corpses* were arranged in a similar manner to those described above. On the ground floor, in the middle window bay, there was an entrance preceded by stairs. The entrance opening was covered with a basket arch and surrounded by a profiled frame. The first-floor windows were decorated with panels. On the panels there were heads; the middle head was segmental in shape, whereas the two side ones were triangular. The second-floor windows had aprons beneath the sills and plates without corners above the openings. The *avant-corpses* were probably topped with triangular tympanums; there was a smoothly framed oculus in each of them. The shape of the north tympanum has survived (Figs. 1, 2).

The side elevations were arranged in a similar manner to that described above. They are regularly shaped with five window bays, of which three have openings. Counting from the south, the east elevation had windows in the first, second and fourth bays; the west elevation had windows in the second, third and fourth bays<sup>2</sup>. There were plates in the strip between the storeys. The regularity was emphasised with pilasters (Fig. 1, 3).

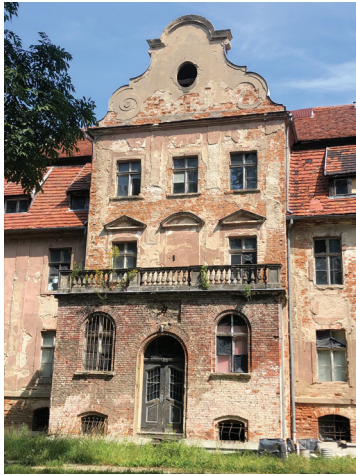
Fig. 2. Rychnów (dep. Namysłów), palace, southern facade, projection of the main entrance, present state (photo by A. Legendziewicz)

The elevation corners are embraced with a pair of pilasters. The *avant-corps* is preceded with a single-storey extension where there are an entrance, semi-circular windows and a balcony on the first floor. The second-floor openings are decorated with segmental head in the middle window bay and with two triangular head in the side window bays. The third-floor windows are decorated with aprons under the sills and plates in the window heads. The crowning takes the form of a gable end with volute framing and an elliptical oculus.

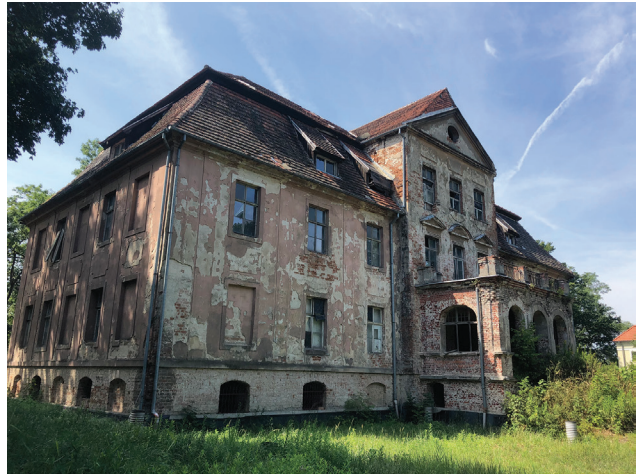
Fig. 3. Rychnów (dep. Namysłów), palace, view from the north-east, present state (photo by A. Legendziewicz)

The north elevation faces, from the garden, is composed in a comparable manner. The *avant-corps* is emphasised with an arcaded loggia that is standing in front of it and has a balcony on the first floor. It is crowned with a low triangular tympanum with an oculus; a high roof can be seen from behind the tympanum. The east elevation consists of five window bays. The spaces between the equally spaced pilasters are filled with blind windows that are lined on two storeys. The ground-floor windows are arranged in three bays (I, II and IV – counted from the south) and the first-floor windows are arranged in two bays (II and IV). There are plates in the area between the storeys, as is the case with the façade, and there is a small dormer in the lower roof slope.

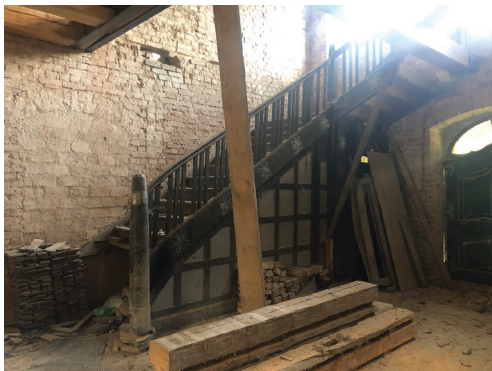
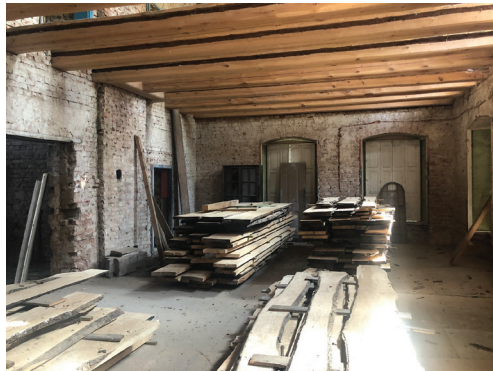
Fig. 4. Rychnów (dep. Namysłów), palace, ground floor, hall with stairs to the upper floor in the back in the middle crosswise sections, present state (photo by A. Legendziewicz)

Fig. 5. Rychnów (dep. Namysłów), palace, ground floor, hall in front of the eastern crosswise sections, present state (photo by A. Legendziewicz)

the entrance leads to a corridor in the middle section. At the end of the section, there is an extension with a staircase and two small rooms. The room layouts in the front and back sections are similar to each other. They consist of two rooms. In the south, they are accessible from the corridor and the staircase via one of the added rooms (Figs. 4–9).

The layout of the first-floor rooms is very similar to that described above, although it is slightly distorted as some of the doorways<sup>1</sup> are bricked in. Two flights of stairs lead to the entrance hall, which is situated in the middle crosswise section in the back longitudinal section. Daylight enters the entrance hall from the north through two windows and two terrace doors. Two doorways were built to access rooms in the side crosswise sections – one doorway is in the east and runs to the back longitudinal section, and the other is in the west and runs to the middle longitudinal-section corridor that is connected with the extension's staircase. In the east, the hall layout follows the ground floor pattern. In the front longitudinal section, there is a large room which is connected with the room that is above the entrance hall via a passage, and there are two smaller rooms that face the garden. The west crosswise-section rooms are arranged in a comparable way to the above. The front and back longitudinal sections consist of two rooms that are accessible from the corridor and are lit through three north-facing windows and three south-facing windows (Figs. 4, 5).

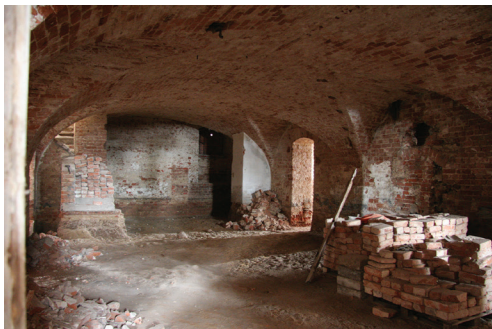
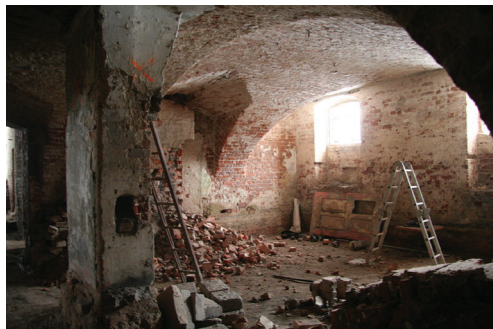
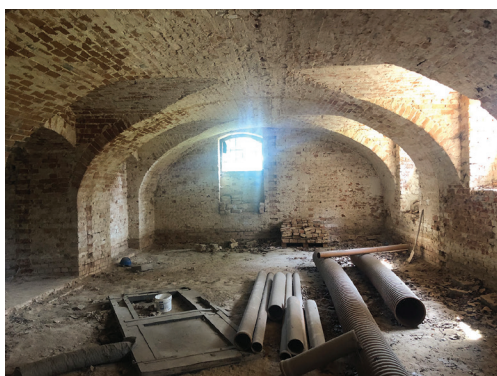
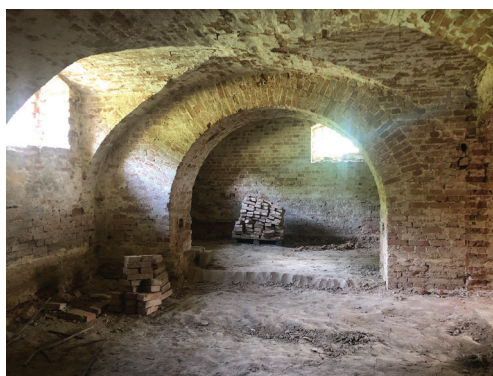
Fig. 6. Rychnów (dep. Namysłów), palace, basement, chamber in the middle crosswise sections, present state (photo by A. Legendziewicz)

Fig. 7. Rychnów (dep. Namysłów), palace, basement, back chamber in the west crosswise sections, present state (photo by A. Legendziewicz)

Fig. 8. Rychnów (dep. Namysłów), palace, basement, front chamber in the eastern crosswise sections, present state (photo by A. Legendziewicz)

Fig. 9. Rychnów (dep. Namysłów), palace, basement, back chamber in the eastern crosswise sections, present state (photo by A. Legendziewicz)

axis; the one in the front has three lunettes and the two in the north have one crosswise lunette each. There is a total of five windows in the lunettes of the chambers and two additional windows in the east wall. Whereas in the west crosswise section across the three longitudinal sections, there is a central corridor. At the front, there are two chambers, each covered with a barrel vault that is built along the east-west axis and lunettes with axes that determine the locations of the south-facing windows. The larger of the chambers has two lunettes and the smaller chamber has one lunette. The back longitudinal section follows a similar pattern as above; it differs only with the vault of the larger of the chambers where the vault is built along the north-south axis. At the end of the corridor, there are small rooms and stairs running up to the ground floor (Figs. 6–9).

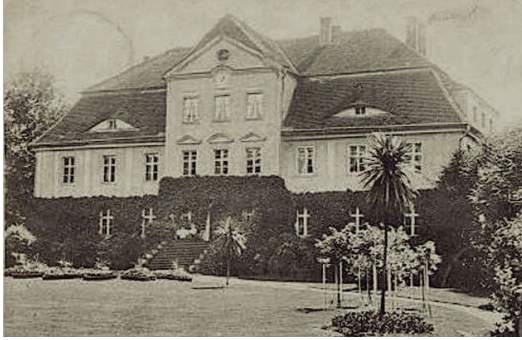
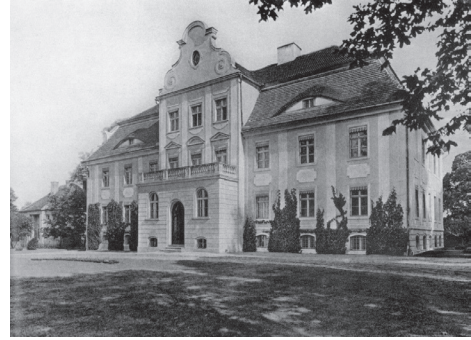
Fig. 10. Rychnów (dep. Namysłów), the palace in the view from the north, a postcard from the beginning of the 20<sup>th</sup> century [www.polska.org.pl](http://www.polska.org.pl) (access: 15.12.2018)

Fig. 11. Rychnów (dep. Namysłów), palace in view from the south-east, view from the first half of the 20<sup>th</sup> century [www.polska.org.pl](http://www.polska.org.pl) (access: 15.12.2018)

The written sources are supplemented by a few archive photographs of palace views. The oldest views show the palace from the north (i.e. from the garden) before it was subjected to the 1906–1907 alterations [12] (Figs. 10, 11). The residence layout, together with the land-stewardsee note at the start of the introduction building and the farm buildings, is documented on the maps of the Namysłów area dating back to from the close of the eighteenth century to the beginning of the twentieth century [3, Tables 14, 17 and 18].

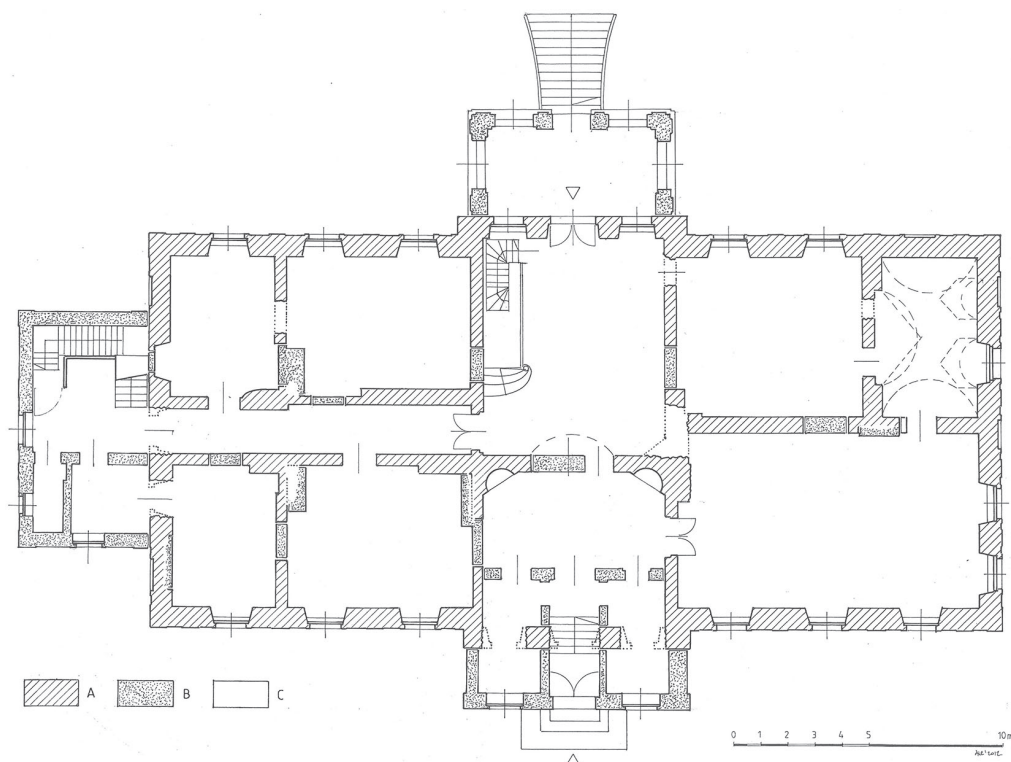
Fig. 12. Rychnów (dep. Namysłów), palace, ground floor plan with chronological wall stratification. A – walls from 1781; B – walls from 1906–1907; C – contemporary and unrecognized walls (edited by A. Legendziewicz)

The original Baroque palace was funded by Ernest Fryderyk von Wentzky in 1781. It was erected on a 31.5 x 15.1 m elongated rectangle plan along the east-west axis and its façade faces south. The building has two storeys, a base course, three-bay three-storey avant-corpses and entrances in the longer elevation walls. The mansard roof was probably covered with ceramic roof tiles; it consists of a multi-pitched roof and a crosswise ridge to emphasise the avant-corpses. There was a landscape park around the residence. There was an entrance gate in the south-west (Figs. 12–14).

The palace is based on a classic plan consisting of three crosswise sections and many longitudinal sections. On the ground floor, the middle crosswise section contained a hallway, which was lit through two south-facing windows. At the north-wall corners there were two obliquely situated, semi-circular niches. A wide passage was arranged in the entrance hall where there were stairs leading up to the first floor and an exit to the garden. A fireplace may have been built in the south-east corner of the hall. The two rooms were connected through two doorways with the east wing and through three doorways in the west wing (Fig. 12).

The west wing was arranged in three longitudinal sections. A corridor filled the middle section. There might have been a service staircase in the west end of the wing; it ran up to the first floor and down to the cellars. The front section had two enfiladed rooms whose doorways were in the middle of the walls. The larger room was situated near the entrance hall and was lit through two south-facing windows, and the smaller room was lit through one south-facing and one west-facing window. Both rooms had fireplaces in their north-east corners and were connected with the corridor via doorways. The back longitudinal section, where there may have been a dining room, was arranged in a comparable manner to the front section, although the doorways enfiladed along the south wall. Fireplaces were also built along this wall; the fireplace built near the entrance from the hall had a decorated hearth (Fig. 12).

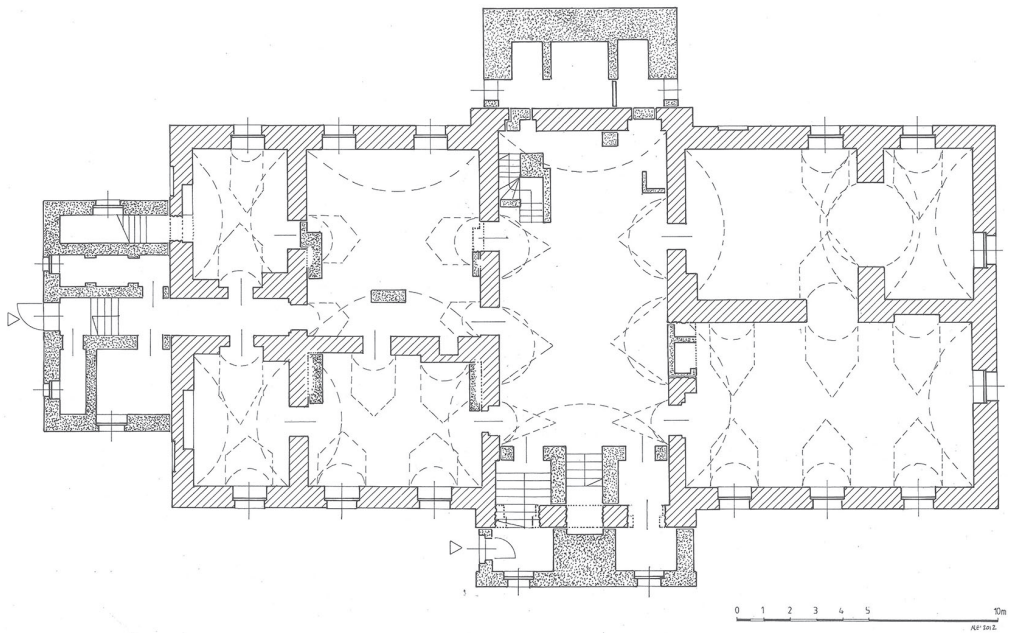
Fig. 13. Rychnów (pdep Namysłów), palace, first floor plan with chronological wall stratification.  
Signs as on the ground floor drawing, compiled by A. Legendziewicz

A similar room layout to that described above was also introduced to the first floor, where there were the owners' rooms. The centrally situated hall filled the middle section and consisted of two rooms. The north room was lit through three garden-facing windows and contained fine stairs. The south room was connected with the north room via a doorway decorated with two semi-circular niches. The light also entered through three windows. In the east crosswise section, there were two symmetrical, two-room suits situated in the front and back longitudinal sections. Both of them had four windows: three windows faced either south or north and one window faced east. The suits were connected via a doorway that was built in the intersection wall. The room layout in the west crosswise section was the same as the ground floor arrangement. The front and back longitudinal sections contained two-room suits, and in the middle section, there was a not very narrow corridor that led to the service stairs. The rooms were slightly smaller than in the east wing; they were lit through three south and north-facing windows and one west-facing window in each of the rooms. It is worth noting that each of the suits was accessible through one doorway from the hall and two doorways from the corridor (Fig. 13).

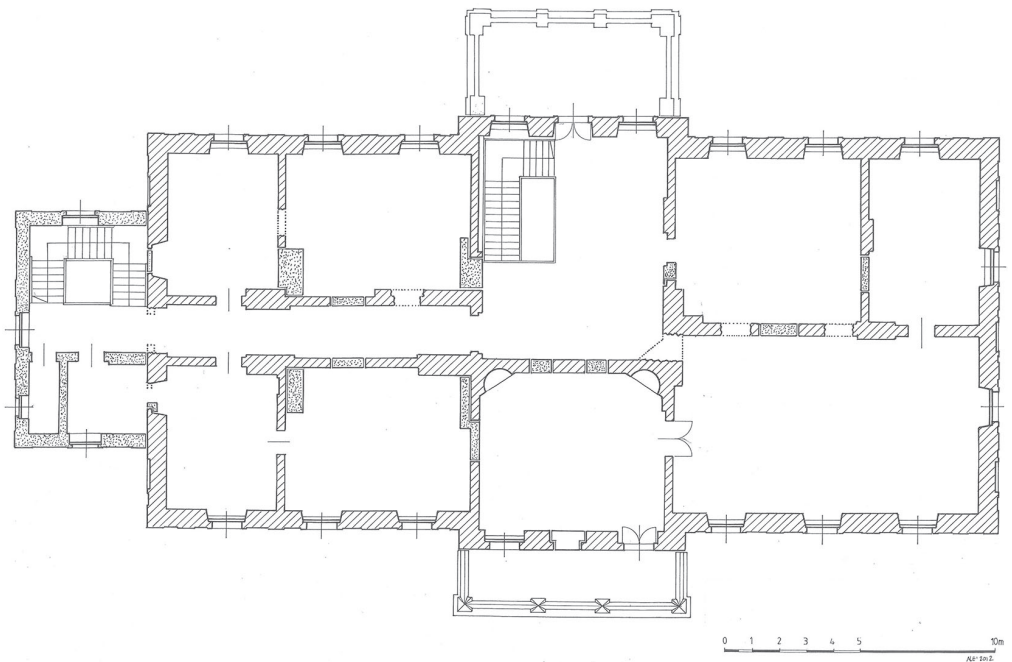
Fig. 14. Rychnów (dep. Namysłów), palace, projection of basements with chronological wall stratification.  
Signs as on the ground floor drawing, (edited by A. Legendziewicz)

Cellars were used for service and storage purposes. These were covered with basket-shaped barrel vaults with crosswise lunettes. Two of the rooms in the chamber situated under the entrance hall and in the adjacent chamber in the north-west were built along the north-south axis; the other chamber rooms were built along the east-west axis. The cellar floors were constructed from 26 x 26 x 7 cm ceramic tiles.

The largest of the chambers had a span of almost 6.7 m; it was situated under the entrance hall and was used as a storage area. Three chambers in the east crosswise section might have been used for a similar purpose. A kitchen was probably located in the west wing along the north wall; this is indicated by the location of chimneys. Meals might have been prepared in the rooms that were situated along the west wall, where the service stairs came down to the corridor (Fig. 14).
