TECHNICAL TRANSACTIONS 1/2018 ENVIRONMENTAL ENGINERING

Barbara K. Wilk (barbara.k.wilk@gmail.com)

BIOVAC[®] WASTEWATER TREATMENT PLANTS IN THE MOUNTAIN NATIONAL PARKS

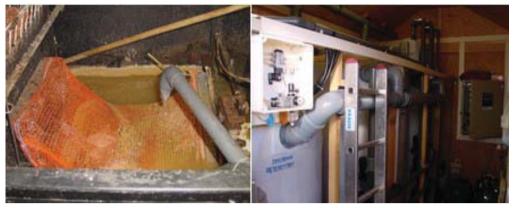
Fig. 2. Biovac® wastewater treatment plant at West Spitsbergen a) bag screen , b) retention tank [10]

The mechanical (primary) sewage treatment is a stage where solids are removed from sewage. Biovac[®] plants usually employ basket screens and bag screens, although occasionally fine screens, sieves or screenings and grit separators (combined in a single unit) are used for larger wastewater treatment plants. The basket screen is a coarse screen made of stainless steel. This device is placed directly by the inlet in manholes or pumping stations to which wastewater is carried by pipe. It is guided by rails and has electric or hand hoist. Floating solids of a particular size are caught in the filtering compartment. The basket turns to a position that guarantees automatic unloading of screenings. The separated solids/screenings are transported to a storage tank or to a filter press via a gutter. The bag screen (Fig. 2) is mounted in front of the retention tank. The bag is made of plastic fibres and removes solids of a particular diameter. Similar bags can also be found in agriculture as a packing material for agricultural crops.

The vertical retention tank (Fig. 2) equalises the sewage flow/composition and serves as a buffer during large flow fluctuations. The tank houses submersible pumps that pump sewage to the SBRs.

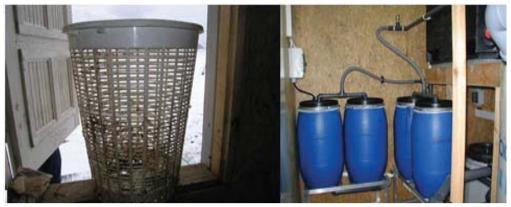
Fig. 3. Sludge processing at the Biovac® wastewater treatment plant [10]

Excess sludge is directed to an aerobic stabilisation tank in which a cyclic aeration takes place via disc diffusers and a blower. After aerobic stabilisation, sludge becomes a stable product that can be stored without risk of odour. The stabilisation process also results in the partial or complete removal of pathogenic microorganisms [10-13]. The stabilised sludge is discharged to the dewatering units and subsequently dried in sludge dryers (Fig. 3).

Sludge presses or centrifuges are used for the mechanical dewatering of sludge at larger wastewater treatment plants. Centrifuges (working in a batch or in continuous mode) separate the solids from the liquid with gravitational and centrifugal forces while filter presses, squeeze water out of the sludge [14-16].

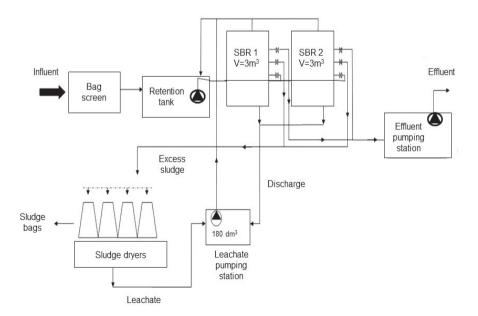
Fig. 4. Flow chart of the West Spitsbergen wastewater treatment plant [10]

In August 2001, the Biovac[®] wastewater treatment plant with a capacity of $10 \text{ m}^3/\text{d}$ was launched at Spitsbergen. The new wastewater treatment plant replaced the rotating biological contactors (RBC), which had been in operation there since 1985 [10]. The following diagram shows the current sewage treatment technology.

The SBR-type treatment plant at Spitsbergen treats mostly domestic sewage comprising toilet waste, food waste, surfactants, toilet paper, fats and detergents. The sewage composition shows high levels of phosphorus, nitrogen, and the presence of coliforms. The sewage composition is also influenced by the chemical laboratory located at the station where various types of chemical analyses are carried out over the year (mainly chemical analyzes of surface waters and rainwater) [10].

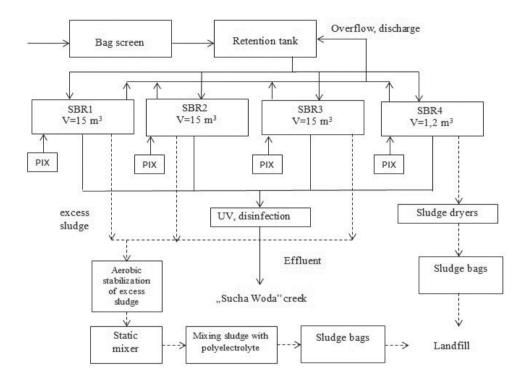
Fig. 5. Flow chart of the Murowaniec wastewater treatment plant [10]

According to the work of Siwek J. et al. [2], the Murowaniec hostel discharged large amounts of NH_4^+ and PO_4^- to the Sucha Woda creek in the years 2008-2009 (the highest concentrations were reported during the summer holidays). Since a new wastewater treatment plant started its operation in 2011, the situation has significantly improved [2]. Figure 5 shows a flow chart of the new Murowaniec wastewater treatment plant.

The plant treats domestic sewage. The hostel has 116 beds and a restaurant. The wastewater treatment plant effluent is discharged into the Sucha Woda creek (13 + 800 km of the Cicha Woda creek).

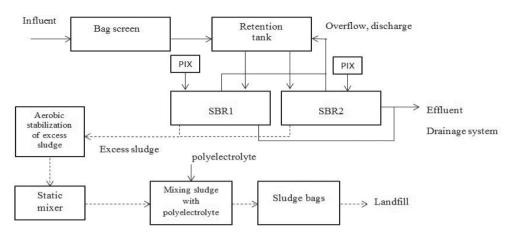
Fig. 6. Flow chart of the Dolina 5 Stawów wastewater treatment plant [10]

The plant treats domestic sewage. The mountain refuge has 67 beds and a restaurant.

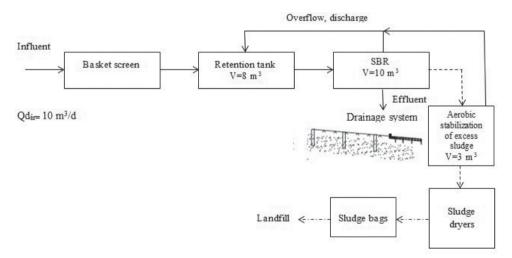
Fig. 7. Flow chart of the Markowe Szczawiny wastewater treatment plant [10]

The Biovac[®] wastewater treatment plant has been treating sewage from the hostel at Markowe Szczawiny since 1995. Figure 7 shows a flow chart of the current treatment process.

The plant treats domestic sewage. The hostel has 72 beds and a restaurant.

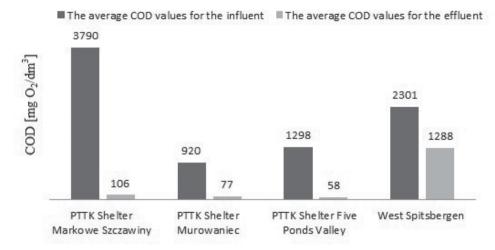
Fig. 8. COD in raw sewage and the effluent from the wastewater treatment plants located in the mountain hostels

According to the studies, the average COD values in raw sewage at the wastewater treatment plants were as follows: Markowe Szczawiny, 3790 mg/dm³; Murowaniec, 920 mg/dm³; Dolina 5 Stawów, 1298 mg/dm³; West Spitsbergen, 2301 mg/dm³. The values were much higher than those found in typical domestic sewage.

The following average values of COD were observed in the effluent: Markowe Szczawiny, 106 mg/dm³; Murowaniec, 77 mg/dm³; Dolina 5 Stawów, 58 mg/dm³; West Spitsbergen, 1288 mg/dm³. The average COD removal efficiency was as follows: Markowe Szczawiny, 97%; Murowaniec, 92%; Dolina 5 Stawów, 95%; West Spitsbergen, 44%.

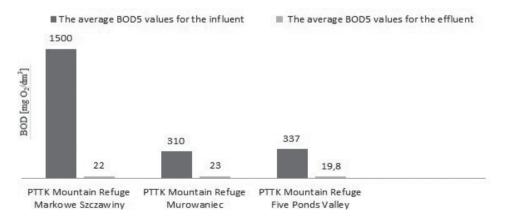
Fig. 9. BOD₅ in the raw sewage and in the effluent from the mountain hostels

The average BOD₅ concentrations in raw sewage at mountain hostels were as follows: MarkoweSzczawiny,1500mg/dm³;Murowaniec,310mg/dm³;Dolina5Stawów,337mg/dm³;

The average BOD_5 concentrations in the effluent from the wastewater treatment plants were as follows: Markowe Szczawiny, 22 mg/dm³; Murowaniec, 23 mg/dm³; Dolina 5 Stawów, 19.8 mg/dm³; a Polish polar station at West Spitsbergen, 500 mg/dm³.

The average BOD₅ removal was: Markowe Szczawiny, 79%; Murowaniec, 92%; Dolina 5 Stawów, 96%.
