DOMINIKA KUŚNIERZ-KRUPA*

NEW BUILDING TECHNOLOGIES IN THE CONTEXT
OF REVALORIZATION OF A HISTORIC BUILDING
(ON THE EXAMPLE OF CONVERSION OF AN OLD DORMITORY INTO
AN ADMINISTRATIVE OFFICE)

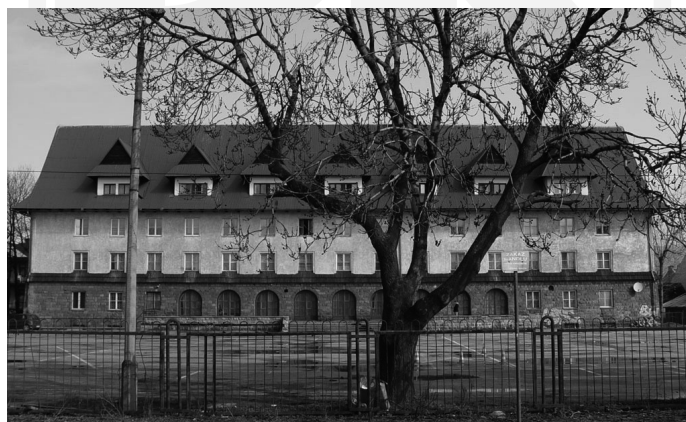
Ill. 2. View of the dormitory building in Nowy Targ from the south (from Al. Tysiąclecia) before project intervention, November 2008 (photo: D. Kuśnierz-Krupa)

The building of the old dormitory in Nowy Targ is an example of an investment which was revalorized and its regional forms and details were highlighted again, owing to its adaptation and introduction of a new function into the building. The object is located in the city centre on the main street: Aleja Tysiąclecia. Because of its location within the conservation protection zone, just outside the city centre on the border of the downtown zone, the object is under protection of the director of the branch office in Nowy Targ, Lesser Poland Voivodeship Monument Protection Office (Ill. 1). The masonry building was erected in the mid-20th century, with a basement and 4 storeys (+ 1 subterranean storey). It was designed in the traditional style of regional architecture with distinct elements of Zakopane style [6]. That trend commonly occurs in the architecture of the Podhale region and the Nowy Targ Valley, and creates the characteristic features of the cultural landscape in that region. Since the moment of its erection, the building has served as a school dormitory for high school students from outside Nowy Targ. In recent years, its technical condition deteriorated (Ill. 2)

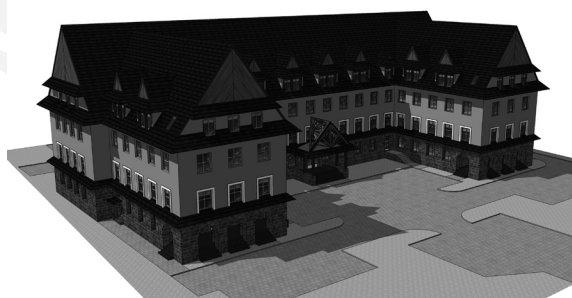
III. 4. Visualization of the revalorization project for the dormitory in Nowy Targ. View from the north-east, [in:]
Archive of ZERIBA DG

The first stage of work connected with adapting the building to serve the office – administrative function was carried out from August till December 2012. Then, on the basis of project documentation¹ prepared by ZERIBA Designing Group, the object elevation was modernized and the roof covering was replaced. The colour scheme of the facade was kept in shades of grey. It was insulated by applying the Termo Organika system: ‘Termonium plus fasada’, using silver-grey panels 1000 mm long, 500 mm wide and 15 cm thick; produced on the basis of innovative raw material refined with a graphite composition, which added to granules during the polystyrene production process, it improves the insulating properties of panels, thanks to which better results of thermal insulation can be achieved. The roof was covered with roofing shingle-like sheets and painted granulated stone imitating traditional shingles, which covered the building roof in the past. Dormers and upper parts of gable walls were lined with wooden siding, which was painted and impregnated with water-soluble grey paint, to be applied outside. Window openings of the 1st floor were highlighted with light-grey 20 cm wide bands. In contrast, the window openings in the attic were highlighted with black bands. The stone facing on the ground floor, characteristic for the Podhale region, was cleaned and filled in. The main entrance from Al. Tysiąclecia was emphasised by a glass roofing spot-fixed to the elevation, which does not disrupt the architectonic composition of the south facade of the building. The entrance on the north side was emphasized with an openwork wooden construction (painted the same shade of grey as the dormers and roof gables) alluding to the architecture of the region.

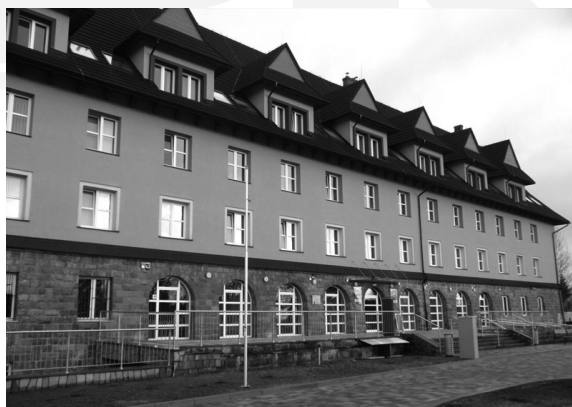
III. 5. Dormitory building from the south (from Al. Tysiąclecia) after revalorization, 2014
(photo: D. Kuśnierz-Krupa)

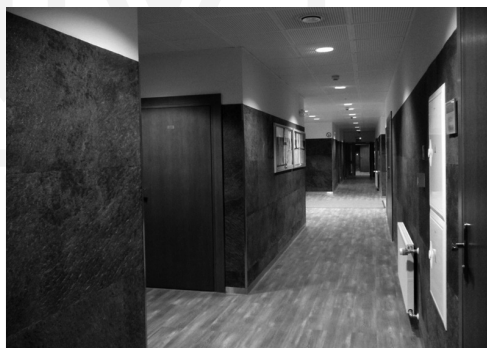
III. 7. View of the object interior after modernization – County Council meeting room, 2014, (photo: D. Kuśnierz-Krupa)

In selected rooms of particularly formal character (such as the County Council conference room or the Starost's office with the meeting room) it was decided to finish the walls with wooden panels. High aesthetic requirements, as well as those technically connected with fire hazard (fire resistance) enforced the use of the latest technologies. Materials classified as A2-s1, d0 (the highest class of non-flammability for flammable materials) were selected. While selecting concrete products, as a reference point, the designers chose Gustafs panels, which apart from their high quality and technical parameters matching the project requirements, allowed for using identically looking elements in 3 different variations – typified by higher fire resistance and “acoustic” (perforated panels with various degree of sound absorption).

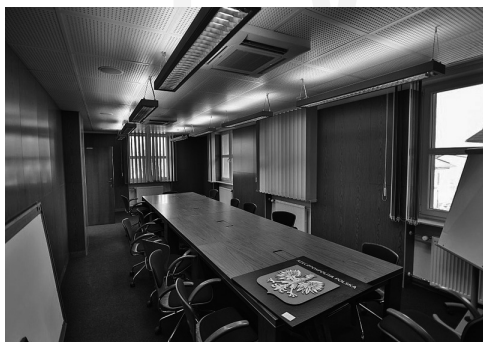
III. 10. View of the object interior after modernization – County Administration Board meeting room, 2014
(photo: D. Kuśnierz-Krupa)

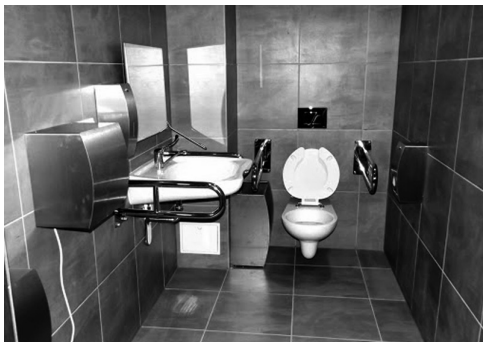
III. 11. View of the object interior after modernization – toilets on the ground floor, 2014 (photo: D. Kuśnierz-Krupa)
