JACEK DĘBOWSKI, KATARZYNA NOWAK, KATARZYNA NOWAK-DZIESZKO\*

## AIRTIGHTNESS OF THE LARGE PANEL BUILDINGS BEFORE AND AFTER THERMAL MODERNIZATION

#### 4. Analyzed flats in the system buildings

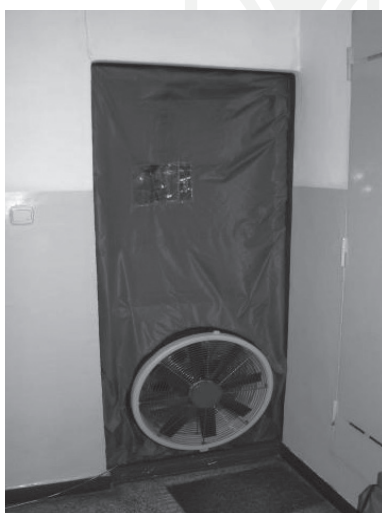
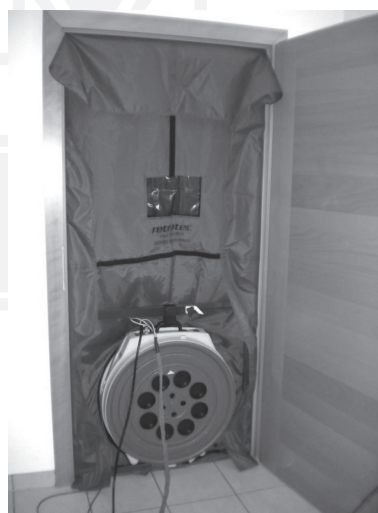
Taking into account the facts above the authors conducted the airtightness measurements in two different flats located in the W-70 system buildings. The tests were conducted using the Blowerdoor set (Ill. 1) with the digital controller Retrotec 3000 and Fantestic program to analyze test data.

Ill. 1a. Blowerdoor set the in the Flat number 1

Ill. 1b. Blowerdoor set the in the Flat number 2

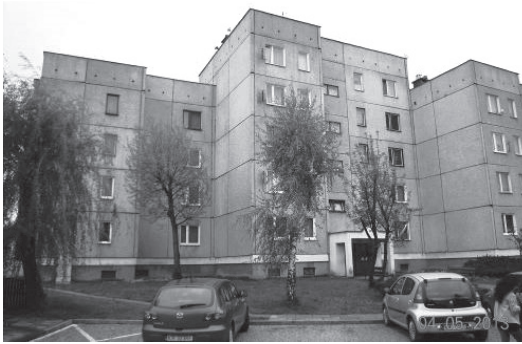
The first tested flat is located at the first level of the five-storey block of flats before thermal modernization (Ill. 2a) but with the new windows. It is a three room corner flat with the separate kitchen and bathroom, total area 53,4 m<sup>2</sup>.

III. 2a. Building #1 – North-East elevation

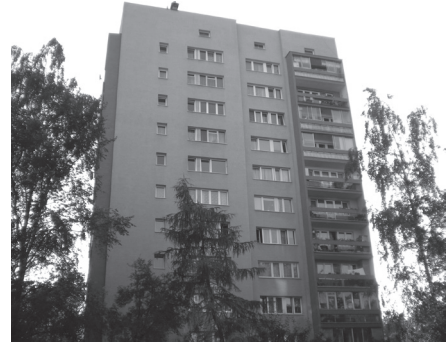
Second flat is located on the seventh floor of the eleven-storey block of flats after thermal modernization (Ill. 2). It is also a three room corner flat with kitchen and bathroom and with the new windows, total area 49 m<sup>2</sup>.

III. 2b. Building #2 – East elevation

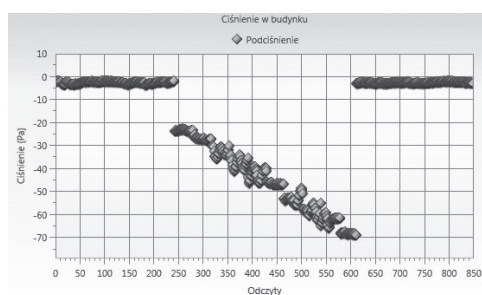
III. 3a. Diagram of pressure difference in building 1 – depressurization test

III. 3b. Relation between air flow and pressure difference in building 1

Test results of both methods, for particular buildings, are presented respectively in Tables 1 and 2 and in III. 3 and 4.

In both buildings, 1 and 2, number of air changes  $n_{50}$ , in case of method A is much higher than permissible value of 3 h<sup>-1</sup>; in building 1 value of  $n_{50}$  is almost 200% higher. However in case of method B, number of air changes, in building 1 is about 27% lower than permissible value, in building B about 40%. The difference between methods is directly connected with the dynamic air flow through the ventilation ducts. Nevertheless, the influence of system joint leaks is clearly noticeable in the tests' results.

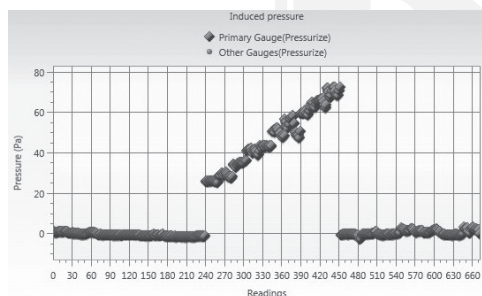
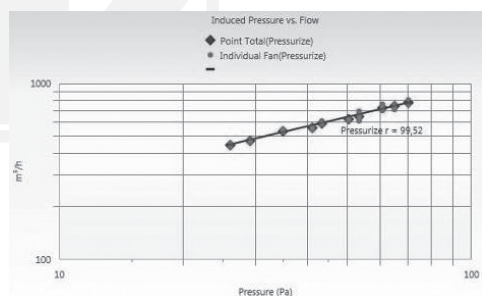
III. 4a. Diagram of pressure difference in building 2 – pressurization test

III. 4b. Relation between air flow and pressure difference in building 2

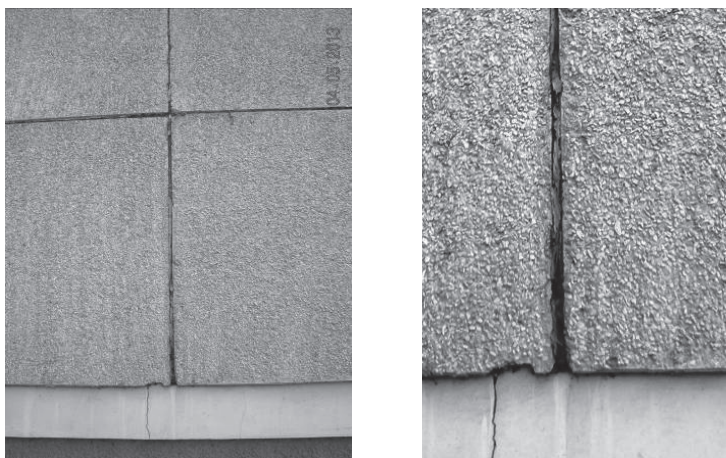
During the tests, the system joints in the not insulated building number 1, were monitored. In this flat, on the external walls, the vertical scratches caused by the presence of the system joints could be observed (III. 5 and 6). Due to the low temperature difference between the internal and external environment, only about 5°C, the infrared analysis were impeded.

III. 5. System joint in building number 1 – external view

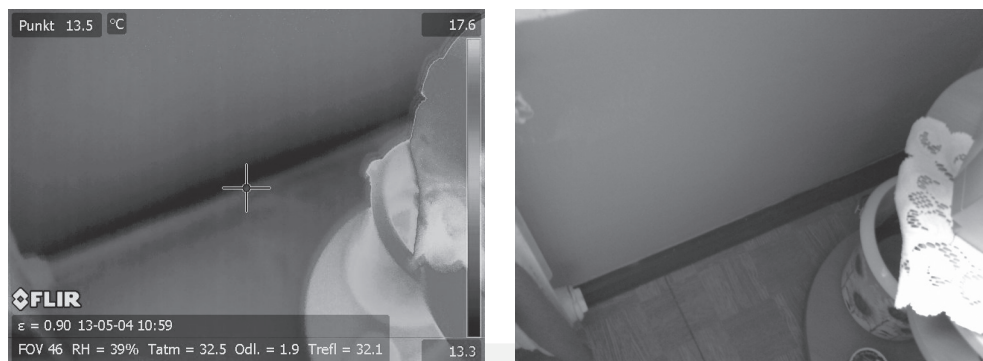
To make the monitoring possible and to increase the air flow through the joints the condition of 100 Pa underpressure was forced. It revealed the other system joint leaks: connection between floor and external wall, connections of windows, results presented in Ill. 7 and 8.

Ill. 7. Thermal bridge – connection between floor and external wall in building number 1

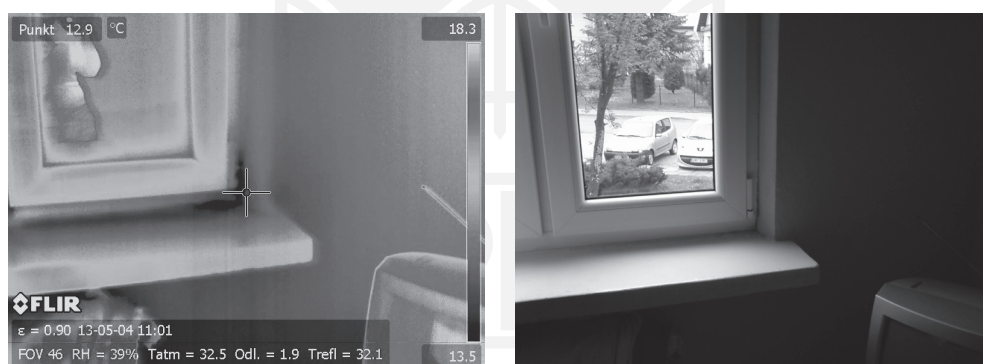
Ill. 8. Thermal bridge – connection between window jamb and external wall in building number 1
