Magdalena Rzeszotarska-Palka (mrzeszotarskapalka@zut.edu.pl)
Department of Landscape Designing, Faculty of Environmental Management
and Agriculture, Westpomeranian University of Technology in Szczecin

CONTEMPORARY DEVELOPMENT CONCEPTS FOR THE ESCARP OF THE
POMERANIAN DUKES' CASTLE IN SZCZECIN

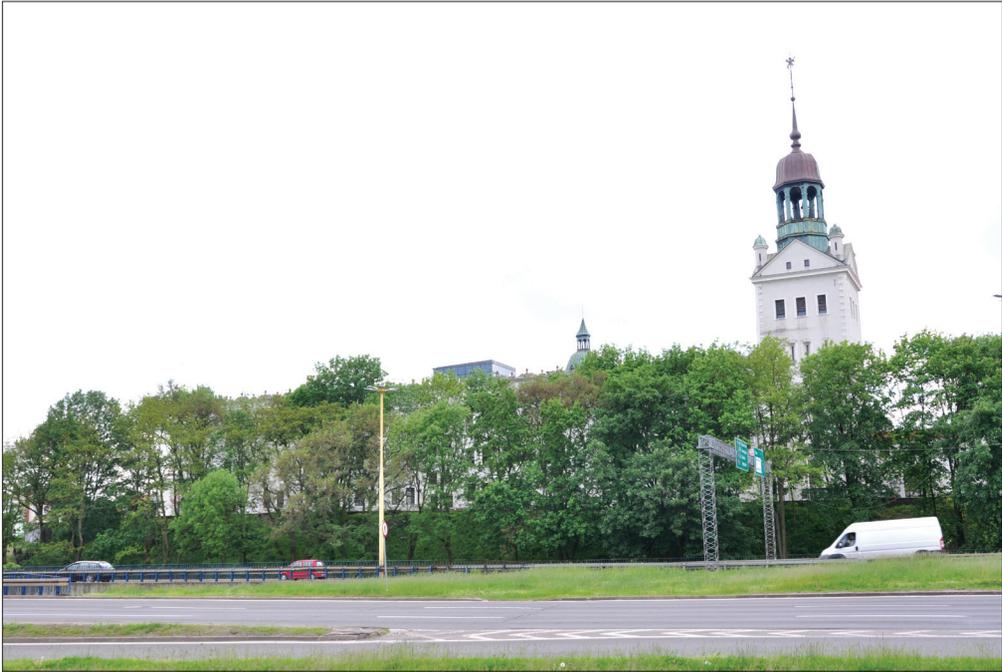
Fig. 3. The Pomeranian Dukes' Castle in Szczecin covered with trees – view from the side of Castle Route (Trasa Zamkowa), May 2017 (photo by M. Rzeszotarska-Palka)

Still the 2010 geotechnical expertise proved that possible earthwork that would change the shape and ecosystem of the escarp could be detrimental [14]. The escarp is made exclusively from non-homogenous made ground, still its condition is currently stable. This is also fostered by the root system of the trees growing there, that plays the role of anchors, and the fact that trees take their water from the ground secures low soil humidity. The permeable soils of the escarp are the gravitational flow path for ground waters towards Odra river, thus the removal of trees would intensify this process and could trigger landslides. Caution was advised in changing the development of that area. It was deemed necessary only to remove the less valuable, unhealthy trees and to absolutely leave the trunks in the soil, with their stabilizing

function replaced over time with newly planted plants. The experts also ascertained that it is not recommended to introduce such changes in the shape of the escarp that would increase its steepness or load [14, p. 7–8].

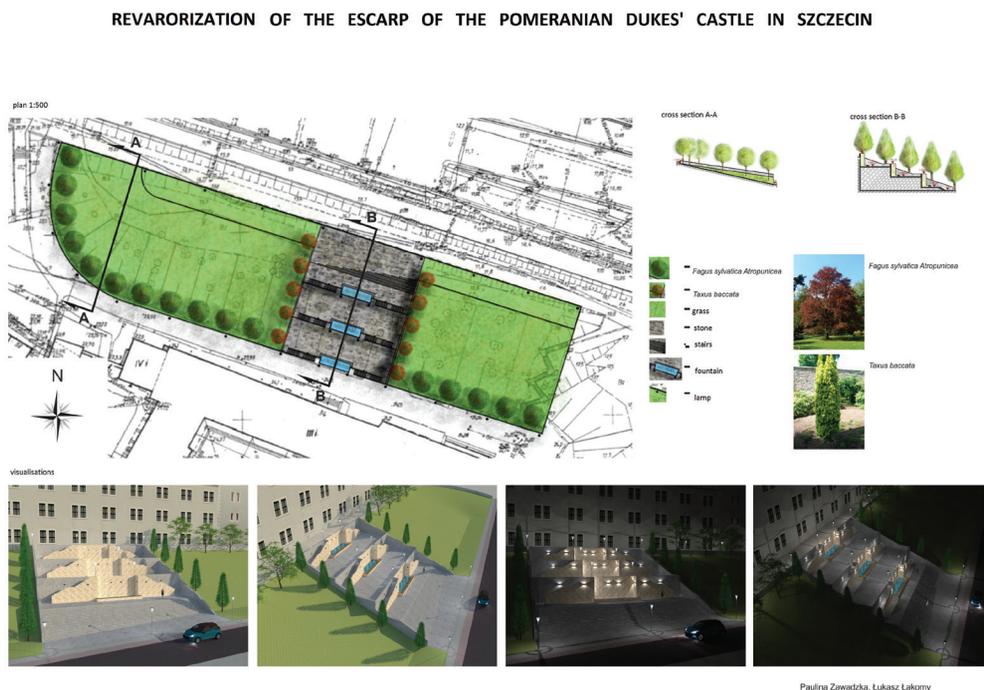
The issue of development of greenery areas around an object as important as the Pomeranian Dukes' Castle in Szczecin also became subject of many concept works developed during the *Revalorization of historic gardens* classes at the faculty of landscape architecture of ZUT in Szczecin. Various concepts with common aim of exposing the castle silhouette were developed under supervision of the author of the present paper. Some of them envisaged complete cutting out of the existing trees, assuming the absolute necessity for stabilization of the escarp with a system of reinforced concrete poles and foundation slabs, with differently composed terraces on top of them – from a style that resembles the renaissance quartered gardens (Fig. 5) to the more modern proposals of walking alleys going gently down the escarp. In other works the students proposed less radical solutions, assuming leaving the existing trees in the lower zone of escarp (following the recommendations of the geotechnical survey), only exposing the castle silhouette (Fig. 4).

Fig. 4. Revalorization of the escarp of the Pomeranian Dukes' Castle in Szczecin, authors: Ł. Łakomy, P. Zawadzka under the supervision of M. Rzeszotarska-Pałka, ZUT in Szczecin 2014

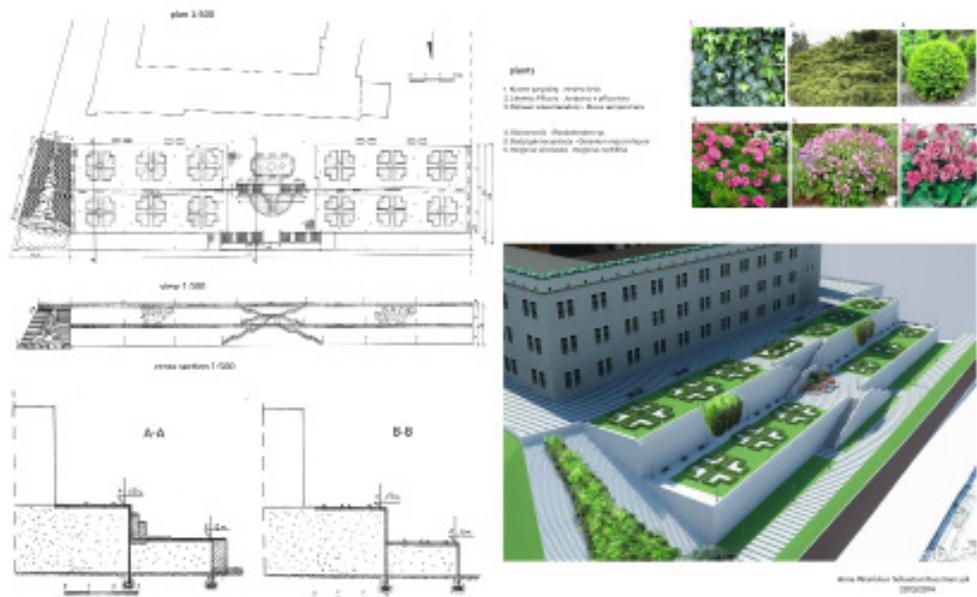
Fig. 5. Revalorization of the escarp of the Pomeranian Dukes' Castle in Szczecin, authors: A. Wisińska, S. Kaczmarczyk under the supervision of M. Rzeszotarska-Palka, ZUT in Szczecin 2014
