JOANNA JADWIGA BIAŁKIEWICZ*

GREATER POLAND RESIDENTIAL ARCHITECTURE AND MONUMENT PROTECTION ISSUES

Abstract

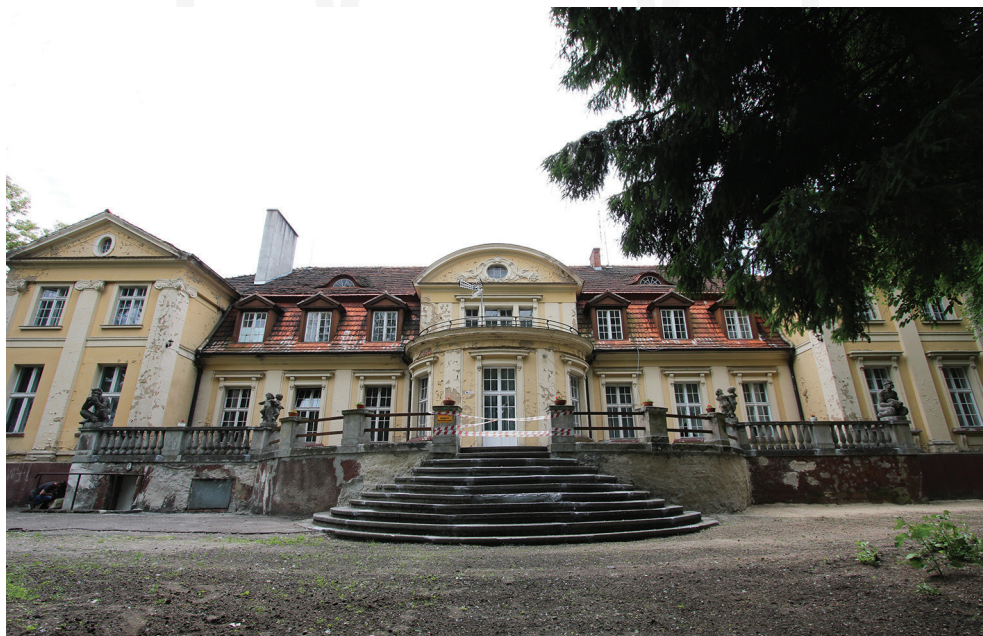
III. 2. Pałace in Bieganowo, garden elevation with a terrace, current condition (photo by J. Białkiewicz)

Currently the palace in Bieganowo is in a very poor condition, with far reaching devastation of the original architectural tissue. The elevations are falling into decay due to progressing moisture on the belt of the plinth as well as the foundation walls. The cracked plaster flakes off. From the side of the façade, the visitors' attention is attracted by a defacing, carelessly made driveway made of asphalt. Nevertheless, from the point of view of preservation the garden elevation is in the worst condition: the retaining wall of the terrace collapsed. This brought about the destruction of the original handrail with balusters and the statues ornamenting it, which for a long time were lying on the terrace on the ruined terrace, not protected against further devastation in any way. A closer look at the elevations reveals next problems: bad condition of the window and door woodwork, alarming condition of the gutters, the rainwater pipes and the roof tiles. The interiors of the palace have also suffered a lot, due to humidity as well as far reaching "renovations", never arranged with the preservation services, connected with covering or destroying numerous historic elements of the fittings. Interestingly enough, the devastation of the palace described above actually occurred over the last 25 years. In 1989 the state of the preservation of the residence in Bieganowo was defined as good in the Record Sheet of Monuments of Architecture and Construction¹¹. Quite so, the photographs from that period present this building in a satisfactory condition, outside as well as inside. Therefore, the question arises, concerning the reasons for such a far reaching destruction of a legally protected monument, caused in a relatively short time.

the Wielkopolskie Province Monuments Preservation Officer set the deadline for the performance of renovation and securing works and arranging the park by the end of January 2009¹⁵. This deadline was not met¹⁶. Only in July 2009 the Agricultural Property Agency commissioned conservator's examinations, which revealed strong negligence of the architecture of the palace, as well as its surrounding area, with the progressive degradation process, calling for immediate conservator's intervention. The documentation from the examination was sent to the office in mid-September, and in December the office prepared a reply in which it conditioned the issuance of a renovation permit on completing the deficits and improving the objections towards the design filed¹⁷. The decision on the permit to conduct the first stage of the renovation works was finally issued in April 2010¹⁸. It was not, however, completed in the validity period of the document, and the Provincial Monuments Preservation Officer did not conduct any inspection which would reveal this situation. In 2012 the palace was inspected due to the planned disposal of the property. For the next time a bad condition of the elevation and a "catastrophic" condition of the terrace was revealed¹⁹, which resulted in a letter sent to the Agricultural Property Agency about the need to obtain another renovation permit²⁰. Similarly to the previous years, however, no specific action were undertaken. When Jadwiga Szafarek was awarded the lease of Bieganowo in a tender, in April 2013 she obtained 50 thousand PLN of financial support from the EU funds, intended for the renovation of the elevation of the palace and replacement of the damaged parts of the roof²¹. The permit of the Wielkopolskie Provincial Monuments Preservation Officer was issued in March²². As a result of the investor's efforts, only the condition of the terrace improved after its provisional repair. The elevations and the roof are still in a very poor condition.

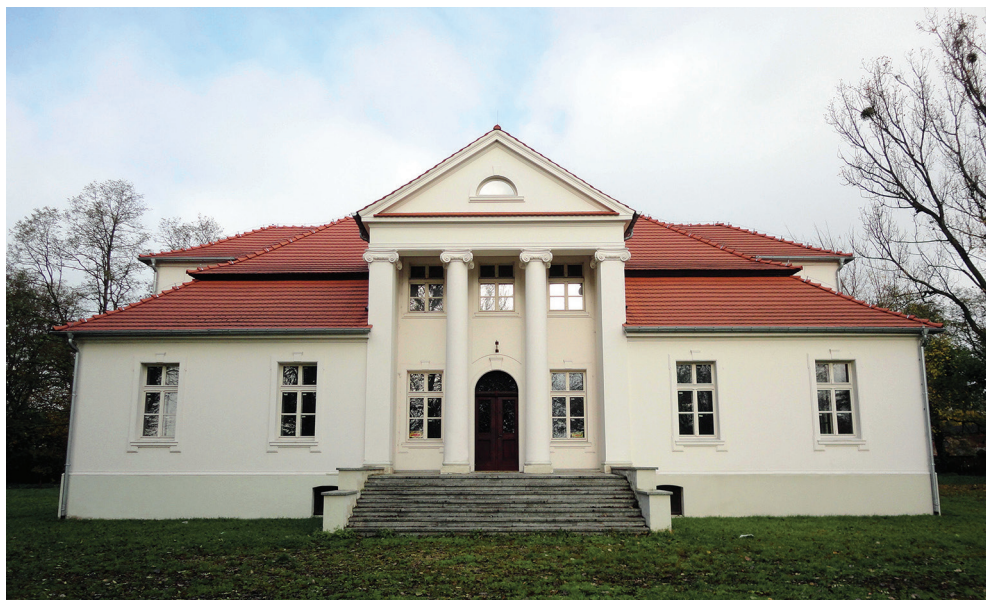
III. 3. Mansion in Wódki, front elevation, current condition (photo by J. Białkiewicz)

The renovation of the mansion in Wódki was realized in the years 2004–2009 and can serve as a model of revalorization of this type of buildings. The foundation, basement and ground floor walls were dried, anti-water installation was executed and plasters were renovated, maintaining in the off-white colour, characteristic for mansions and harmonizing with the light beige plinth and oak wood entrance door. The window woodwork was replaced (due to its poor technical condition), restoring the original shape of the windows. All the preserved details: window frames, cornices, heads of the columns, were subjected to maintenance works. Furthermore, the destroyed roof truss and covering in the “old” part of the mansion were replaced. New elements appeared, as well, connected with the planned hotel function of the mansion: a simple column portico with a tympanum emphasizing the main entrance to the “old” part of the mansion from the east, and a wooden porch from the west; furthermore, a “kitchen” entrance from the north (in the “old” part) was covered by a roof on wooden supports. The renovation of the interiors comprised e.g. the demolition of the secondary partition walls erected in the 1970s, cleaning, strengthening and securing the original wooden staircase in the hall, cleaning the original colours of the walls and completing the original parquet in the hall.

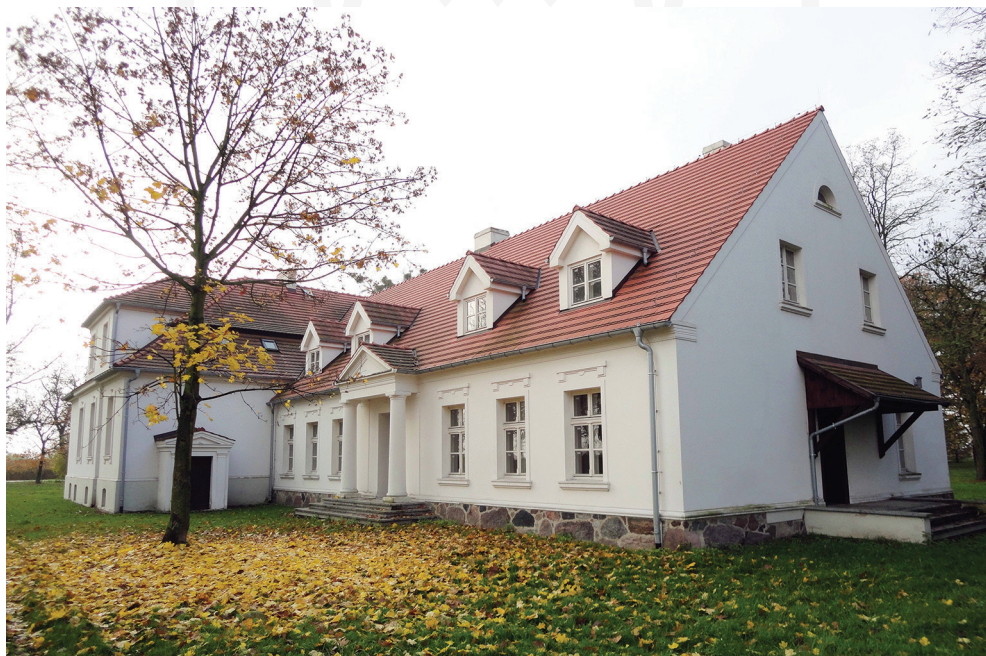
III. 4. Mansion in Wódki, side elevation, current condition (photo by J. Białkiewicz)
